Strengthening of bridge slab at Kami-Imasu Bridge (Japan)

8. Strengthening of Bridge Slab at Kami-Imasu Bridge (Japan)

Owner: Japan Highway Public Corporation
Engineer: Japan Highway Public Corporation
Date of Construction: 1964
Date of Repair: 1976

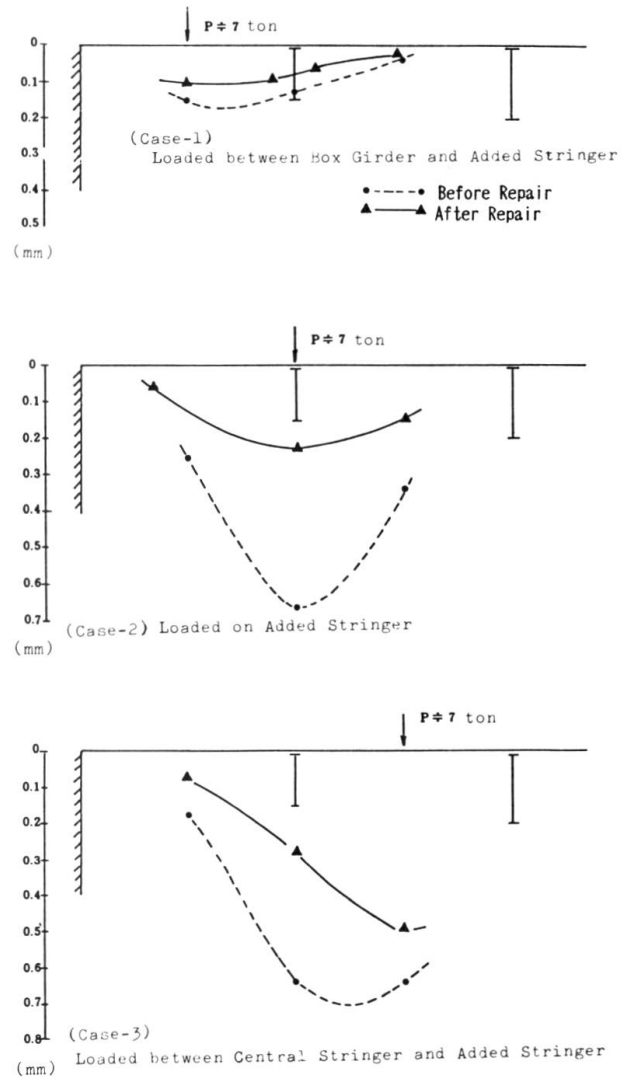
Fig. 2 Effect of Repair

A loading test was conducted, using a truck with a 7-ton rear wheel load in order to measure the difference of deflections before and after the strengthening. The result is shown in Fig. 2.

In cases where the wheel was located between the main box girder and the added stringer (Case-1), on the added stringer (Case-2) and between the original stringer and the added stringer (Case-3), the deflections at the loading points after repair were decreased to 60%, 66% and 78%, respectively. The repair work is, thus, estimated as successful.

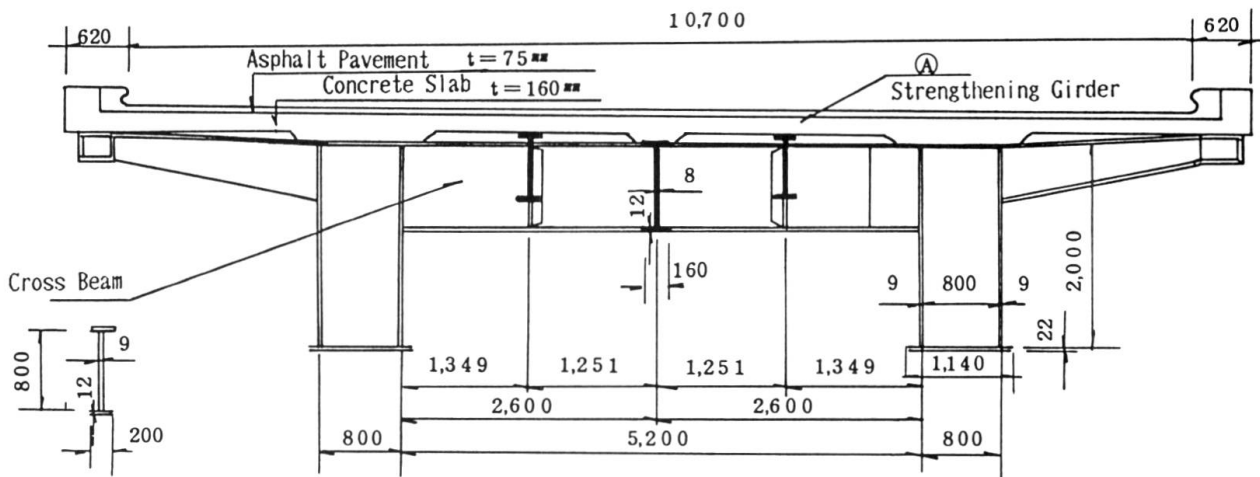
Fig. 1 Structure

After ten years of service, cracks in the slab increased to such an extent that it had to be repaired and strengthened. Finally it was decided to install stringers in between the original main box girders and the original central stringers as shown in Fig. 1. The reasons for the adoption of this method are as follows:

- 1) The traffic volume was so large that it was difficult to conduct the repair work on the upper side of the slab.
- 2) It was expected to be sufficiently effective on decrease of the bending moment of the slab.
