The Collapse and Reconstruction of a Prestressed Concrete Box-Section Girder

Hugo Bachmann

Werner Horisberger,

During the construction of a prefabricated hall roof, a 25 m long prestressed box-section girder collapsed. The major cause of the failure was an inadequate structural design of the support regions. There was no transverse end beam present and support bearing points were not placed beneath the webs of the girder. The resulting transverse bending together with insufficient end anchorage led to the collapse. 45 similar beams, of which half were already erected, were in consequence locally strengthened in the support regions. Thus an original remedial solution, scarcely externally visible, was developed and tested through an on-site load test.

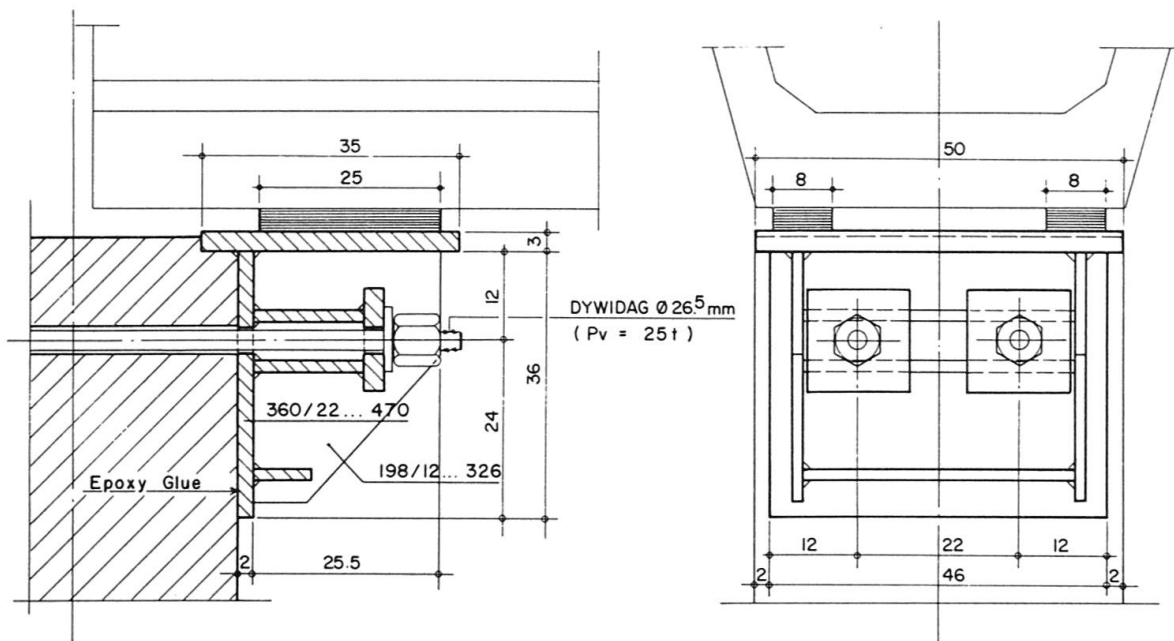
Two problems stand with this solution. Firstly, there is the introduction of eccentric nib loads to the edge columns. Then secondly there is the taking up of torsional effects on the girder stemming from one sided loading during erection. There are also the further disadvantages of high costs, difficult realisation with the already erected sections and dissatisfactory aesthetics. Therefore this variant was not taken any further.

A further possible remedial solution consists of sitting the girders upon steel nibs as shown in Fig. 15. If the deformation of the support surface is away from the end then sufficient end anchorage is guaranteed. The choice of special small neoprene pads allows the transference of the support forces directly beneath the webs. This largely eliminates the transverse bending. The steel nibs are connected to the in-situ concrete columns with post-tensioned rods.

Fig. 15 Remedial solution "Steel Nib"

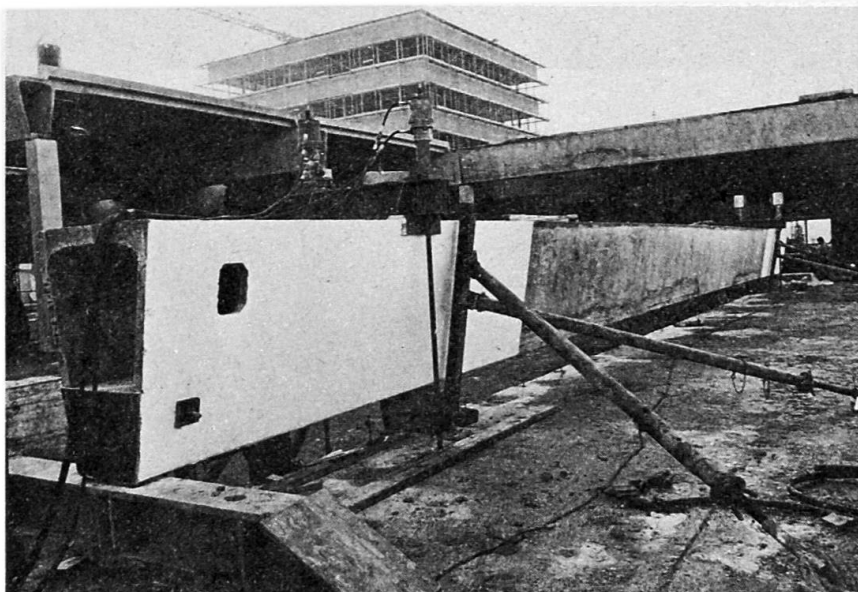
A view of the test arrangement is given in Fig. 19. The girder with 25 m span was placed over a wall of the very stiff lower storey. The centre point of the neoprene lay only 7 cm from the girder end which corresponded to the most possible extreme position in the system.

Fig. 19 Test at the building site

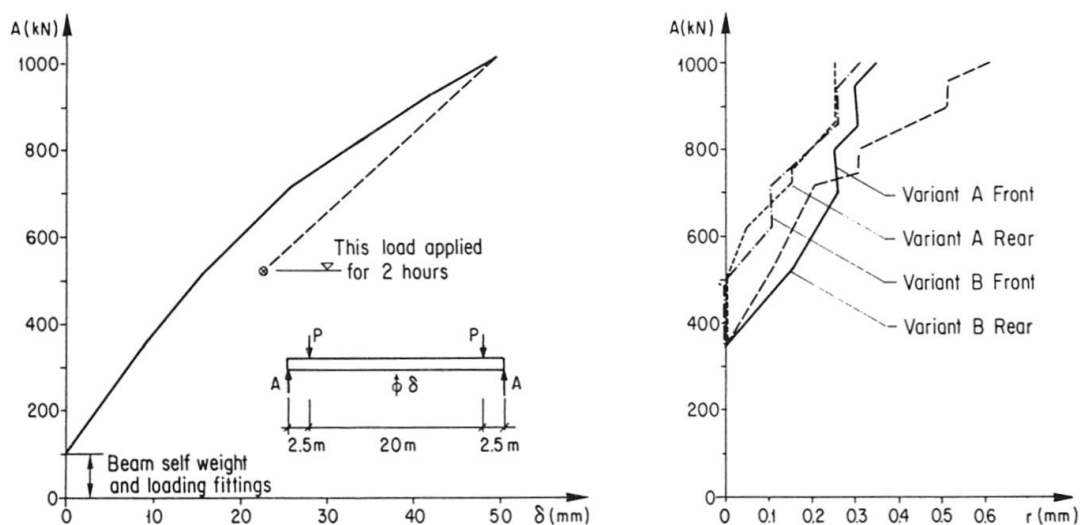
Both remedial solutions showed themselves to be workable. The self weight of the beam and the test fittings led to a support reaction of 115 kN. With a support reaction corresponding to that of a full working load i.e. with $Q(g+p) \approx 500$ kN there first appeared a few cracks in the web of maximum width 0.15 mm. The mid-span deflection (without self weight) was 16 mm. Following on from here a load giving a support reaction corresponding to twice the working load reaction, i.e. $2Q(g+p) \approx 1000$ kN, could be obtained without fracture. Under this maximum loading the largest crack width in the webs was 0.60 mm and the deflection midspan = 50 mm. Fig. 20 shows the midspan deflection and also the crack widths as functions of the support reaction. Fig. 21 shows the crack pattern at the girder end A.

Fig. 20 Midspan deflection of the girder and also the largest crack width r in the webs as a function of the support reaction
