The Clifton Suspension Bridge – Preservation for Utilisation

M. Stuart CULLIMORE

Deputy Chairman
Clifton Suspension Bridge Trust
Bristol, UK

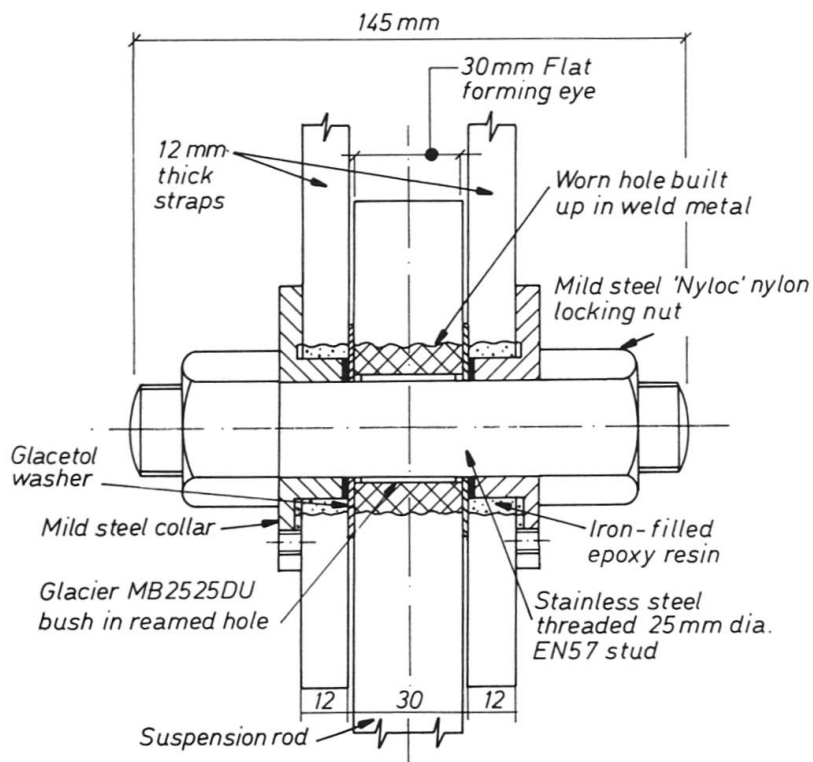
Fig. 6 Suspension rod bolt replacement

The shackles and cleats were repaired in situ by fitting bushes bedded in iron loaded epoxy resin injected into the worn eyes (Fig. 6). Stainless steel studs, 25mm dia. replaced the 38mm dia. wrought iron bolts. The bottle screws in the rods had been freed by injecting penetrating oil under pressure so that when replaced the length of the rods could be adjusted to equalise their tensions.
