Flash Floods on Bridge Piers

Alfonso KRUMDIECK

Civil Engineer
Electrowatt Eng. Services Ltd.
Zurich, Switzerland

3. THE FLASH FLOOD OF FEBRUARY 13, 1982

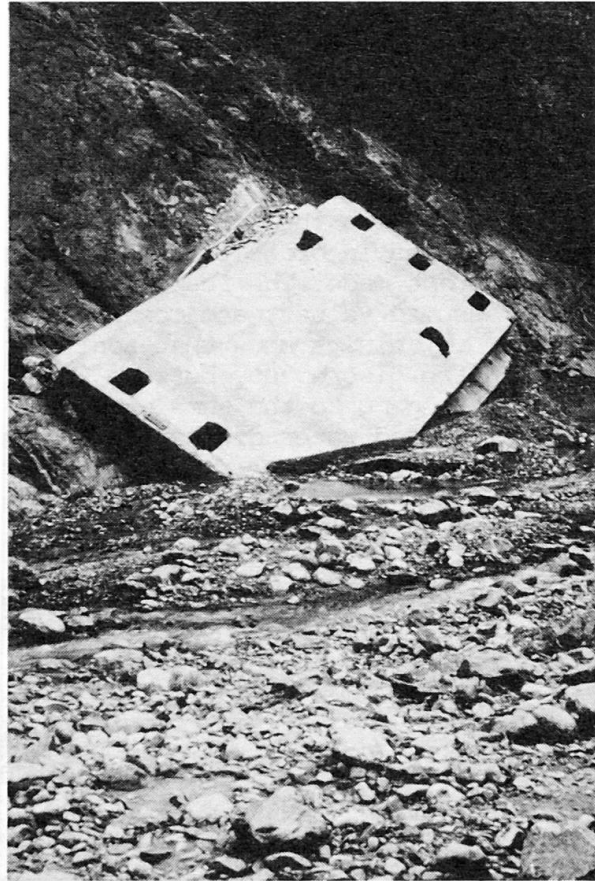
Huge quantities of bed material were reported to have been dragged along the river bed. The peak velocities which occurred during the event could not be directly measured. From eye witness accounts these were estimated to be about 30 to 60 km/h, however these must be judged critically. Taking into consideration that huge bridge slabs of 200 tons of weight or more were moved hundreds of meters downstream, it can be safely assumed, that peak velocities of approximately 50 km/h occurred, (see Fig. 2).

FIG. 2 200 Ton Bridge slab after the flash flood.

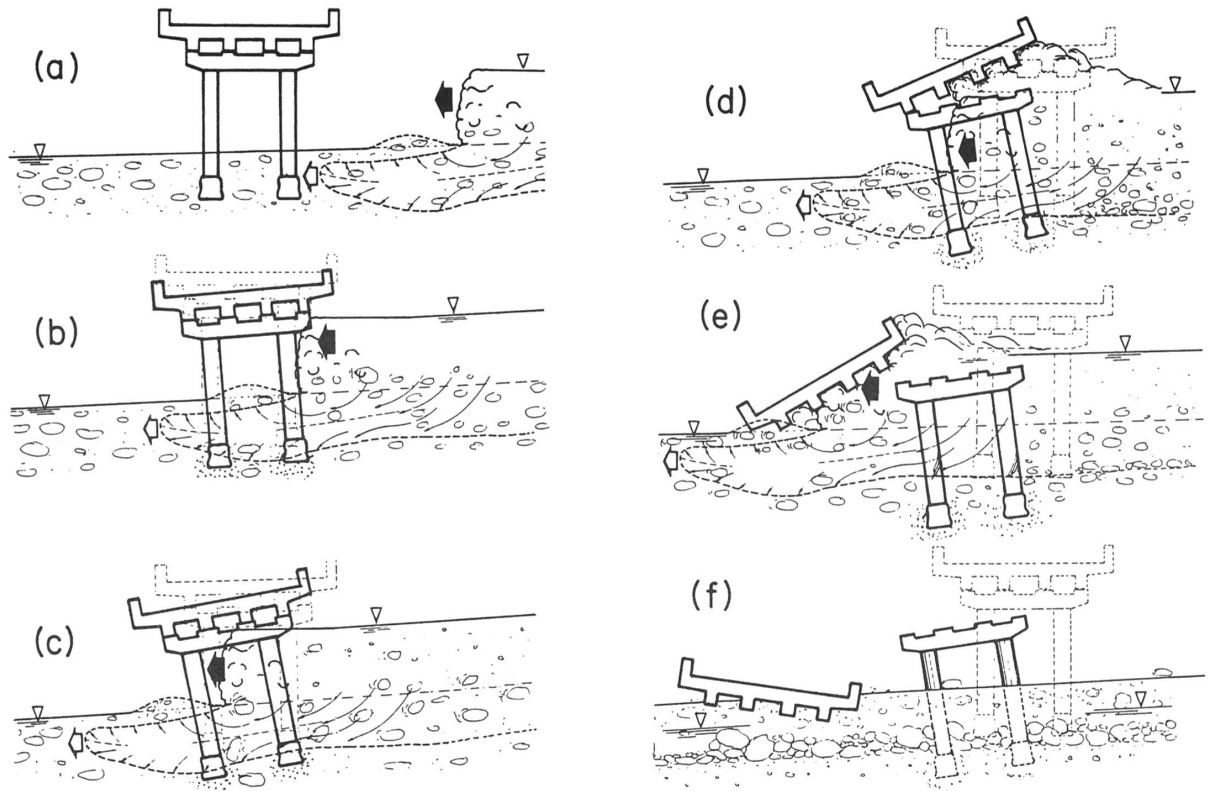
It is postulated that this temporary fluidization of the soil in front of the water wave caused those piers to collapse or to sink before erosion had time to act. This temporary fluidization of the soil is also the reason which allows the incoming water wave to enrich and to reinforce itself with not only the water retention pirated from the saturated soil, but also with the fluidized soil debris as well. This explains why the measured discharge runoff can be, in certain cases, far greater than the calculated discharges from the rainfall records alone.

Figure 4 gives a schematical interpretation of the sequence of events suffered by at least one of the bridges of the catastrophic flash flood that occurred on February 13, 1982. The photographs of figures Nr. 5, 6 and 7 taken after the catastrophe, demonstrate that the piers have sunk and moved several decimeters and meters but were not broken, and the displacements are evident.

FIG. 4 SCHEMATICAL VIEW OF PROPOSED FAILURE MECHANISM

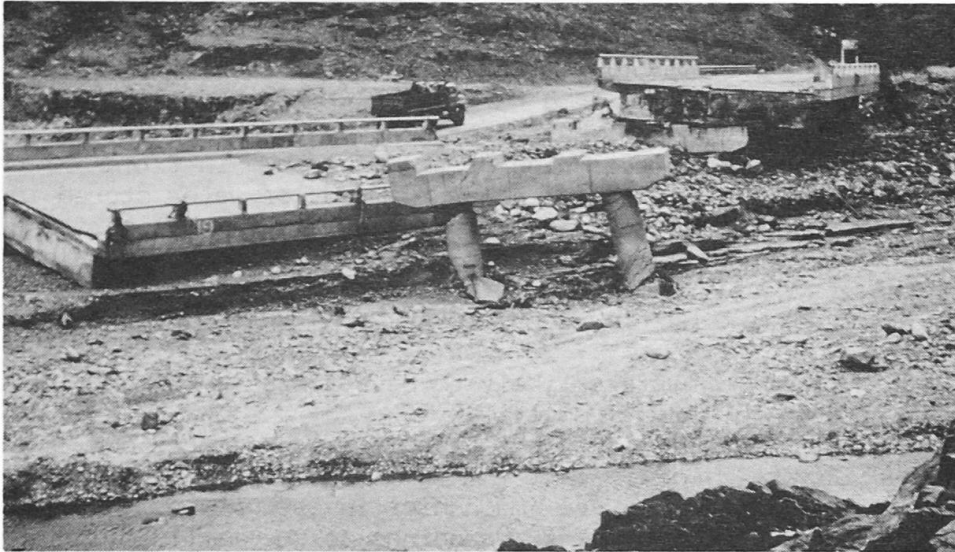
FIG. 5 Bridge destroyed by the flash flood of February 13, 1982.

Bridge piers in rivers which are likely to be affected by flash floods should be designed in the most conservative way.

1. To check with a thoroughly soil mechanics investigations, the possibilities that the soil may have on its surroundings to become fluidized in any time of the usefull life of the bridge.
2. The foundations of the bridge piers should be deep enough.
3. To provide pier protections, inclusive for the part below the surface of the river bed.
4. The design height for the bridge slabs should take into consideration the possibility of an incoming flash flood peak.

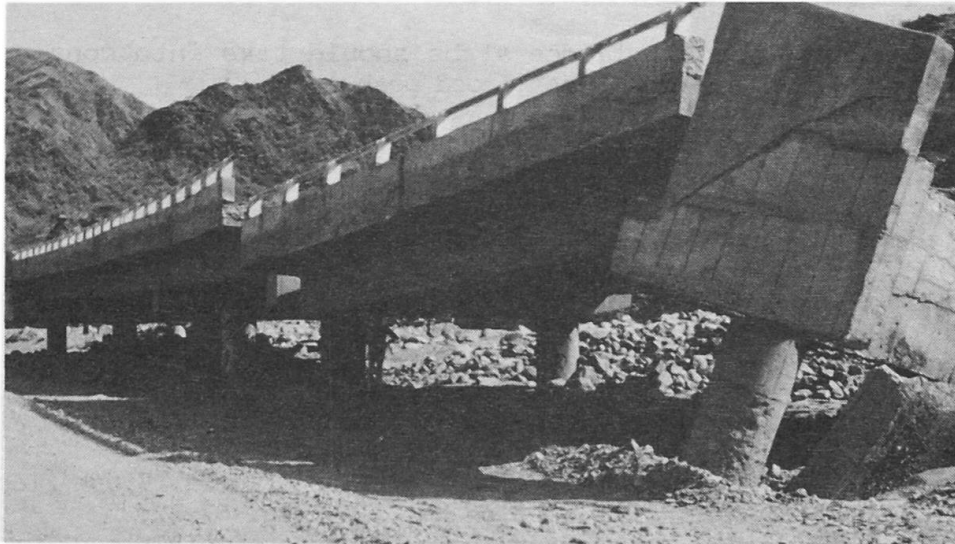
FIG. 6 Piers sunken due to fluidization of the river bed.

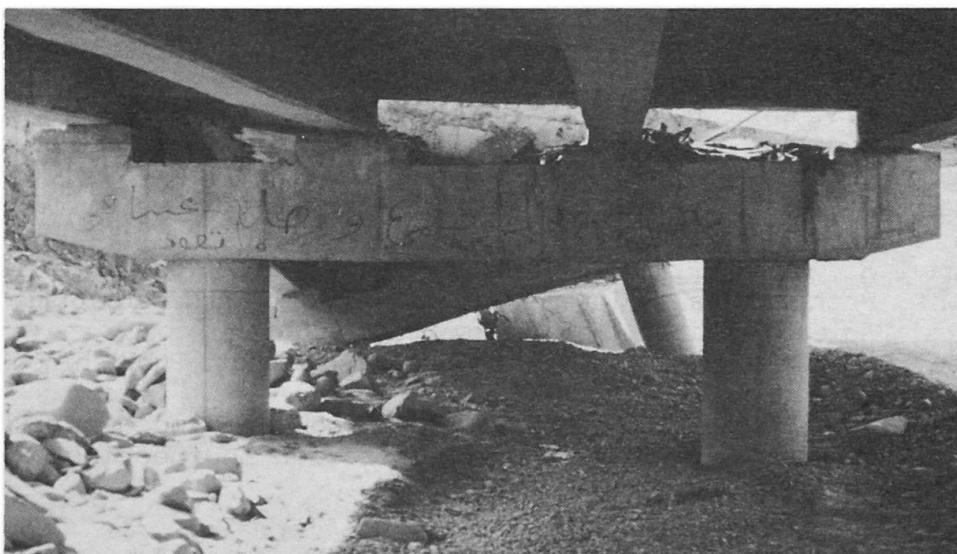
FIG. 7 Support structure damaged by the flash flood.
