Zeitschrift: **IABSE reports of the working commissions = Rapports des commissions de travail AIPC = IVBH Berichte der Arbeitskommissionen**

Band (Jahr): **2 (1968)**

AMERICAN EXPERIENCES WITH THICK PAVEMENTS ON ORTHOTROPIC STEEL DECK BRIDGES

F.F. FONDRIEST

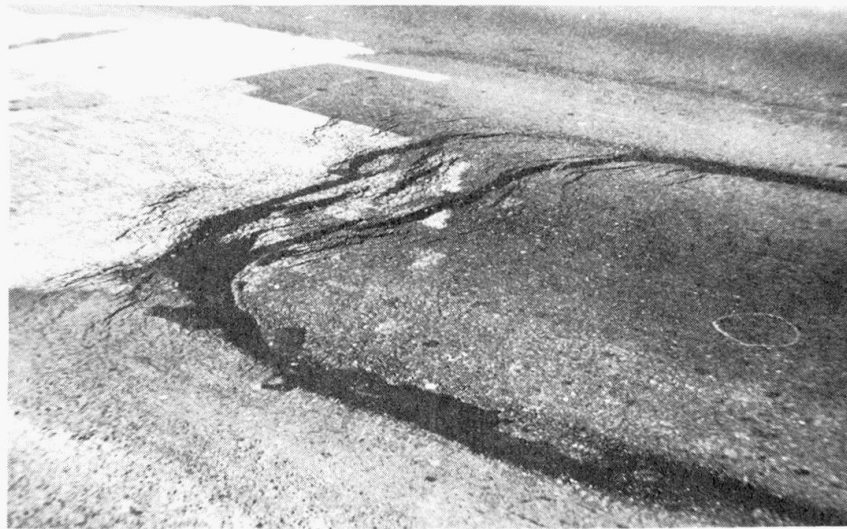
Within a few weeks after being opened to traffic, random cracks appeared in the AC surfacing. Shortly thereafter the pavement began debonding and within three months was literally shoved off the bridge. The mode of failure can be seen in Figure 3. The AC was replaced again using only an emulsion tack coat to bond the pavement to the deck plate. Within nine months the new AC pavement had again failed in the same manner as before. The pavement was replaced a second time in the same manner. This third pavement has remained in place and is performing reasonably well after almost two more years of service.

FIGURE 3. MODE OF FAILURE DUE TO DEBONDING OF THE AC PAVEMENT ON THE ULATIS CREEK BRIDGE AFTER ONLY A FEW MONTHS IN SERVICE

As was shown in Table 2 there is a wide variation in the amount and gradation of aggregate chips used. The importance of an effective bond can be determined from the experience of the AC surfacing placed on a portion of the Ulatis Creek Bridge. In this installation, only an emulsion tack coat was used to provide bond between the deck and the pavement. This lack of bond resulted in a complete failure of the pavement. Another instance of a lack of good bond was noted on the Troy Test Bridge where a heavy loading of fine stone chips was used in conjunction with an AC leveling course. After about 2 years in service, moderate cracking had occurred in the surfacing and upon removal of the pavement, little or no bond was found between the seal coat and the asphalt pavement. There was, however, sufficient shear resistance to prevent the pavement from shoving. The only other instance where the bond between the bond coat and the pavement was qualitatively checked was on the Humphreys Creek Bridge. In this instance the bond was found to be excellent.
