# Prepared discussion

Zeitschrift: **IABSE reports of the working commissions = Rapports des commissions de travail AIPC = IVBH Berichte der Arbeitskommissionen**

Band (Jahr): **2 (1968)**

DISKUSSIONSBEITRAG  
ZUM THEMA III (DÜNNE FAHRBAHNBELÄGE)

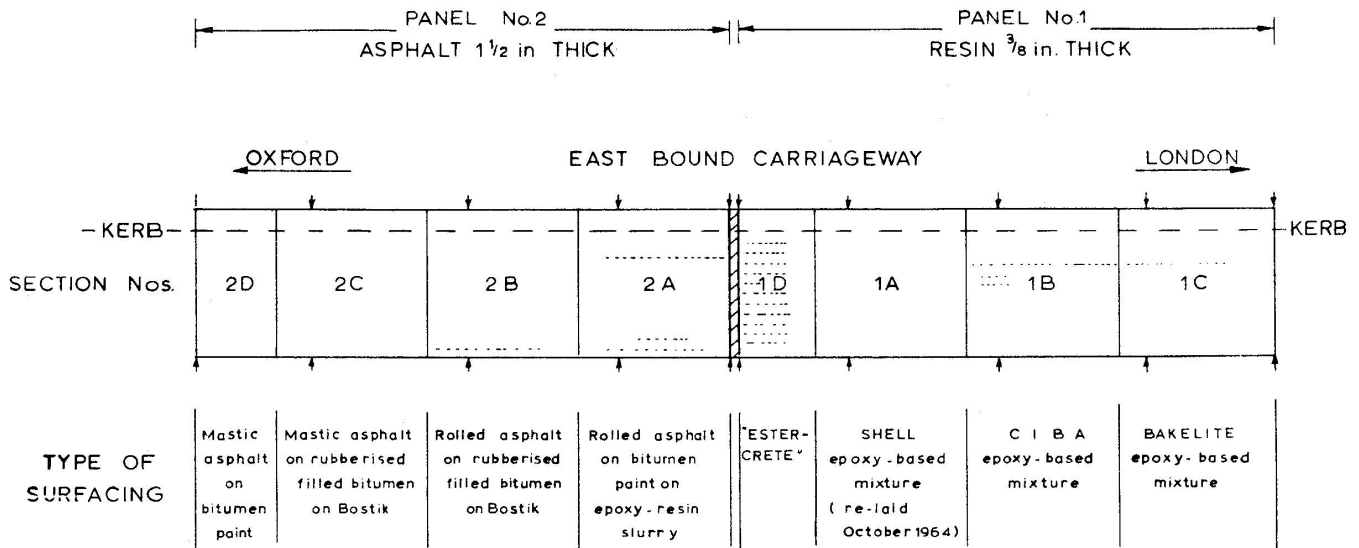
NOTE: The small arrows show position of the transverse stiffener.  
 The cracks visible in the surfacings in April 1965 are shown thus.....

Fig. 2 LAY-OUT DIAGRAM. SEVERN BRIDGE TEST PANELS ON TRUNK ROAD A40 (WESTERN AVENUE), DENHAM, BUCKS., NOVEMBER 1963.

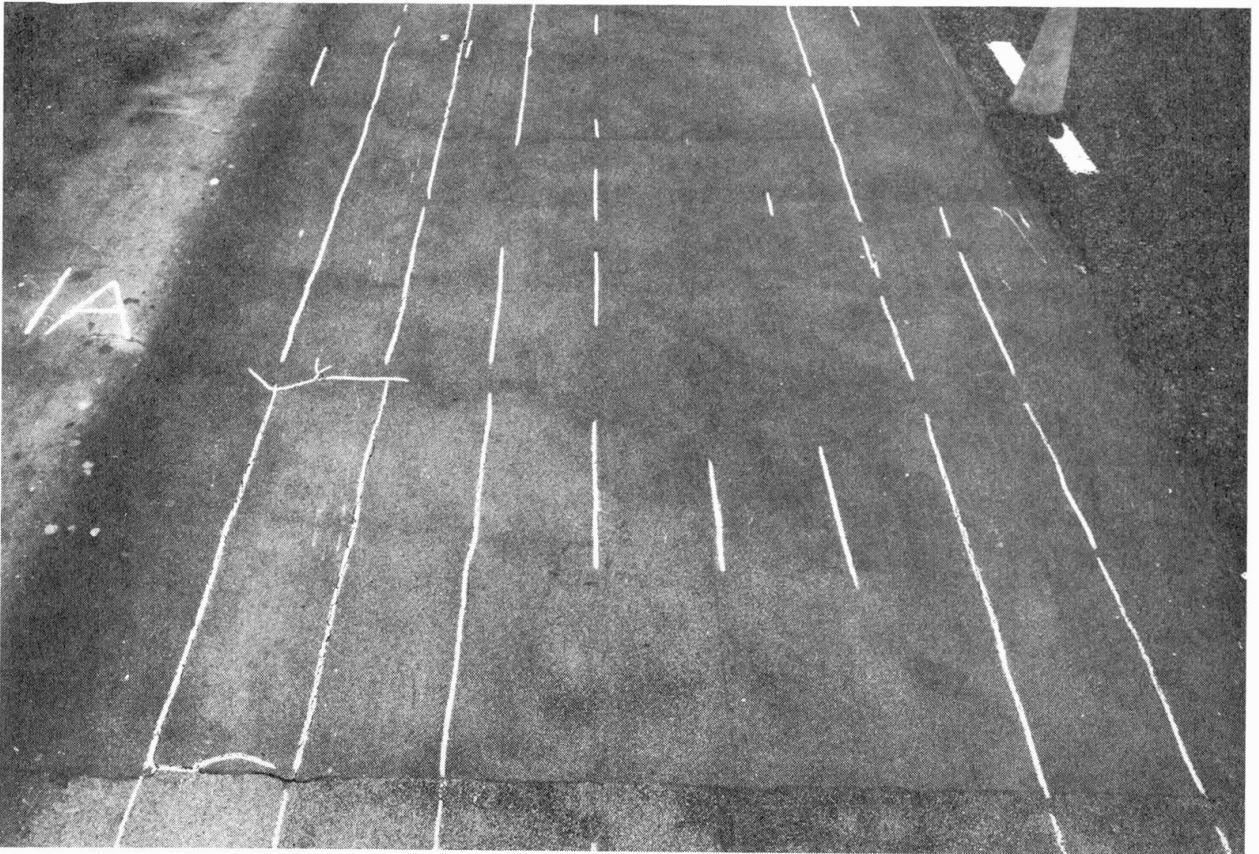
The panels were opened to traffic in November 1963. The first cracks appeared over the stiffeners in the wheel tracks on Sections 1A and 1D, early in 1964. Subsequently, there was a rapid deterioration of the condition of Section 1A, probably due to a defective constituent in the resin, and it was replaced in October 1964. The replacement was made with a fresh batch of the material to the same specification. It was more durable than the previous batch, but it deteriorated in a similar manner and was removed in April 1968. Cracks have developed in the "Estercrete" on Section 1D over all the stiffeners, but they have not widened appreciably and the material still firmly adheres to the steel.

FIG. 3 CRACKING IN EPOXY RESIN SURFACING ON SECTION 1A, NOVEMBER, 1967

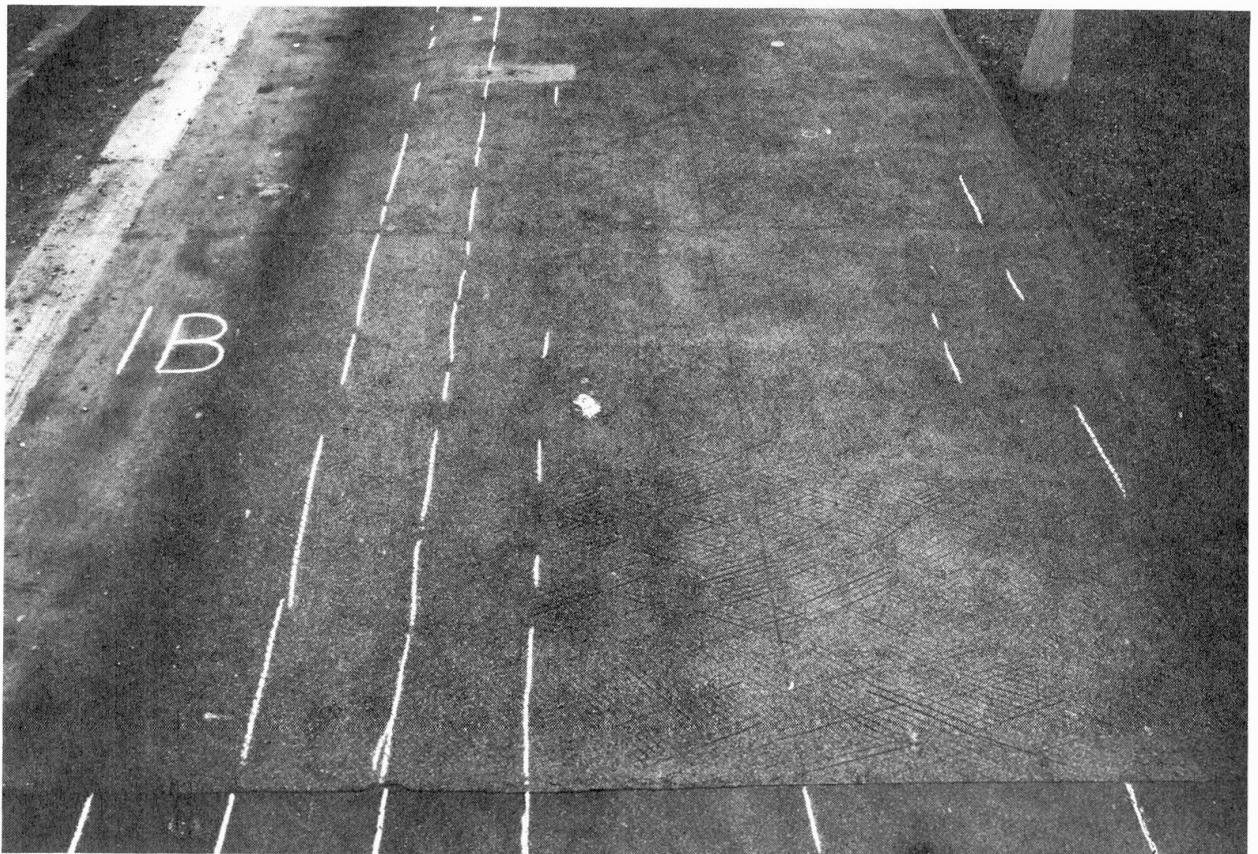
On Sections 1B and 1C the surfacing was in good condition until the beginning of 1965. Then one crack appeared over the stiffener in the nearside wheel track. Since then additional cracks have developed in both the wheel tracks, but the materials still adhere firmly to the deck between cracks. The condition of the four resin surfacings in November 1967 is shown in Figs. 3-6. As reported in a previous paper the mastic asphalt laid at the same time is still uncracked and has vindicated its selection for the deck of the Severn Bridge in 1966.

The resin on Sections 1B, 1C and 1D would still be regarded as providing a good running surface with a good skidding resistance. However, they are not adequately protecting the steel in a region where a small amount of corrosion could have a serious effect on both the ultimate and fatigue strength of the bridge deck.

FIG. 4. CRACKING IN EPOXY RESIN SURFACING ON SECTION 1B, NOVEMBER, 1967

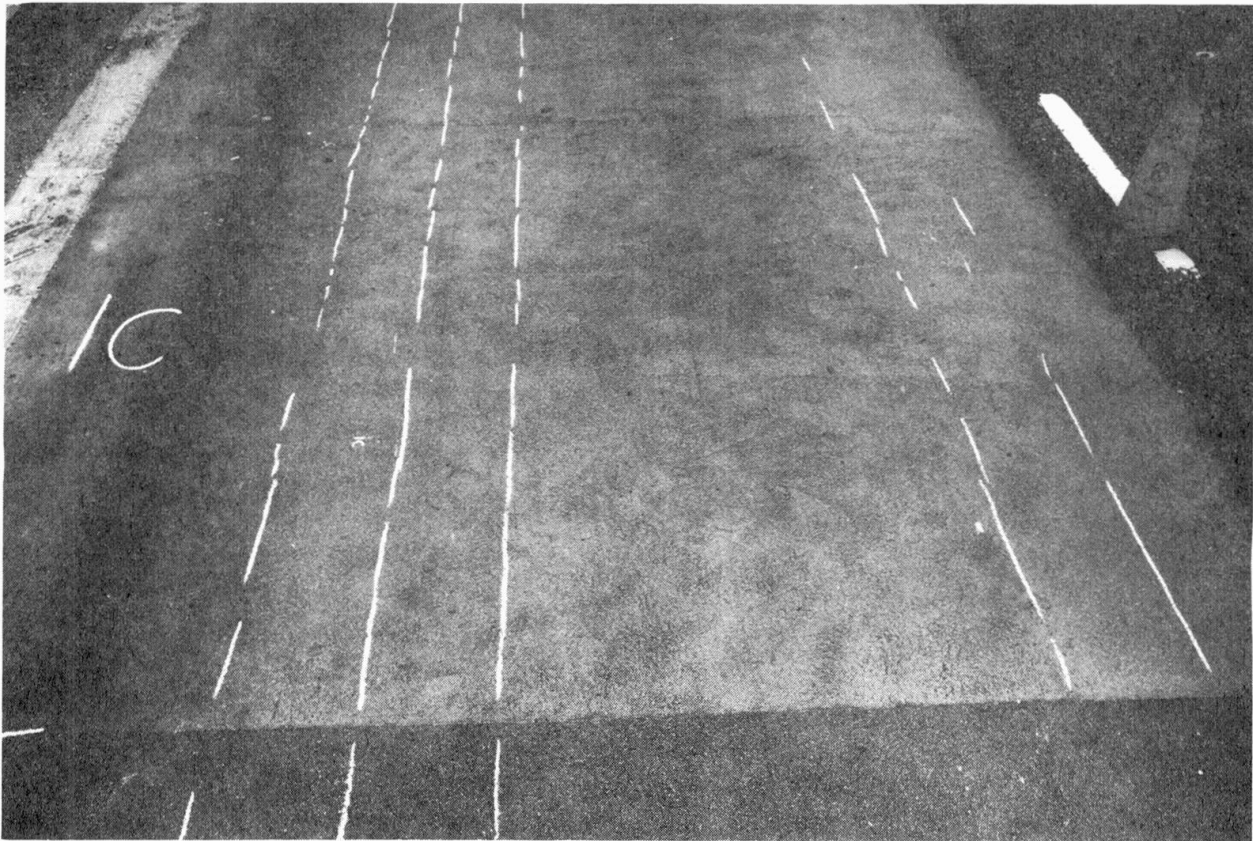
FIG. 5 CRACKING IN EPOXY RESIN SURFACING ON SECTION 1C, NOVEMBER, 1967

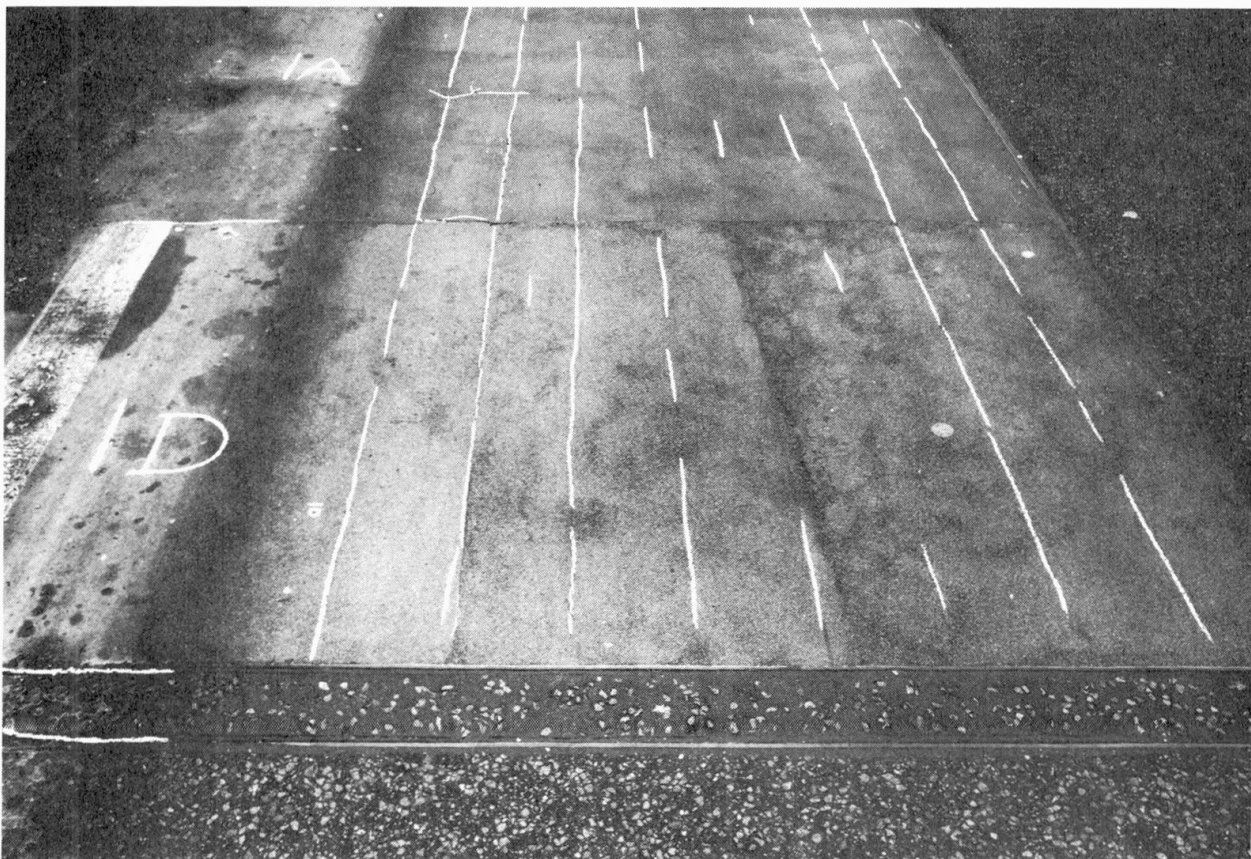
FIG. 6 CRACKING IN "ESTERCRETE" SURFACING ON SECTION 1D, NOVEMBER, 1967
