# Session III: Construction, performance, renewal

Zeitschrift: **IABSE reports of the working commissions = Rapports des commissions de travail AIPC = IVBH Berichte der Arbeitskommissionen**

Band (Jahr): **032 (1979)**

**Construction, Performance, Renewal**

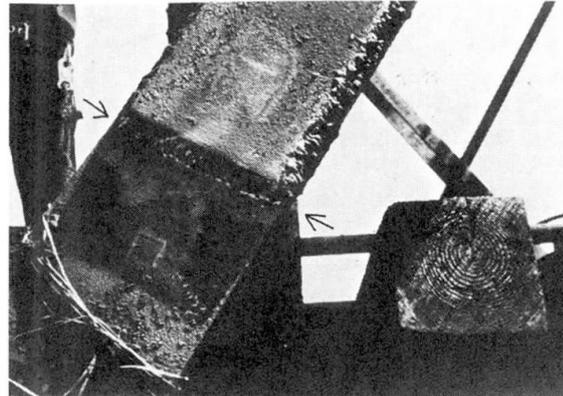
Fig. 18 Eye Bar Weld

The type of repair shown in Figure 18, the addition of welded plates to an eye bar member could be a disaster in a non-redundant load path structure. The crack is illustrated by the light line of magnaflux at the toe of the weld. In this bridge, because of its multiple load paths, collapse will not occur if one of these members cracks through.

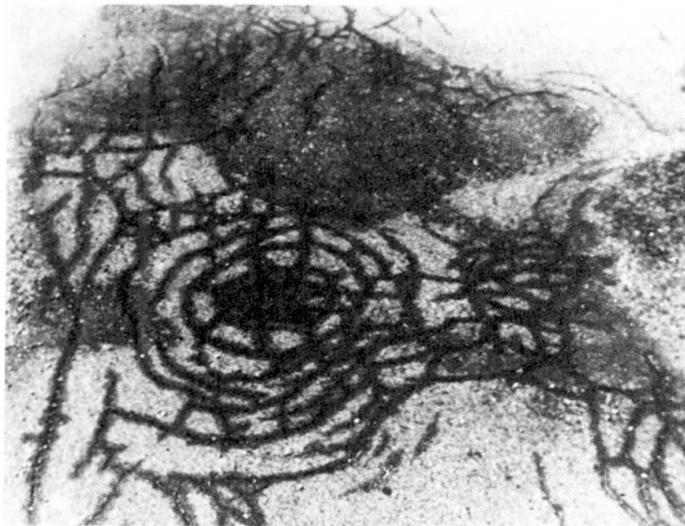
Fig. 3 Destruction du revêtement

Pont de Giustia à Marmorera, altitude 1684 m, route du Julier, section Bivio - Marmorera. Année de construction: 1958

La remise en état a entraîné la démolition du revêtement en mortier bitumineux, le piquage du béton sur 10 cm d'épaisseur et son remplacement, le renforcement de l'armature de la dalle de roulement et la pose d'une couche d'étanchéité en lès de nylon enrobés d'une masse bitumineuse, adhérente sur le béton de la superstructure. Les désordres ont été réparés en 1974.

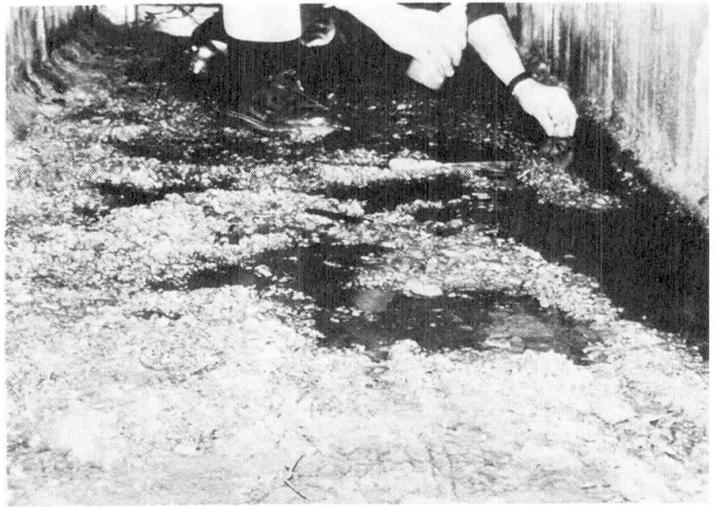
Fig. 8 Dégât de gel au plancher de caissons inaccessibles

Dégâts de gel au plancher de caissons inaccessibles (fig. 8). Les désordres sont causés par l'action corrosive des sels de dégel. Par suite d'un déboitement de canalisation, l'eau s'est accumulée dans les caissons. La corrosion du béton a atteint 7 cm de profondeur.

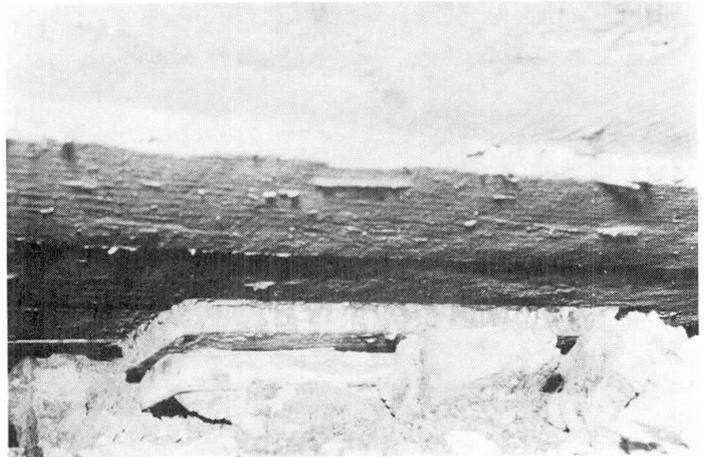
Fig. 9 Désordres aux assises d'appuis

Pont du Steilerbach, Sufers, N 13c, altitude 1420 m, section Andeer - Hinterrhein, année de construction 1959. La remise en état, exécutée en 1972/73, a nécessité le renouvellement de l'étanchéité, le drainage des caissons et le remplacement des appuis et des joints de dilatation.

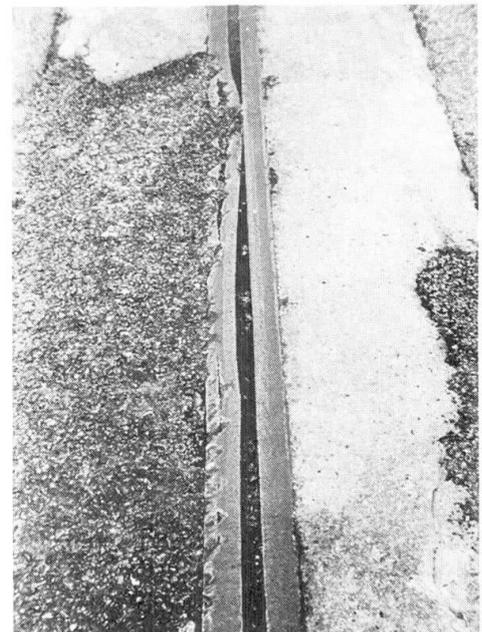
Fig. 10 Joint de dilatation endommagé

Les joints de dilatation en saillie sur le revêtement sont accrochés au passage par les lames des chasses-neige. Les joints de construction trop légère ne résistent pas aux sollicitations répétées du service hivernal (fig. 10).

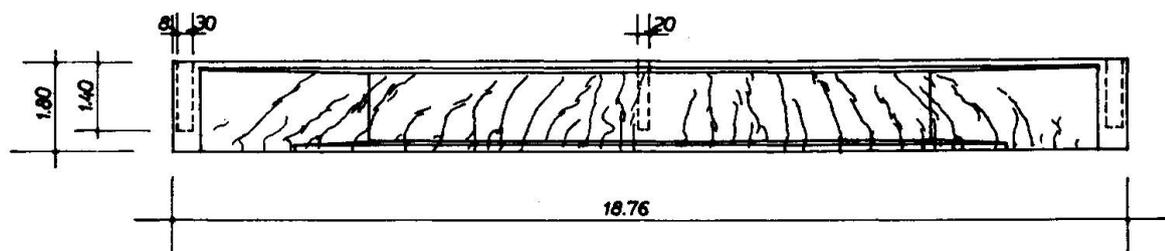
Fig. 2 - Crack pattern on the external rib of bay No. 21

As an example, figure 2 shows the cracks of the external rib of bay No. 21.
