Some Remarks on the Service Behaviour of Steel Railway Bridges

R.A.P. SWEENEY

CN Rail

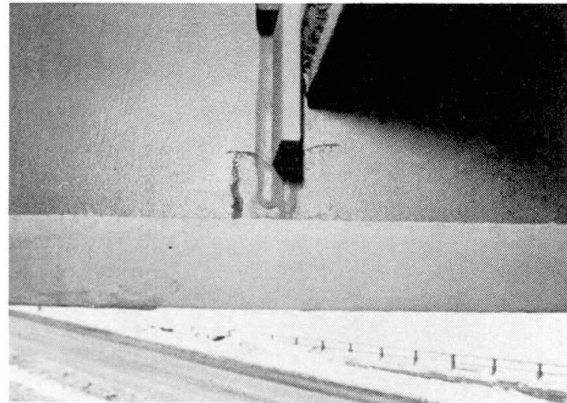
The first group of problems to turn up on our railway on welded structures were cracks at the bottom of stiffeners on skewed structures. Figure 4 is typical of this detail with a diaphragm or brace frame attached to the stiffener. Note that the stiffeners are not extended to the bottom flange. This was in blind obedience to the dictum of an early researcher in welded construction that one should not weld to the tension flange. Because of the stresses introduced by the differential deflections of the connected girders, and to small out-of-plane movements, the first cracks appeared in less than 5 years on heavily travelled lines.

Fig. 4 "U" shape crack

The crack would start at the bottom of the stiffener and form a "U" shape crack around the bottom of the stiffener. If the original stiffener-web weld was of good quality, this crack would turn out into the web and slow down considerably.

Unfortunately in many cases the only adequate cure is not to have the detail in the first place. If the crack isn't going to go anywhere, and if it has not damaged the structure too severely, it is best left alone as the retrofit may make things worse. Cracks at the bottom of stiffeners tend to be in this category.

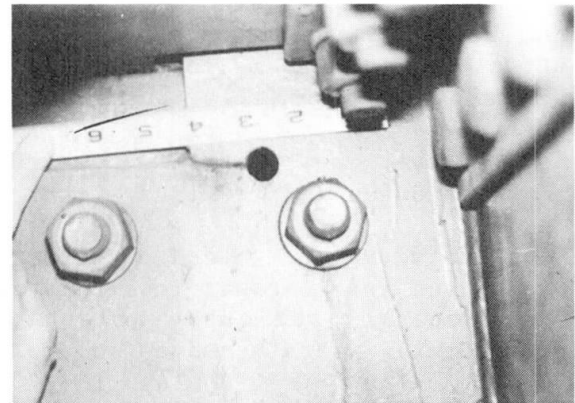
Fig. 7 Zero Radius

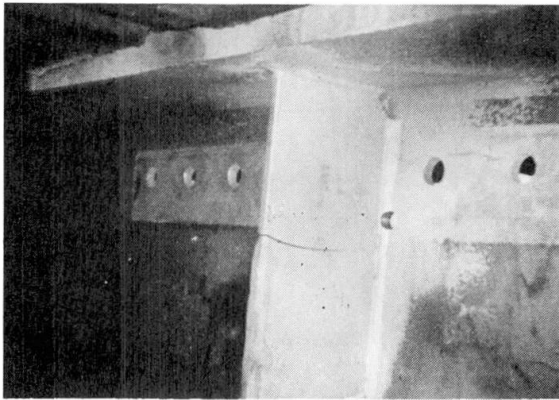
Fig. 11 Hole at Stiffener

In some cases such as where a crack penetrates the stiffener to web weld a minimum of three holes must be drilled. The following procedure has been used successfully on at least two bridges:

1. Drill 7/16 diameter holes on both sides at the stiffener through the web at an approximate angle of 30° away from the stiffener (Figure 11) making sure

to get a truly circular hole with as few rough edges as possible.

2. The resulting hole in the web should be reamed from the outside using a reamer of the same diameter throughout.
3. Attention should be taken so that all rough edges are made smooth even though a truly circular hole is not obtained. Hand filing may be necessary.

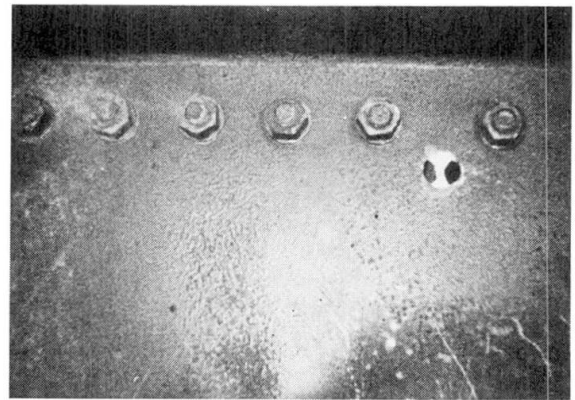
Fig. 12 Other Side

Figure 12 was taken after the two holes drilled from the inside had been reamed to one hole from the outside flush with the stiffener on the inside. The white metal along the vertical centerline of the hole is the stiffener.

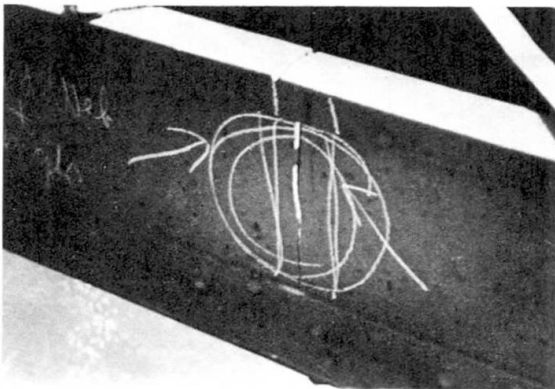
Most riveted structures were internally member redundant in that they were fabricated of several components (Figure 3). Their advantage is that cracks do not jump from piece to piece. The chord member of the truss shown in Figure 13 cracked on one side, but not on the other side of the member, and carried rail traffic for some time before detection and repair. In a welded box like member the crack would have propagated all around.

Fig. 13 Crack in chord

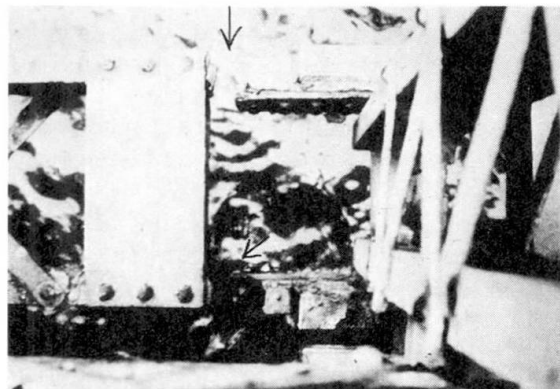
Fig. 14 Chord Severed

Most trusses are multi-load path structures. The truss in Figure 14 had its bottom chord completely severed and yet remained standing because of the alternate load paths provided by the bracing, floor system, etc. The truss shown in Figure 15, which did not have adequate bracing, did not remain standing when one of its diagonals was severed by a shifting load. It is unfortunate that it didn't have sufficient redundancy.
