The long-term behaviour of viaducts subjected to heavy traffic and situated in an aggressive environment: the viaduct on the Polcevera in Genoa

R. MORANDI

THE VIADUCT ON THE POLCEVERA, FOR THE GENOA-SAVONA SPEEDWAY.

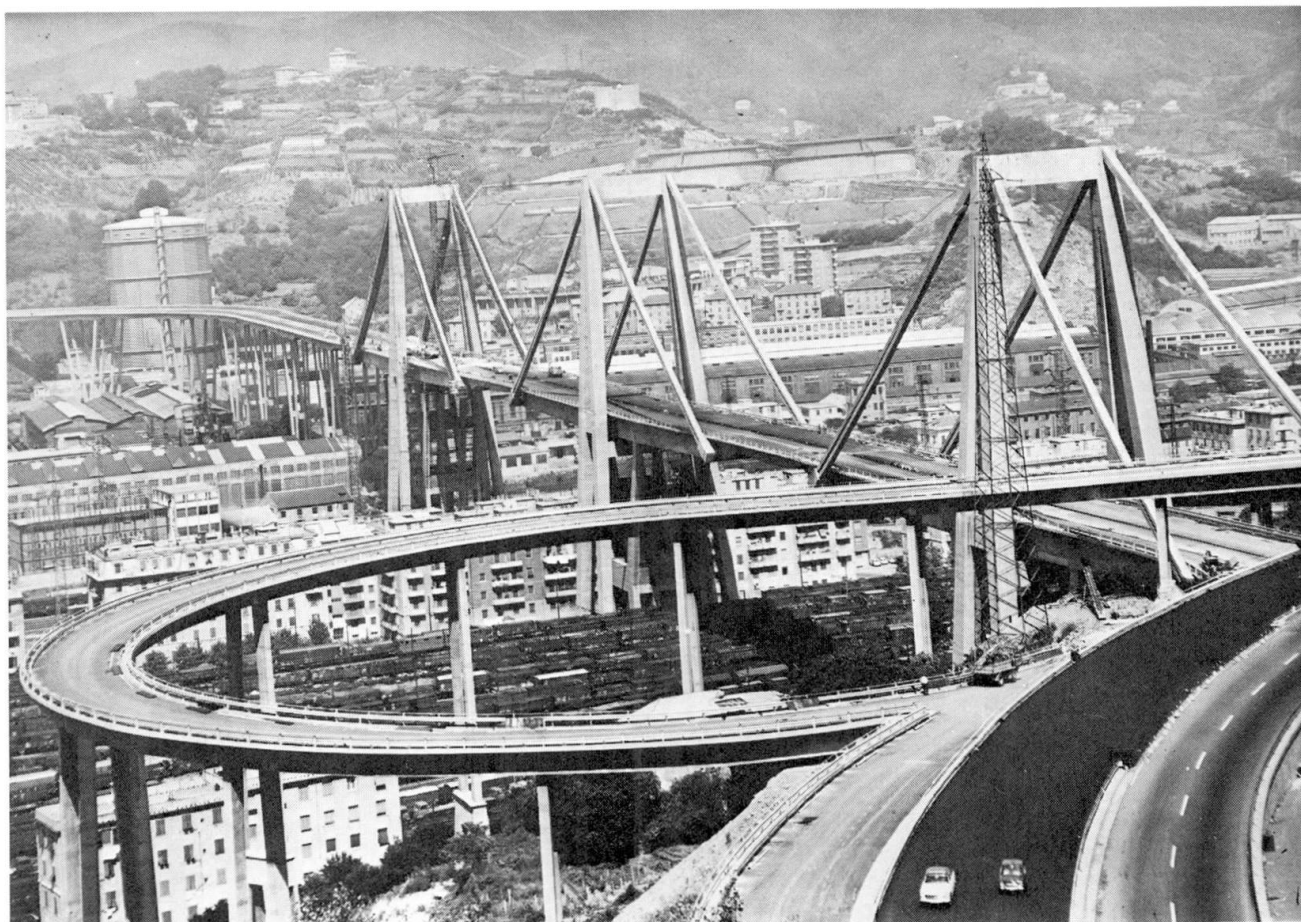
Figure 3 - General view of the structure.

Essentially, it has been ascertained that the structure stands the very heavy traffic to which it is continuously submitted without signs of deterioration or static inadequacy.

Some slight cracks of a very small size (much below 0.2 mm) have been noticed in the secondary connecting cross elements - which obviously had not been prestressed - and which were surely due to the vibration caused by the traffic.

In the whall structure, besides some small imperfections of execution which caused some small rust spots to appear on isolated areas due to insufficient end cover of reinforcement, the project has carefully placed within the concrete all steel elements, except, of course, the cadmium-lined plates of the bearings for the simply supported girders.

All these plates have been literally corroded in little more than five years by the extreme aggressiveness of the atmosphere and had to be substituted, with rather complicated processes, with stainless steel elements.

Furthermore, in these last years the external surfaces of the structures and especially those exposed towards the sea and therefore more directly attacked by the acid fumes of the chimneys, start showing an aggression phenomenon of a chemical origin.

This is obviously due to the production of soluble salts resulting from the combination of the acids of the fumes with the free lime of the concrete : the well-known loss of superficial chemical resistance of the concrete itself.

I think that sooner or later, may be in a few years, it will be necessary to resort to a treatment consisting of the removal of all traces of rust on the exposure of the reinforcements, to fill the patches, with epoxidic type resins and finally to cover everything up with elastomers of a very high chemical resistance.
