Artikel: Restoration and widening of the Tasman bridge

Restoration and Widening of the Tasman Bridge

D.J. LEE

B.K.G. CROSSLEY

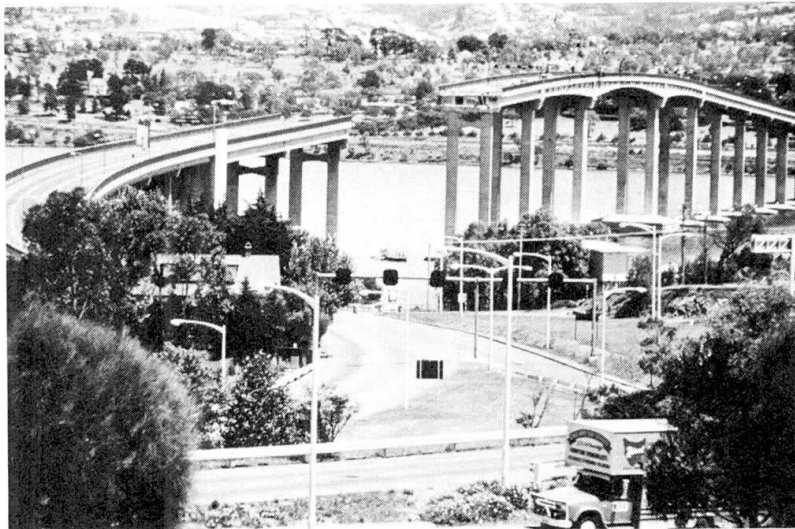
Fig. 1 Tasman Bridge after collapse

In January 1975, the ore carrier S.S. Lake Illawarra, fully laden and displacing 17,000 tonnes, collided with Piers 18 and 19 of the bridge bringing down these piers together with three spans of the eastern main viaduct and leaving a gap of 128 m. The centre one of the three spans fell on the bow of the ship which quickly sank, the tragedy resulting in the loss of twelve lives. The severence of the only road link also caused quite substantial social disruption, as the eastern shore has mainly dormitory suburbs, with the majority of the city's infrastructure being on the western shore.

The consequences of the accident to the remainder of the bridge were relatively minor as it had performed in accordance with design provisions. Span 16-17, the only remaining eastern main viaduct span on the river side of the gap, had remained in position supported by the stay bolts. Pile Cap 20 had suffered severe damage when it was hit by the falling span 19-20, whose trajectory of free fall was intercepted by one end hitting the bow of the ship. The columns on either side of the opening were deflected towards the gap at the top by up to 200 mm and the lower part of the columns was severely cracked. Otherwise the remaining 19 spans of the bridge were undamaged.

As the majority of the bridge was intact, the decision to renovate rather than rebuild was a straight forward one, as not only would it be much cheaper but also very much faster, the latter being of prime importance under the circumstances.

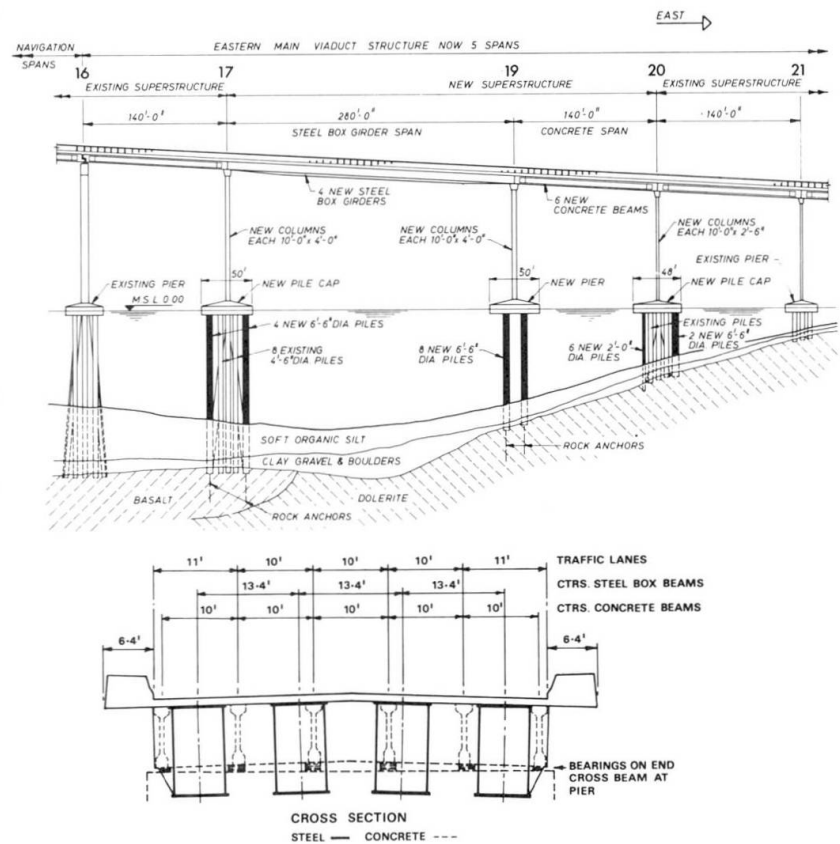
Fig. 4 Details of restoration

The method adopted is shown in Fig. 4 and has been reported on previously by LESLIE [7] and [8]. As the broken 1.4 m diameter piles at Pier 18 (40 m to bed level being the deepest part of the river), rose 15 m above the mud level this pier was omitted and the method involved the replacement of the three fallen spans by two spans; an 85 m steel span 17-19 and 43 m concrete span 19-20. Cross-sections are shown in Figs. 6 and 7. The scheme involved 14 new 2 m diameter vertical piles rock anchored at the base, some of which were to be used both as falsework piles and permanent piles. Foundation conditions were predetermined using one borehole per pile and were good, consisting of almost fresh dolerite at Piers 19 and 20 and partly weathered basalt at Pier 17. At Piers 17 and 20 the existing columns and pile caps had to be demolished and replaced. At Pier 17 additional piles, working in conjunction with the eight existing 1.4 m diameter raking piles, a bigger cap, and heavier columns were required to resist the greater loads from the double span. At Pier 20 there are no additional loads, but it was considered necessary to replace the badly damaged pile cap and columns, and the falsework piles required to achieve this were incorporated into the permanent structure, although not strictly required from a strength viewpoint. As there was a considerable time saving involved, the replacement of the substructure at these two piers was to be undertaken without demolishing the flanking spans (total mass 1,250 tonnes each) supported by them.

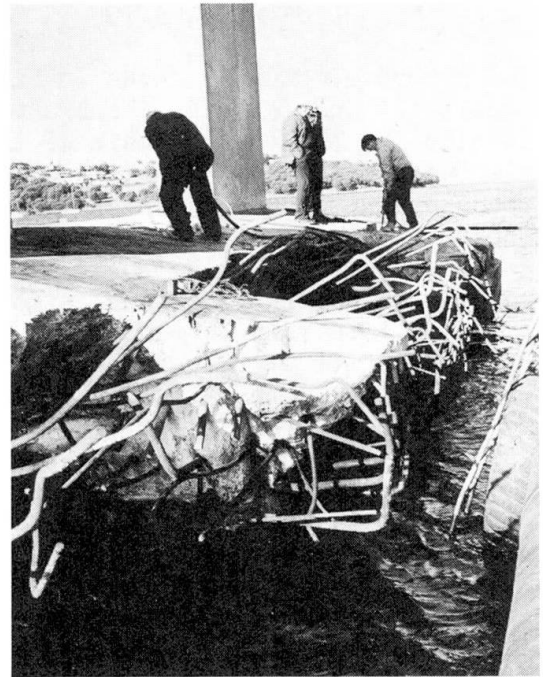
The security of Pile Cap 20 was more difficult as it had lost about one third of its volume (Fig. 5) and the remainder was extensively cracked and in some places crumbled. Its load carrying capacity was unknown and although it had to be replaced later it was decided to do temporary repairs before any major work commenced. These were in two parts:-

Fig. 5 Damage to Pile Cap 20

- Replacement of the concrete which had been removed without attempting to repair or remove and replace the cracked concrete.

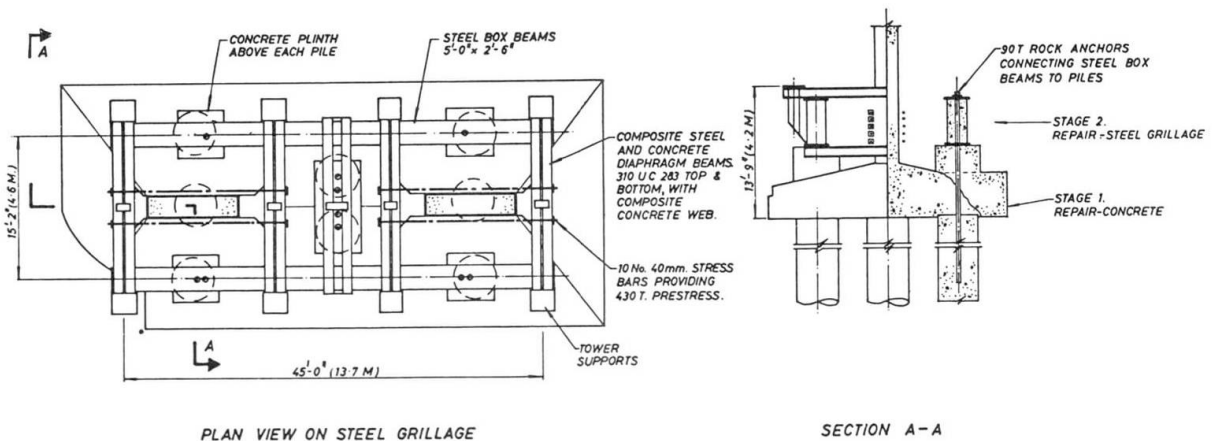
Fig. 6 Pile Cap 20. Temporary steel cap

- Construction of a temporary steel pile cap above the existing cap (Fig. 6). Its purpose was to enable column loads to bypass the existing cap and be transmitted directly into the piles. This action was achieved by stressing the steel cap to the columns and by casting concrete plinths on top of the existing cap, directly above the piles, and stressing the steel cap to the piles by means of rock anchors drilled and grouted into them.

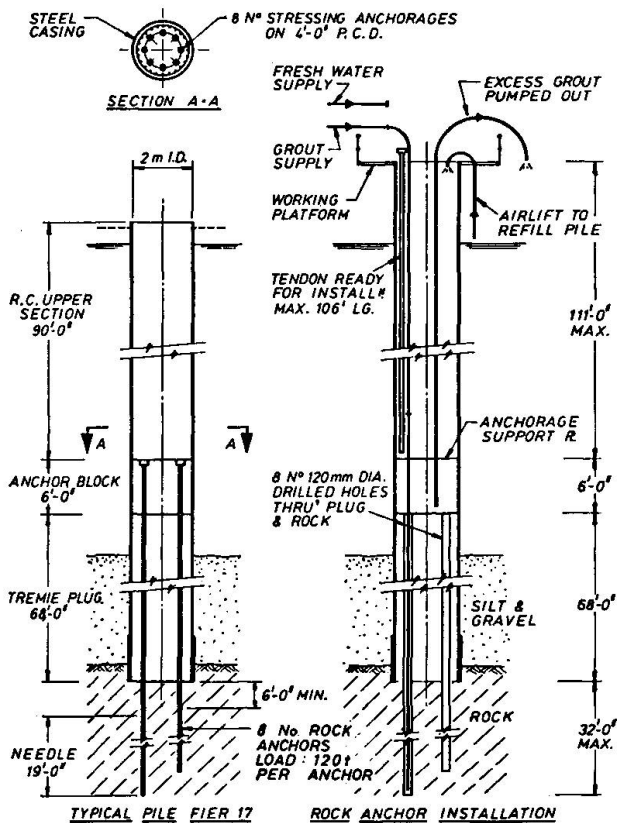
Fig. 7 Pile details

Details of the new vertical piling are shown in Fig. 7. 2 m diameter was selected as being the largest size which could be

reasonably handled. Base fixity to the piles was provided by means of rock anchors. At Pier 19 where all piles are vertical deck deflection under a 45 m/sec. transverse wind is 40 mm being 1 in 1,500 of the deck height above foundation level. The maximum loads per pile at this pier were 10,630 kN and 4,650 kNm.

The principle design features of the piles were; casing designed to be dewatered; reinforced concrete tremie plugs (40 MPa) to give F of S against flotation of 1.1; rock anchors designed for maximum corrosion resistance and each one tested in accordance with FIP recommendations. For safety reasons the test load was 70% UTS and lock off load 54% UTS.

At Pier 17 due to frequent rock joints the anchor holes could not be sealed and the installation method was modified to enable anchors to be grouted in a flooded pile (Fig. 7). Individual holes were kept grout filled while the grout leaking into adjacent holes was flushed out. A reservoir at the top of the plug enabled the grout quality to be monitored by underwater TV camera while visibility was maintained by downward circulation of fresh water.

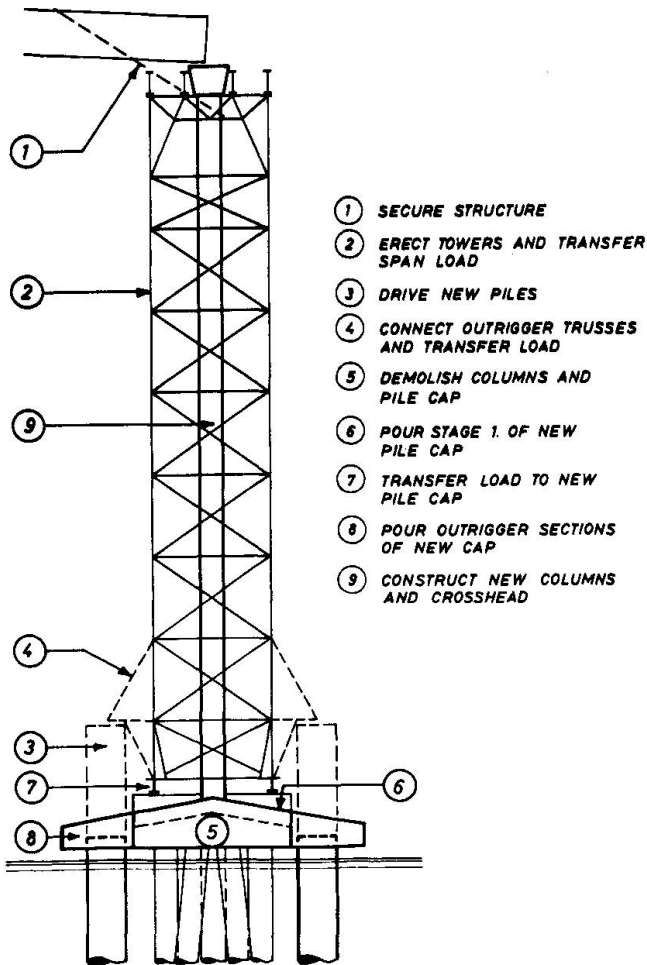
Fig. 8 Pier 17 construction sequence

The steel towers fulfilled many functions, including support of existing spans during column demolition, bracing for new concrete columns during construction, supports for the erection derricks and landing points for the new beams. The construction sequence involved in the use of the tower at Pier 17 is shown in Fig. 8.

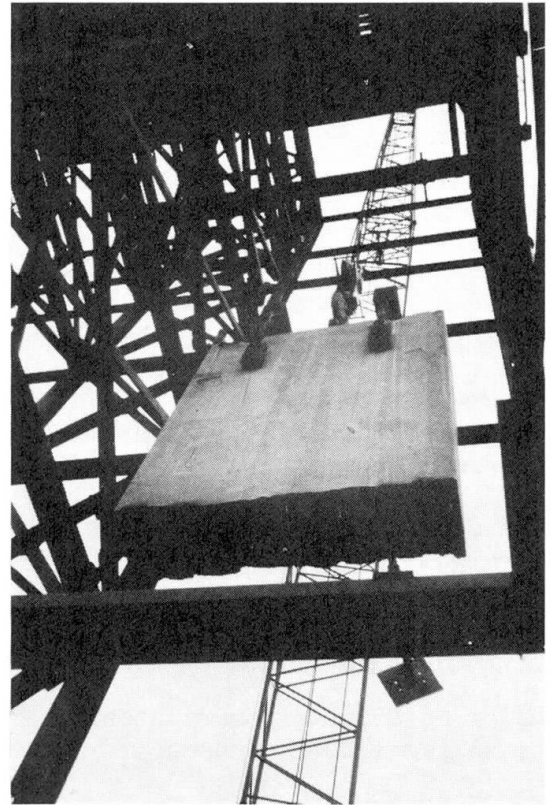
Fig. 9 Column demolition

The original columns were made up of precast concrete blocks, vertically stressed together with Macalloy bars. They had a cross-section of 3 m x 0.75 m and were cut horizontally using a thermic lance and hydraulic wedge splitters. The 25 tonne pieces were lifted out through the top of the falsework tower (Fig. 9). Twelve working days were required to remove the two legs of the Pier 20 column.

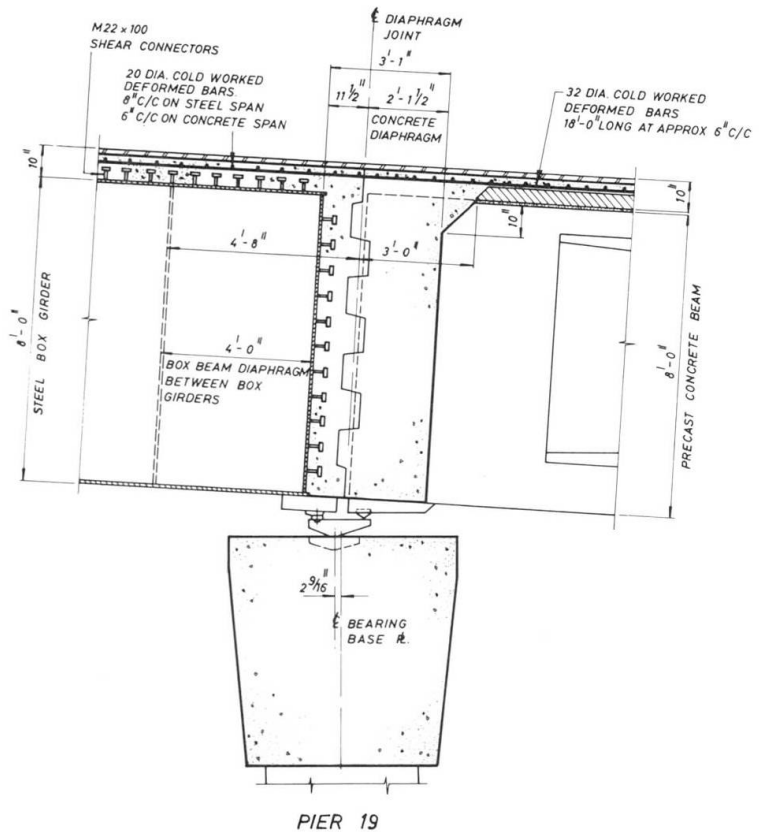
Fig. 10 Continuity connection steel/ concrete spans

the finite element analyses of the end crossbeams. The continuity detail between the steel and concrete spans over the piers (Fig. 10) was similar to that used in the original design.

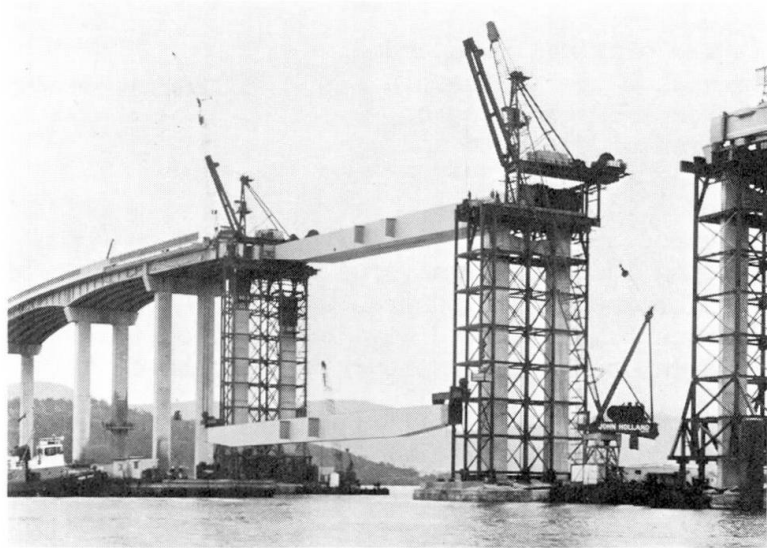
Fig. 11 Box girder erection

The adopted scheme used luffing 'A' frame lifting derricks specifically designed by the Contractor for the purpose (Fig. 11). By using temporary cantilever extensions at the ends of the boxes, they were lifted outboard of the towers as a single unit and positioned on top of the towers. The boxes were towed to site on a barge and then lifted. The operation from mooring of the barge to lifting the girders 40 m, and positioning them on temporary bearings on the falsework towers took about 20 minutes.

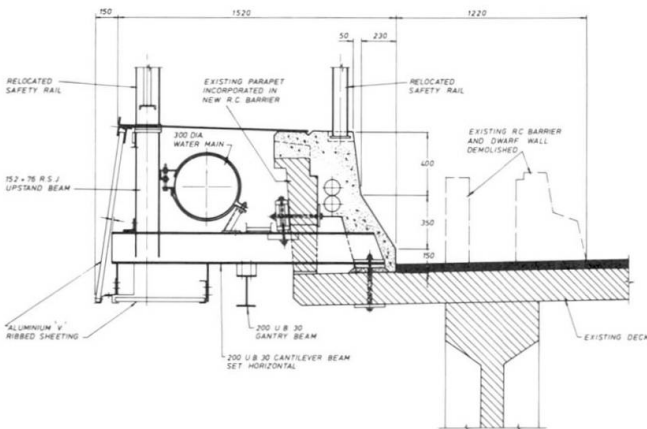
Fig. 12 Bridge widening details

While the bridge was out of service the opportunity was taken to widen it from four to five lanes over its full length. This permitted the operation of a rather more comfortable 3:2 tidal flow system rather than 3:1 as previously. The widening was achieved by cantilevering new footways and using the existing concrete deck for the five lanes (Fig. 12).

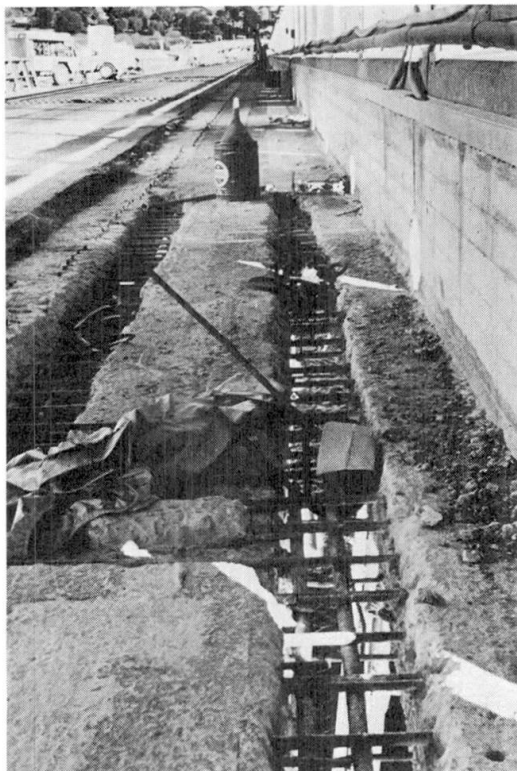
Fig. 14 Slots

It was originally intended to anchor the tendons in the deck by breaking out an area of concrete and casting a traditional anchor block. To reduce the required demolition and avoid cutting the main transverse deck reinforcement, the Contractor, Pearson Bridge (Tas.) Pty. Ltd. proposed cutting a slot 3 m x 200 mm (Fig. 14) into which the bare strands were anchored using an epoxy with fillers. The method worked very well.
