# Application of photon tomography to weld inspection

Autor(en): **Frank, Karl H. / Kohutek, Terry L.**

Zeitschrift: **IABSE reports = Rapports AIPC = IVBH Berichte**

Band (Jahr): **37 (1982)**

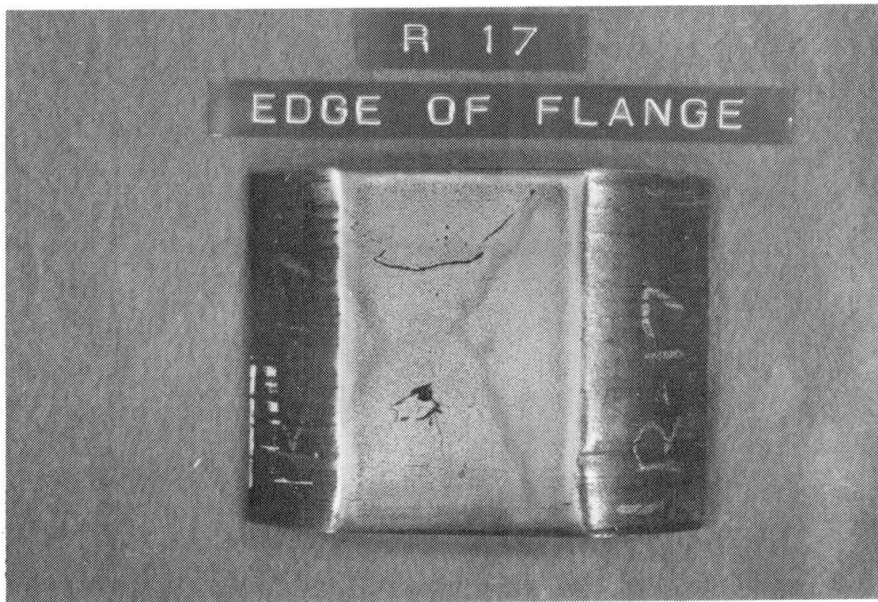
Fig. 3 Edge of Core Showing Two Defects

Many of the cores from the bridge had visible cracks at the edge of the weld. These welds were butt welds used to join the plates comprising the flanges of the "H" shapes used for the members of the truss. A typical example is shown in Fig. 3. The edge of the weld, at the flange tip, contains two large defects. Standard radiography of the cores, at 1% sensitivity, did not image these large cracks. A tomogram was taken of the core perpendicular to the face shown in Fig. 3. The results are shown in Fig. 4. Both defects are imaged. The curved shape and depth of the upper defect was confirmed by destructive examination.

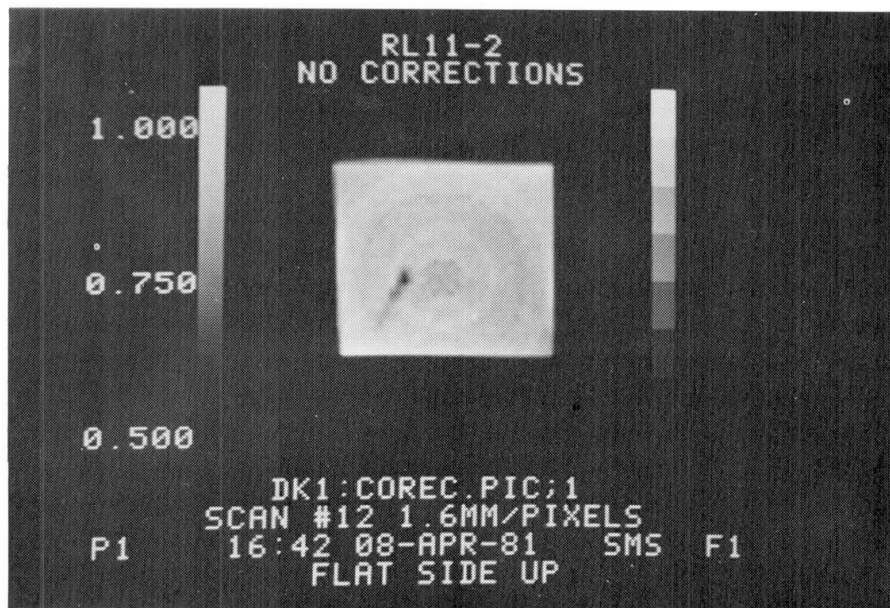
Fig. 5 Tomogram of Embedded Defect

In another core, a defect was found by radiography. An internal defect was interpreted as porosity by the radiographer. A tomogram across the weld at the defect produced the results shown in Fig. 5. Figure 6 shows a cross section of the weld at the location of the tomogram slice plane. The defect imaged in the tomogram agrees with the results of the destructive examination. The defect is not porosity but a fusion line defect.
