Fatigue Failures of Steel Railway Bridges in China

SHI YONGJI

This paper briefly describes the basic conditions of steel bridges on Chinese railway lines including their date of construction and the materials, technology and specifications used. Fatigue cracks are classified according to the age of the bridge at the time of their detection and then their causes analysed. Finally, examples are given of fatigue failure in bridges from every period of construction.

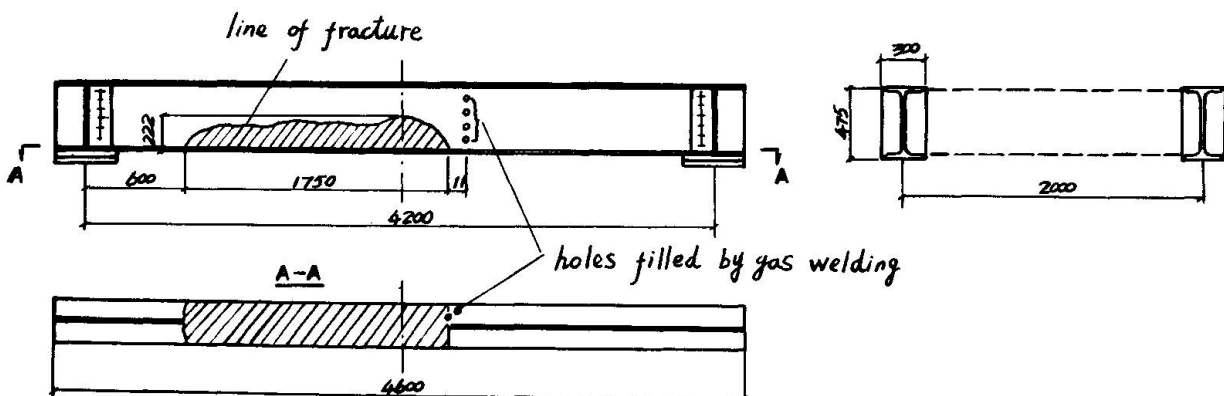
Bridge No. 248 on the Beijing-Baotou Railway Line was a rolled I-beam bridge which was manufactured in Britain in 1898 and erected in 1903. Its original length was 7 M and was cut down to 4.6 M in 1947 to be used as a simple span. There were four drilled holes of $\phi 19$ on the webs and two on the bottom flanges. These holes were filled later by gas welding when it was cut. It so happened that at about 11 o'clock in the morning of November 30, 1967, after a heavy snow fall, a large piece of flange metal broke off together with a portion of the web. Fig 1 is a sketch of the girder and the failure location. Photo 1 is the fallen off piece. From the fracture surface, we could find that the weld quality was very poor. Under repeated action of train load through a long period of time, fatigue crack was initiated at the notch (Photo 2).

Fig 1 Sketch of the girder bridge No. 248 and its failure location

Samples were taken from the girder for chemical analysis and mechanical test. The steel strength was equivalent to that of the carbon steel but was high in S, P and N content which made it difficult for welding. The ductility of the material at low temperature was rather poor and the ageing effect tendency was quite strong. U-notch impact test showed that the brittleness transition temperature was about $+15^{\circ}\text{C} - 0^{\circ}\text{C}$.

This accident once more teaches that direct repair welding on steel girders must be strictly forbidden. Otherwise it would be very much likely that weld defects or weld cracks should appear and deterioration, a decrease in ductility in particular of the weld metal and the heat affected zone would happen. And these would certainly give rise for the formation of fatigue crack and brittle fracture. This is an important problem we must pay attention to in the reconstruction and maintenance of bridge in the future.

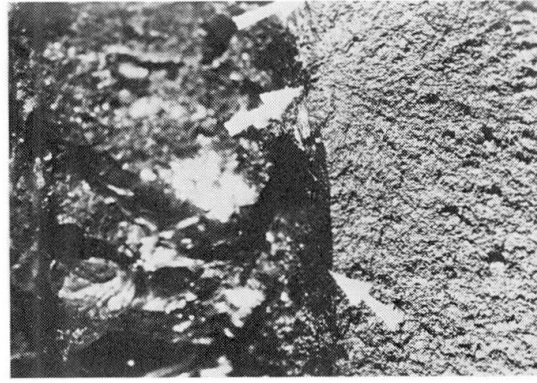
Photo 2 Fatigue crack at the notch of bridge No. 248

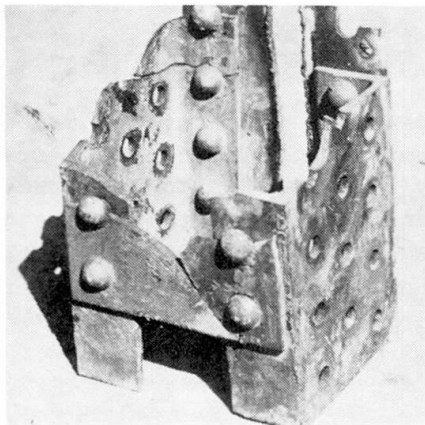
On March 23, 1973, the fracture occurred at the upper panel point of the first diagonal of the 16th truss built in 1930, with a span length of 33.54 M.

Photo 3 show the location of the fracture.

Photo 3 The form of the fracture member of Taizi River Bridge

Field investigation revealed that fatigue crack took place at an early stage in one of the diagonal channels. The other channel was pulled to break with obvious appearance of a bottleneck. The causes of the formation of the fatigue cracks are as follows:

At the time of design 50 years ago, the fatigue behaviour of the riveted joints was not clearly understood. The present train load and train load and train density (about 80 trains per day) on the bridge were much greater than those when the

bridge was first constructed. The lateral bracings were too weak, so the passing trains caused the truss to produce great vibration in the horizontal direction.

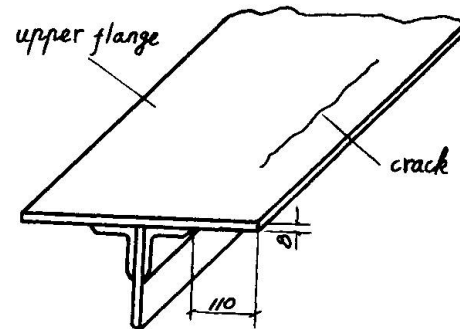
In some old-type riveted girders, both the upper and lower flange cover plates were provided in conformity to the moment diagram. Some of them often stopped at a distance from the bridge support. The flange plate between the support and stopped point was rather thin (8 MM only), but it cantilevered out as many as 110 MM (Fig 3). This was why longitudinal fatigue cracks often took place at this location. The two major causes of the formation of this longitudinal fatigue cracks are: (1) high impact forces under the direct train wheel load. (2) Transverse deflection of the upper flange induced by the vertical deformation of sleeper under train load. The beam action of sleepers on D.P.G. Bridges arose from a difference that existed between the center to center distance of the main girders which was 2 M and the gauge distance of the rails which was 1.435 M.

Fig 3 Crack on the upper flange
