# Design and retrofit for fatigue damage in web gap

Zeitschrift: **IABSE reports = Rapports AIPC = IVBH Berichte**

Band (Jahr): **37 (1982)**

## **Design and Retrofit for Fatigue Damage in Web Gap**

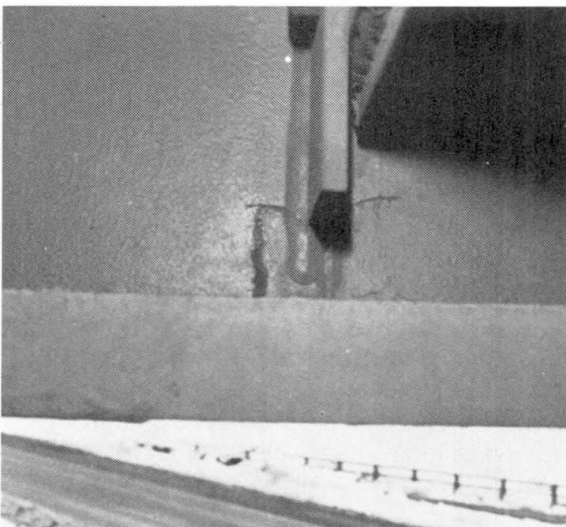
Fig. 1 Cracking at Transverse Diaphragm Web Connection Plate (Skewed Bridge)

Figure 1 shows an example of a detail which developed a fatigue crack. This crack is caused by displacements in the third dimension which occur as a result of interaction between primary (main girders) and secondary members (cross-frames, diaphragms, lateral bracings, etc.). This is the out-of-plane displacement which is not considered in the present design practice [2].

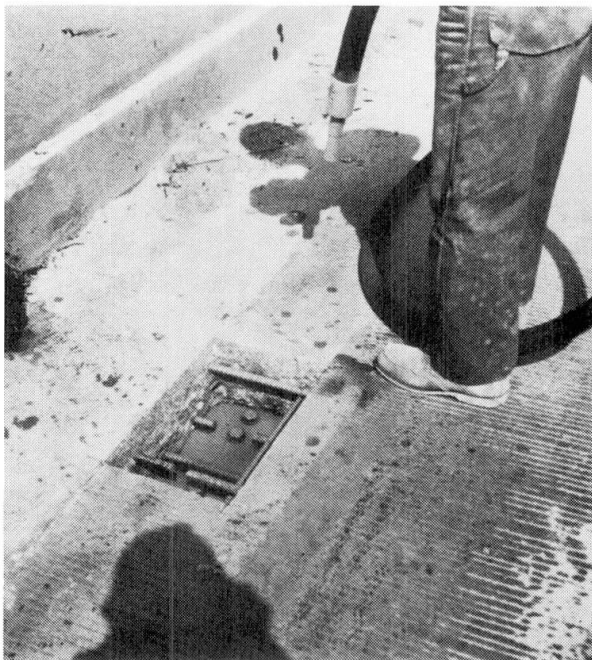
Fig. 11 Portion of Slab Removed to Gain Access to Flange

This can be accomplished by either welding or bolting the connection plate to the flange in order to provide a positive attachment and prevent the distortion. The alternative of welding the connection plate to the flange is generally not exercised for two reasons. First, there is concern regarding the quality of welds which can be provided under field conditions. Second, in older bridges, the weldability and fracture toughness of the flange material is unknown. Hence, welding the connection plate to the flange is generally not a practical alternative. The web gap distortion can be eliminated by providing a bolted connection between the connection plate and the flange. If the retrofit is carried out with the concrete slab in place, it is necessary to remove a rectangular portion of the slab in order to gain access to the embedded flange, as illustrated in Fig. 11. Bolt holes are then drilled in the flange and connection plate, and splice angles are inserted between the flange and the connection plate, as shown in Fig. 12. The resulting connection prevents distortion in the web gap.

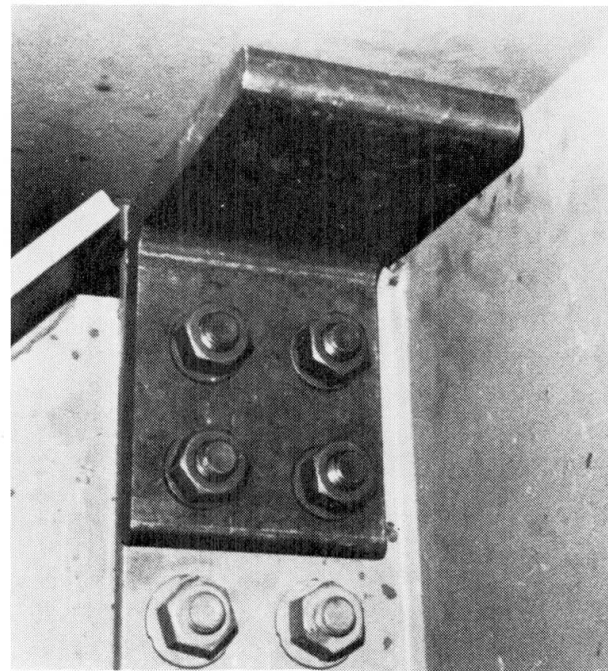
Fig. 12 Splice Angles Inserted Between Flange and Connection Plate
