Zeitschrift: **IABSE reports = Rapports AIPC = IVBH Berichte**

Collapse of a Cantilevered Truss Supporting a Heavy Crane

JOHN M. HANSON

Wiss, Janney, Elstner & Assoc.

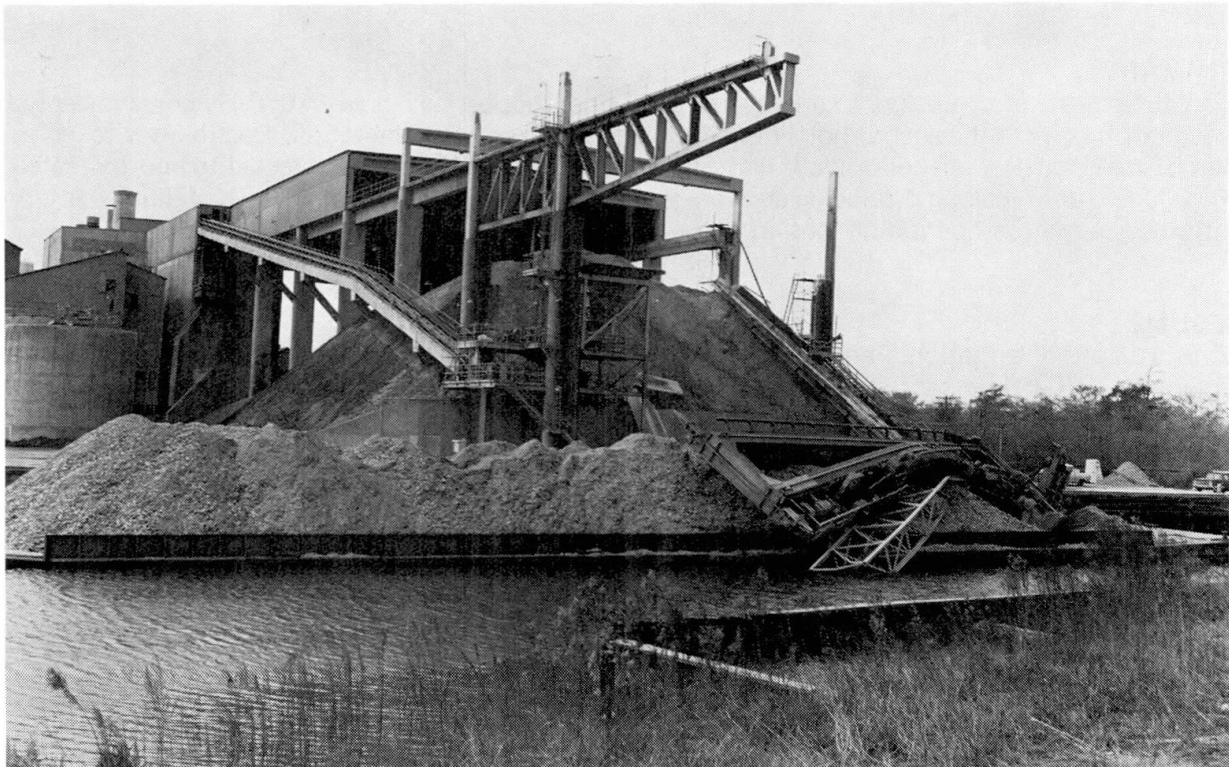
The site of the collapse of a very large cantilevered truss supporting a heavy 1070-kN crane is shown in Fig. 1. At the time of the collapse, about 10:30 A.M., the crane was at the end of the truss, removing oyster shells from a barge. The operator of the crane was killed, and another man working near the barge was severely injured.

The position of the collapsed truss and markings on the debris clearly established that the failure occurred as a result of loss of the tensile reaction. When this occurred, the truss began to rotate about the compressive reaction. This rotation was resisted by the crane rail, which exerted a horizontal pull, causing the pier taking the compressive reaction to fail in lateral bending at its base. As a result, the truss also moved backward and inward, and finally collapsed.

Fig. 1 View of Collapsed Truss and Crane

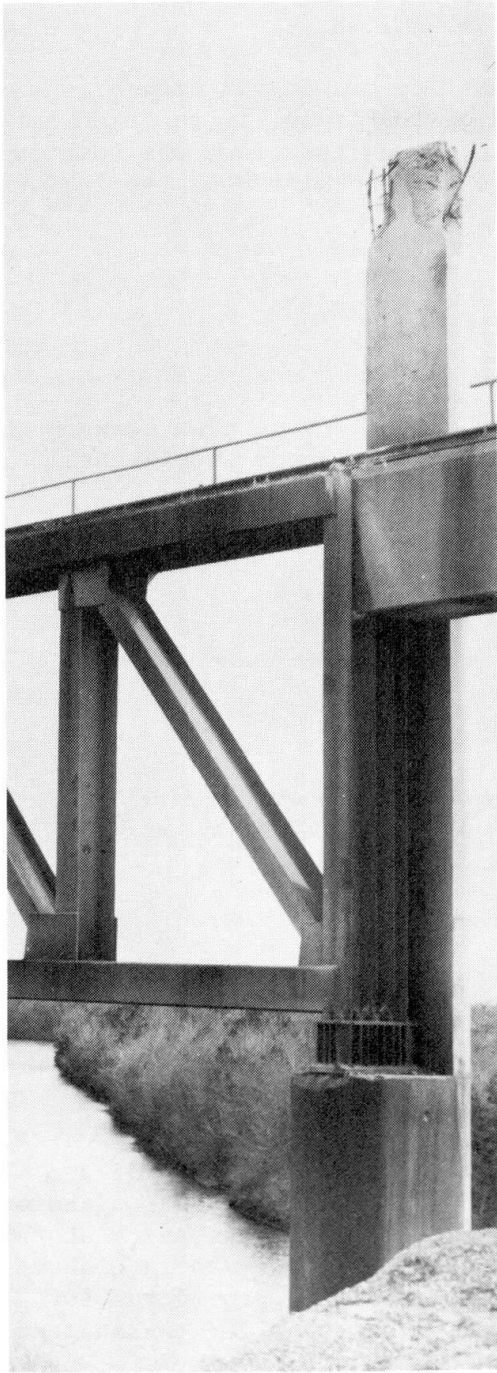
The tensile reaction was resisted by ten 51-mm diameter anchor bolts, arranged in two rows. The picture in Fig. 2 shows how the bolts protruded through a heavy weldment at the support of the truss that did not collapse. A view of the pier where the failure occurred is shown in Fig. 3. Seven bolts may be observed protruding from the pier. The bolts were bent by the impact of the truss, which occurred after the pier failed that was taking the compressive reaction, and the truss began to fall. Two bolts on the near side of the pier were broken below the top surface, apparently from the truss rolling off of the pier. One bolt, on the far side near the column extending above the top of the pier, was fractured in the region where grout had been placed between the weldment and the top of the pier. The surface of this bolt, as well as other bolts, was corroded in this region. There was no evidence of deformation or slip of any part of the anchor bolts embedded in the pier.

Fig. 2 Weldment of
Tensile Reaction

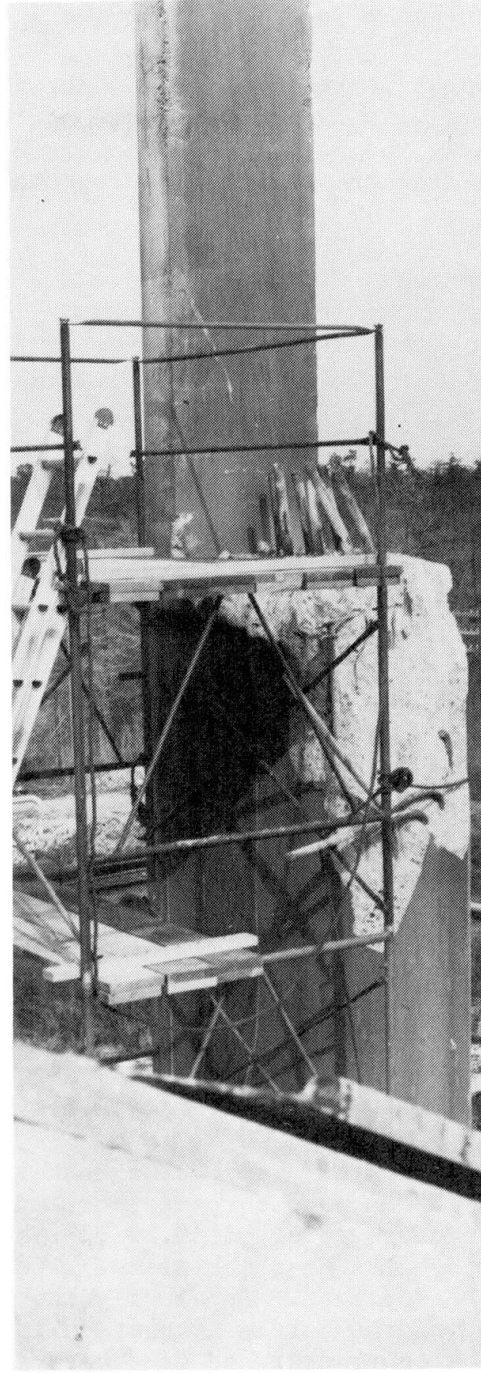
Fig. 3 Failed Anchor Bolts

The tops of five anchor bolts with nuts were eventually recovered. These bolts were fractured near the base of the nuts. It was established that fractures occurred in the threaded portions of all of the bolts.

The collapse of the crane occurred as a result of fatigue failures of the anchor bolts. Considering the potential for unequal stresses in the bolts, it was not surprising that the number of cycles to failure was less than the fatigue life indicated by tests on single bolts. More importantly, a structural connection should have been used for the tensile reaction which would not have allowed fluctuating tension in the anchor bolts.

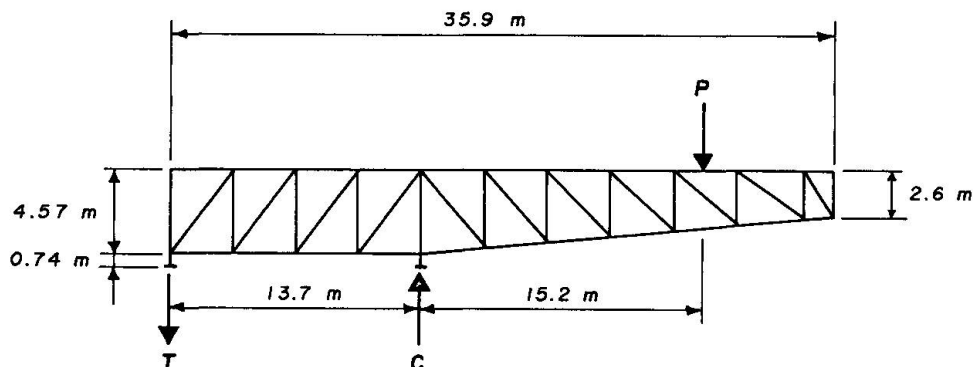
Fig. 4 Elevation of Truss

The length of the trusses, as shown in the line drawing in Fig. 4, was 35.9 m. With the crane bridge at the end of the truss, in position for unloading the barge, the load of the crane, P , on the truss was located 15.2 m from the compressive reaction. The load consisted of the following:

According to the drawings, the anchor bolts had a total length of 3 m with a 152-mm long threaded portion at both ends. The projection above the top of the pier was 0.59 m. The bolts were anchored in pairs at their bottom by a 32-mm-thick plate. The surface of the bolts was in contact with the concrete. Apparently there were no specified procedures for tightening the bolted connection to the truss, although it was reported that the contractor had used a torque wrench.

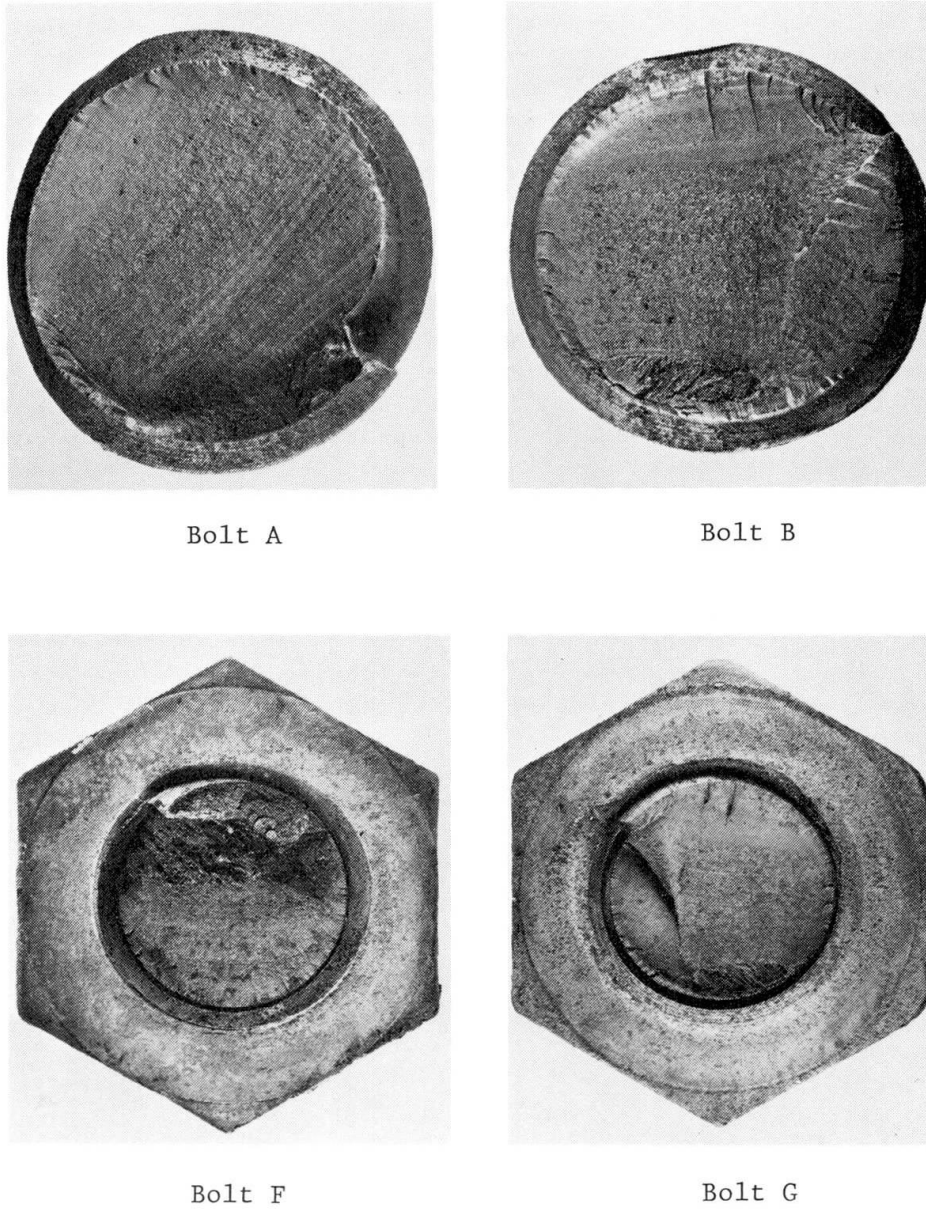
Extensive metallurgical examinations of the bolts were carried out by several parties. There was general agreement that fatigue cracking and fracture had occurred in the threaded portion of all of the bolts. Views of the cracked and fractured surfaces in four of the bolts are shown in Fig. 5. The fatigue cracking appeared to have advanced across the bolts in an intermittent manner. Final ruptures appeared to be due to overloading.

Fig. 5 Fracture Surfaces

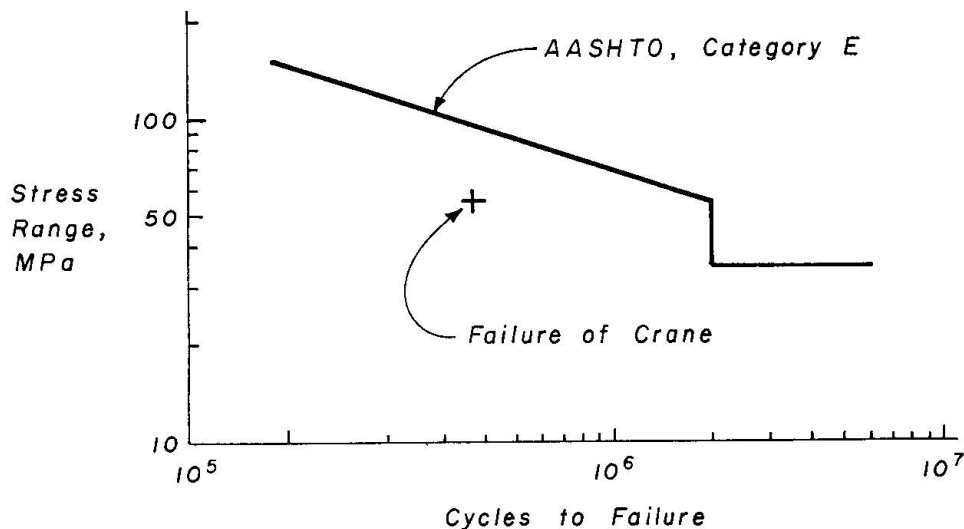
The AASHTO Category E design stress range is shown in Fig. 6. Superimposed on the plot is a point representing a nominal stress range of 55 MPa and 370,000 cycles at which the truss is estimated to have collapsed. The failure occurred well below the Category E design range.

Fig. 6 Comparison of Failure Condition to AASHTO Category E Design Criteria

It should be noted that the AASHTO Category E design stress range is established on the basis that there is a 95 percent level of confidence that 95 percent of the failures will exceed the design condition. There were also a number of uncertainties in the determination of the stress range and cycles causing the failure. However, the most plausible reason for the failure occurring below the Category E design range is lack of uniformity of stress in the anchor bolts. The method of construction apparently did not insure that the stress was uniform when the system was placed in operation. With time, there may have been considerable variation in the bond between the surface of the bolts and the concrete, which may

also have had a significant influence on the stress conditions, irrespective of their adequate end anchorage. Consequently, it is likely that stress ranges as high as 150 to 200 MPa may have occurred in some of the bolts. As noted earlier, the examination of the fracture surfaces indicated that the fatigue cracks advanced across the bolts in a variable manner.
