# Displacement-induced fatigue cracking of a box girder bridge

Autor(en): **Fisher, John W. / Mertz, Dennis R. / Wu, Kuang-Chong**

Zeitschrift: **IABSE reports = Rapports AIPC = IVBH Berichte**

Band (Jahr): **39 (1982)**

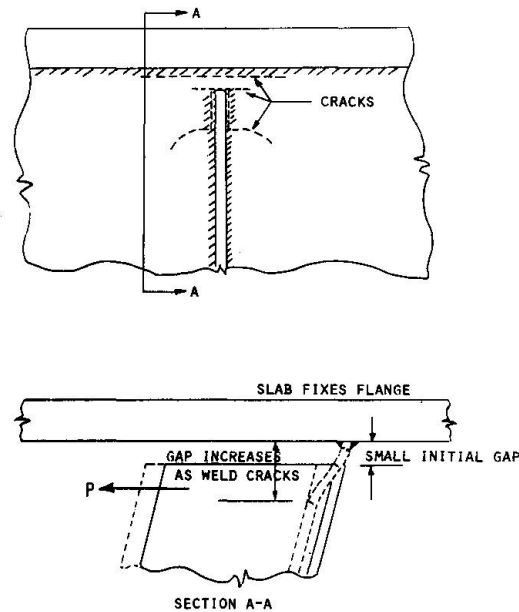
When the web gap is relatively small, i.e. 2.5 cm, the movement of the diaphragm introduces large stresses on the upper end of the fillet weld connecting the diaphragm to the girder web and in the web gap. This results in cracking of the diaphragm-web weld connection at smaller welds, as illustrated in Fig. 3. If this cracking is not arrested through some retrofitting procedure, eventually between 2.5 cm and 5.0 cm of the weld will crack introducing enough additional flexibility into the girder such that the web gap is forced into greater double curvature. This distortion is shown schematically in Fig. 3. Cracking along the web-flange weld connection and longitudinal cracking in the girder web at the lower end of the diaphragm-web connection crack result from this cyclic distortion. At several locations, cracks formed in the web without significant weld cracking.

This observed cracking results from the distortion of the curved box section and subsequent loading of the diaphragms due to this distortion. This causes forces to be introduced into the girder web adjacent to the top flange, since the transverse connection plate is not welded to the flange. At the bottom end of the transverse connection plates, fillet welds positively attach the plate to the bottom flange which is acting in compression. Therefore, no cracks can develop at this welded end.

Most of the cracking was detected in the outside web of the curved box section and not in the inside web. This is a result of the direction of the out-of-plane movement. The transverse angle that is attached to the upper ends of the web connection plates is relatively stiff compared to the web gap. The outside web is pulled in on one side by the transverse angle producing cyclic tension stresses and subsequent cracking. On the other side, the web is pushed out resulting in cyclic compressive stresses. Since the effective stress range is less, severe cracking was not as extensive prior to retrofitting the structure.

Fig. 3 Schematic of Crack Development

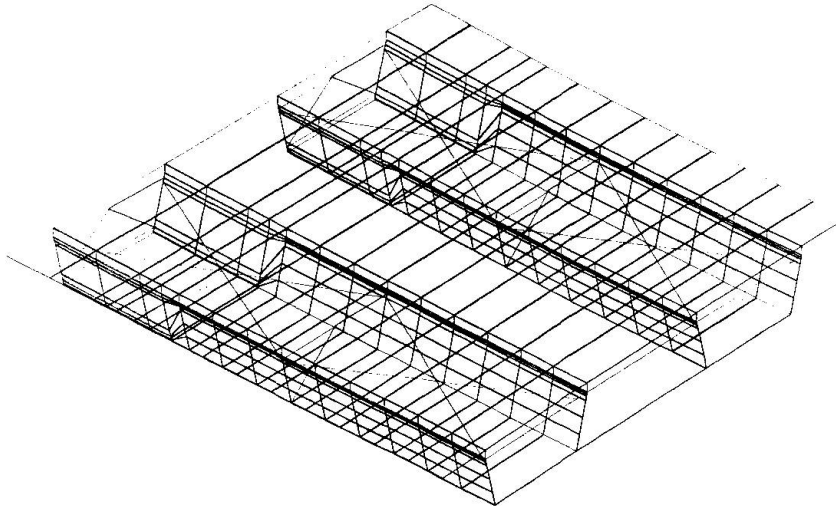
One unit of the three unit Ramp C Viaduct structure was analyzed using the finite element method. SAP4 - A Structural Analysis Program for Static and Dynamic Response of Linear Systems [3] was used to perform the two phase analysis. The first phase consisted of analyzing the entire structure utilizing a gross discretization to model overall structural behavior. The resultant displacements from this and subsequent analyses were used to load the boundaries of substructure models of the region of the structure adjacent to the point of detected fatigue cracking. This second phase produced a better representation of the web gap behavior while conserving computer resources. One such substructure is shown in Fig. 4.

Using an HS 20-44 truck statically placed on the structure to represent live load, the uncracked web gap was distorted sufficiently to produce cyclic stresses varying from  $-7.13$  MPa to  $+52.53$  MPa. The maximum stress range exceeds the fatigue limit of the weld toes and crack propagation is unavoidable. An

Fig. 4 Typical Finite Element Substructure Model

ongoing more extensive investigation suggests that the gap condition may be even more severe than this preliminary study indicates. The stress range in the gap, during passage of the HS 20-44 truck, may be as high as 90 MPa. Under random variable truck traffic, an effective stress range of 45 MPa ( $0.35^{1/3}$  times stress range H20) would result in visible cracking from the estimated 15 million vehicles that have crossed the structure since it was placed in service. Hence, the observed behavior is in agreement with experiment test data and predicted crack propagation.

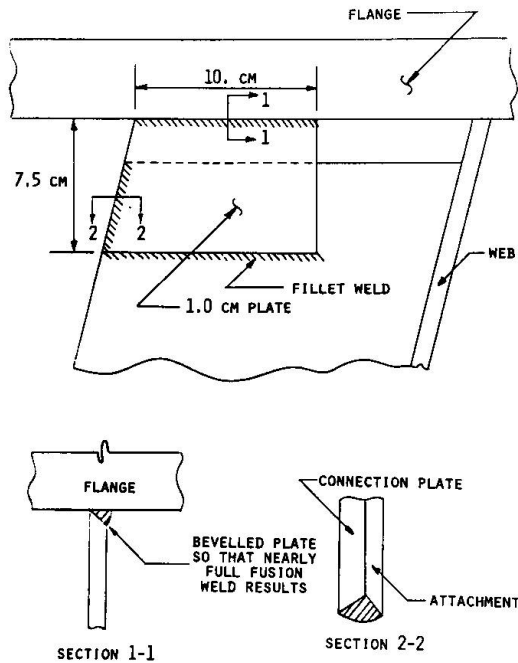
Fig. 5 Detail for Retrofit Procedure

The only conceivable possibility for retrofitting this detail in the negative moment region is to provide a positive attachment between the transverse connection plate and the flange where web gaps now exist. This was accomplished by welding a shear tab to the transverse connection plate and flange, as shown in Fig. 5. This attachment provides a Category C fatigue condition for the flange plate which is not significantly different than the connection plate-web weld.

It is not feasible to cut back the connection plate, increasing the gap length to provide additional flexibility as an alternate solution to the out-of-plane movement problem. The diaphragms in the curved box section are carrying load while maintaining the cross-sectional shape. Cutting the connection plates back would alter the structural behavior and would likely result in more adverse behavior than is currently being experienced and continued fatigue cracking in the girder web.

The corrective action at the Ramp C Viaduct at the intersection of Interstates 695 and 83 has arrested continued crack propagation. Since the existing flange-web weld cracks are parallel to the normal cyclic stress, no further crack propagation is possible once the web gap distortion is prevented. This ensures that the desired life of the structure can be achieved without further adverse cracking.
