Repairs on the Givors Bridge

Bernhard BOUVY

Philippe MOREAU

SUMMARY

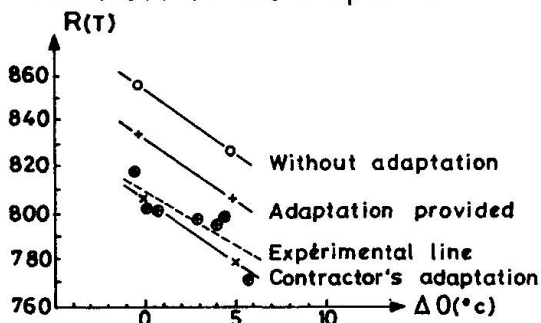
Let us finally point out that the results of bearing pressure measurements confirm those of the adaptation calculations of the contracting firm.

Fig.5 - Variation of bearing pressure on abutment with temperature gradient

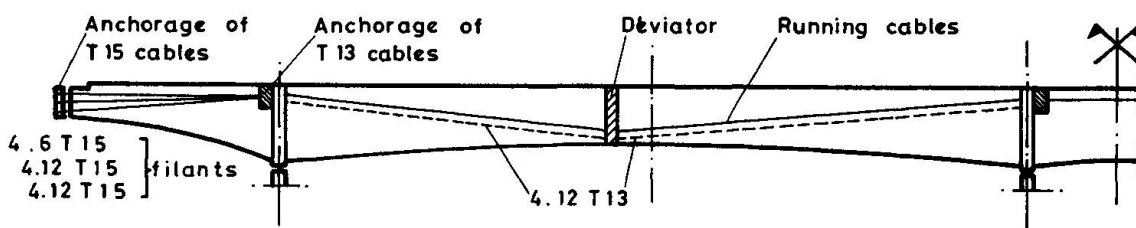
Fig. 6 - Additional prestressing diagram

For the entire structure, the additional cabling includes :

- eight 12 T 15 cables
 - four 6 T 15 cables
 - four 12 T 13 cables
- running from abutment to abutment in each span of 110 m

These cables are deviated in order to improve the efficiency. The anchorage of the 12 T 13 cables is accomplished by means of bosses bearing on the spacers on the piers.

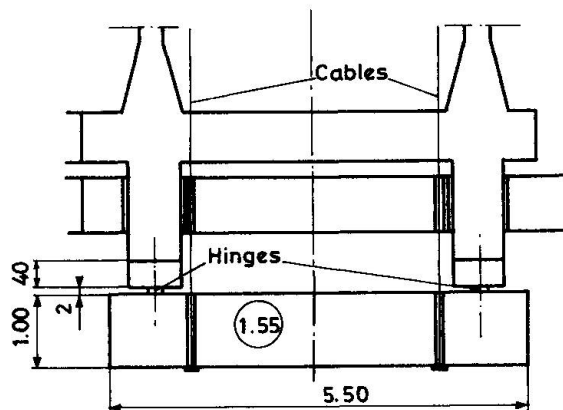
Fig.7 - Anchoring device on abutment

The anchorage of the 6 T 15 and 12 T 15 cables is accomplished, for each caisson, by means of a still (in prestressed concrete) bearing on the end tenons via Freyssinet type hinges.
