Zeitschrift: IABSE reports = Rapports AIPC = IVBH Berichte
Band: 39 (1982)

Artikel: Repairs on the Givors Bridge
Autor: Bouvy, Bernhard / Moreau, Philippe
DOI: <https://doi.org/10.5169/seals-30175>

Repairs on the Givors Bridge

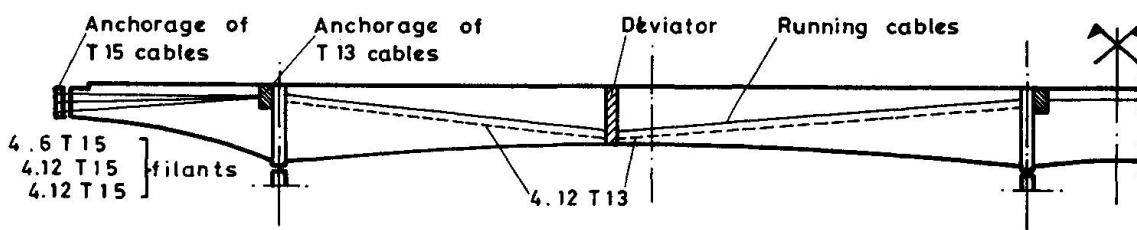
Fig.6 - Additional prestressing diagram

Under these conditions, the tensile stresses to be compensated were T,8 Mpa.

For the entire structure, the additional cabling includes :

- eight 12 T 15 cables
 - four 6 T 15 cables
 - four 12 T 13 cables
- running from abutment to abutment in each span of 110 m

These cables are deviated in order to improve the efficiency. The anchorage of the 12 T 13 cables is accomplished by means of bosses bearing on the spacers on the piers.
