Case Stories of Dolphin Accidents and Remedies

Yoshiaki NAOI
Supervising Engineer
Chuo Fukken Consultants
Osaka, Japan

Toshiyuki ISHIKAWA
Chief Engineer
Chuo Fukken Consultants
Osaka, Japan

The report outlines recent ship collision accidents with dolphins in Iwakuni, Japan and their remedies.

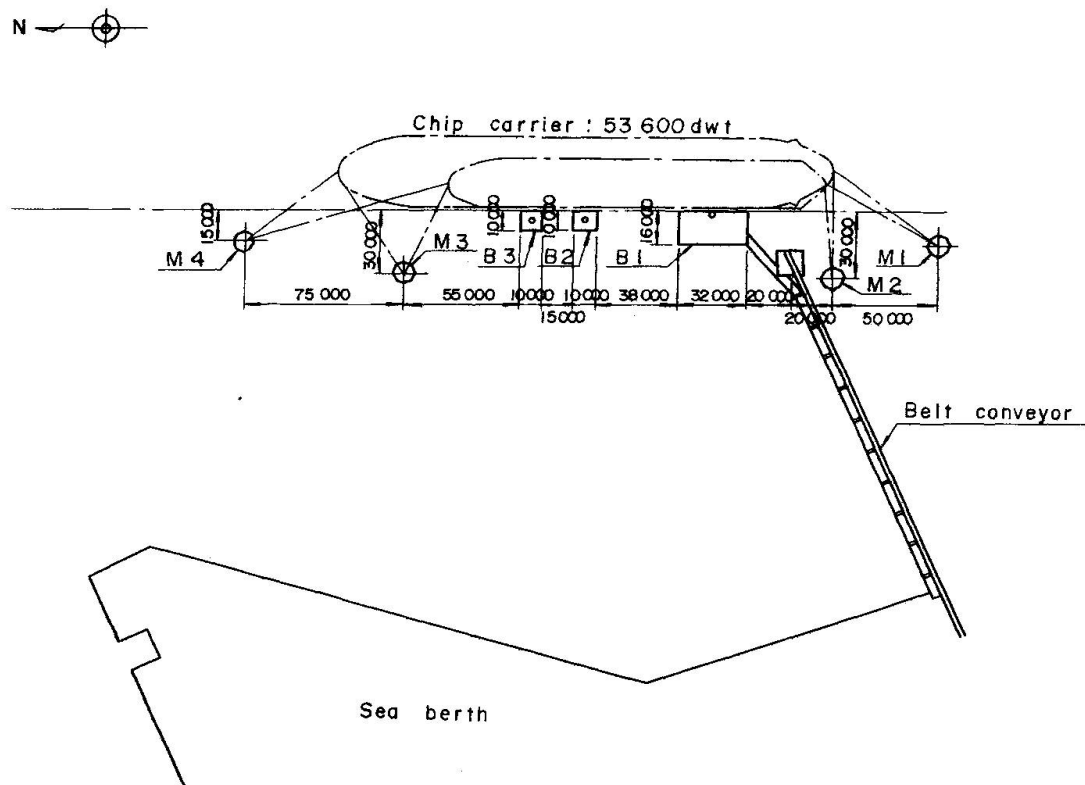
Fig.1 Outline Plan of the Berth

The harbour structure of concern here has a landing berth for wooden chips for paper-making and the berth was designed for foreign chip carriers with 53,600 dwt. As shown in Fig.1 the berth consists of 1 main-breasting dolphin, and 2 sub-breasting ones, and 4 mooring ones.

The north sub-breasting dolphin (B-3 in Fig.1) was damaged in the first collision in 1978, and the south mooring dolphin (M-1 in Fig.1) was again damaged in 1979.

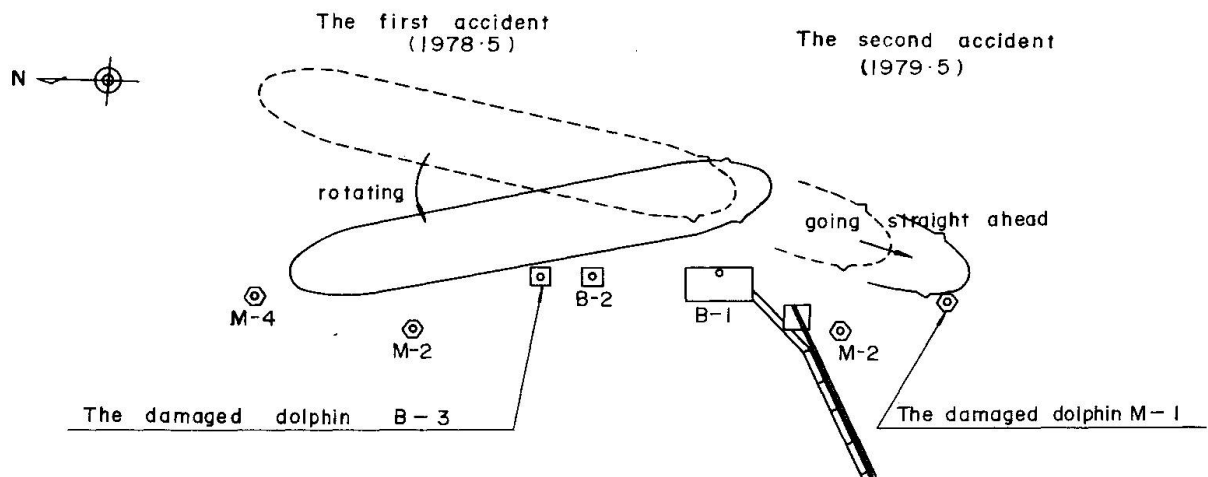
Fig.4 Geometry of the Collisions

The circumstances of the first collision accident in 1978 is described as follows: (See Fig.4)

While the vessel was approaching on her starboard side to the sea berth, the ship swung her stern towards the right side in order to maintain the correct direction for her berthing. After that, the side of the vessel collided with the fender on the corner of the north sub-breasting dolphin B-3.

The fender itself had no function to absorb the impact energy of ships, therefore, the inertia force of the moving ship was directly loaded on the dolphin structure, and the foundation piles were deformed.

As in the first accident the same cargo vessel, in 1979, lost proper speed while she was approaching the berth from the north, then collided with the south mooring dolphin M-1.

Both collisions were caused by the mistakes of the operators. But, as described in the beginning of the article, Japanese coastal/offshore structures are located in very confused sea areas and it is one of the reasons of the frequent occurrence of ship collision casualties.

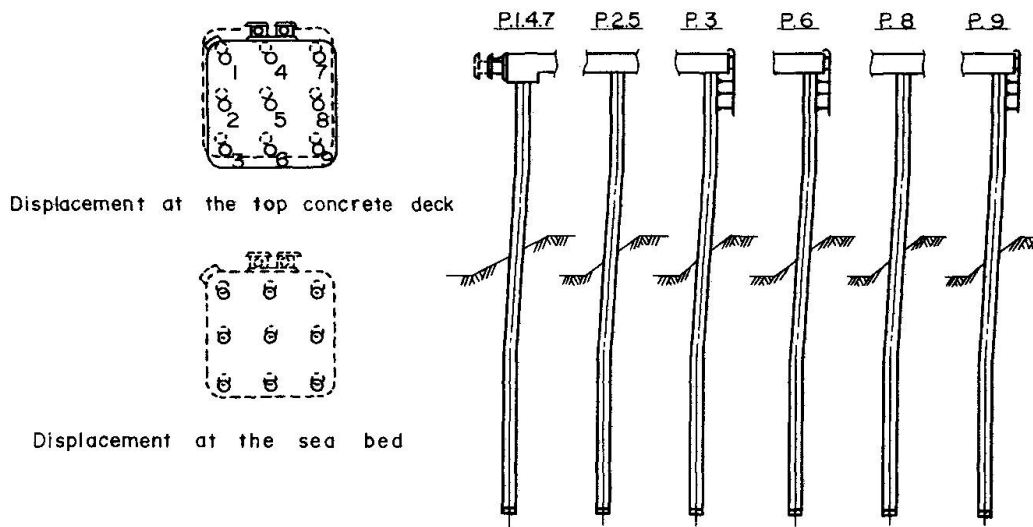
Fig.5 Deformation of Dolphin B-3

The results of our inspection carried out immediately after the accidents are briefly as follows: (See Fig.5)

Upon measuring the damaged dolphin, the deformation was found to be the residual displacement of the top concrete deck:

In the direction of the berthing line	-----	25.2 cm
In the direction of right angle to the berthing line	-----	97.2 cm

Inclination towards the shore on the diagonal line	-----	0° 20'
--	-------	--------

Upon inspecting the piles in the water, the buckling on the piles were found near the welded joints of No.3,6,8 & 9 piles 2 m deep in the water and the shells thereon had been torn off.

The deformation by the collision was more severe on the opposite piles of the collision side. From that fact it was presumed that the dolphin was rotated by the collision impact (the horizontal force) so that those opposite piles were loaded by both the force at a right angle to the axes and the axial force (the compressive forces).

Further, the maximum deformation was found on the middle piles (12.7 mm in thickness) while the upper piles above D.L. -0.50 m were still vertical with little deformation. The reason for this is that the materials of the upper piles were thicker (16.0 mm in thickness) and they were stuffed with filling concrete.

After the diving inspection, voids of 40 cm in width and 100 cm in depth were observed in the sea bed on the offshore side of the piles. It indicated that plastic deformation in the ground occurred by the energy exerted by the collision.

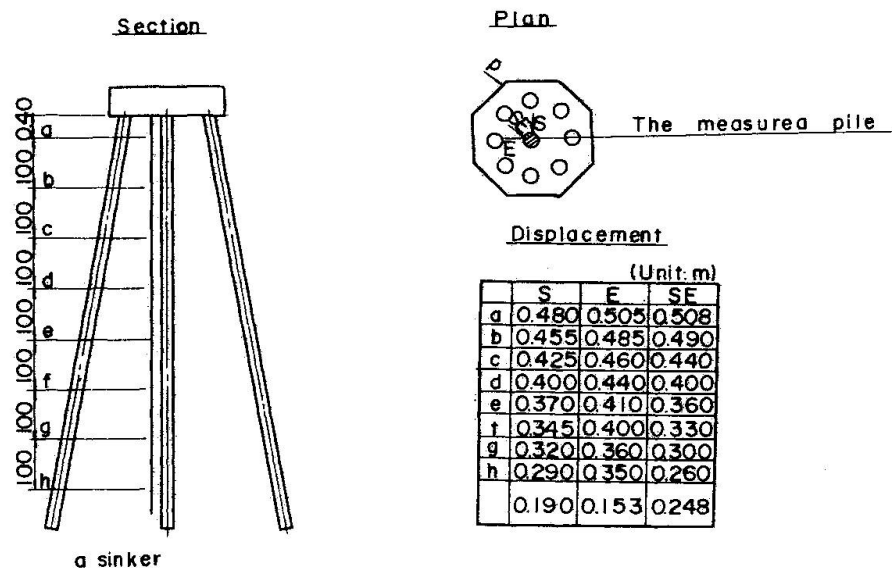
Fig.6 Deformation of Dolphin M-1

An opening made by the collision was found at the junction of the top concrete deck with the steel pipe piles. This opening was 20 cm at its maximum in a direction of north-west. At the same time a wedge from the shearing force (1.6 m in width, 0.2 m in height, and 0.4 m in depth) appeared in the concrete deck.

Upon measuring the deformation of the central vertical pile in three directions, the maximum displacement of 25 cm was observed in the direction of south-east. (See Fig.6)

Shells of barnacles and sea mussels had been torn off around the tidal zone at the top of the piles, and it indicated the hysteresis of deformation.
