Vulnerability of Norwegian Bridges across Channels

Per TAMBS-LYCHE
Director Bridge Division
Public Roads Administration
Oslo, Norway

SUMMARY

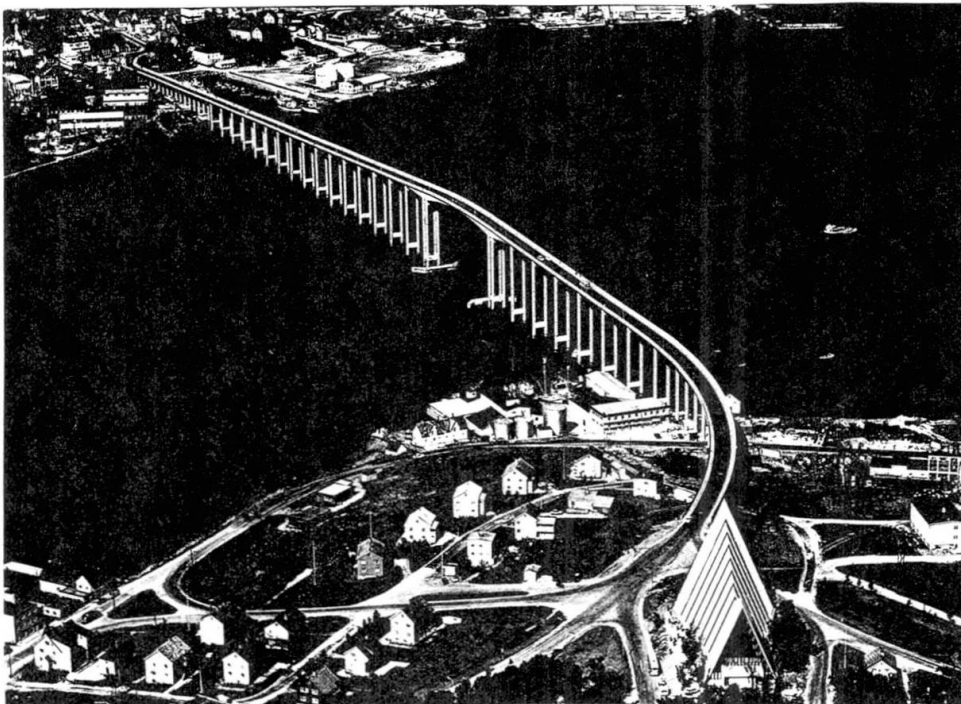
Fig. 2 Tromsø Bridge

To day, having learned by experience from several serious accidents around the world, and also a great number of smaller accidents in Tromsø Sound, we must state that the risk of collision between passing ships and the columns of Tromsø Bridge, was not satisfactorily judged when the bridge was planned.

The center to center distance between the two pairs of columns on each side of the main span is only 80 metres, and between fenders protecting these columns, the channel is only 60 metres wide. Between the main span and the abutments on the Tromsø side and the Tromsdal side respectively, the distance between the pairs of columns varies from 24 to 10 metres.

- I Installation of radar echo equipment along the main channel (on buoys of skerries).
- II Installation of navigation lamps and/or improving existing lighting systems on the bridge.
- III Installation of special warning devices to stop all the traffic across the bridge in case of serious damage to the structure.

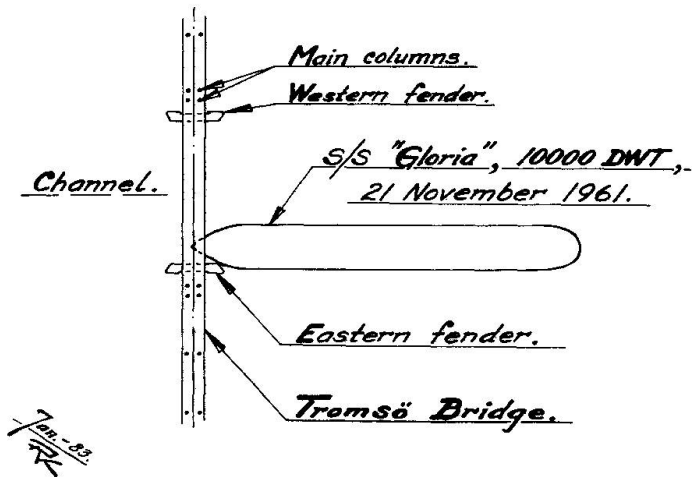
On the 21 November 1961, the 10 000 dwt. S/S "Gloria" ran into the eastern fender. The fender slab above the water as well as most of the concrete piles carrying the slab were completely destroyed and ended on the bottom of the sea. Fig. 3 shows the dimensions of the ship, the channel and the fenders.

Fig. 3 Tromsø Bridge: Collision, November 1961. Dimensions of ship, channel and fenders.

When the two fenders were rebuilt in 1962-63, hollow steel piles KP 35, filled with concrete, were used. The clearance between the fender slab and the nearest columns was 5 metres. Fracture of the piles were expected at a horizontal deformation of the fender of 4.3 metres. This would, approximately, be sufficient to stop a 10 000 dwt ship drifting into the fender at a speed of 0.5 m/sec.

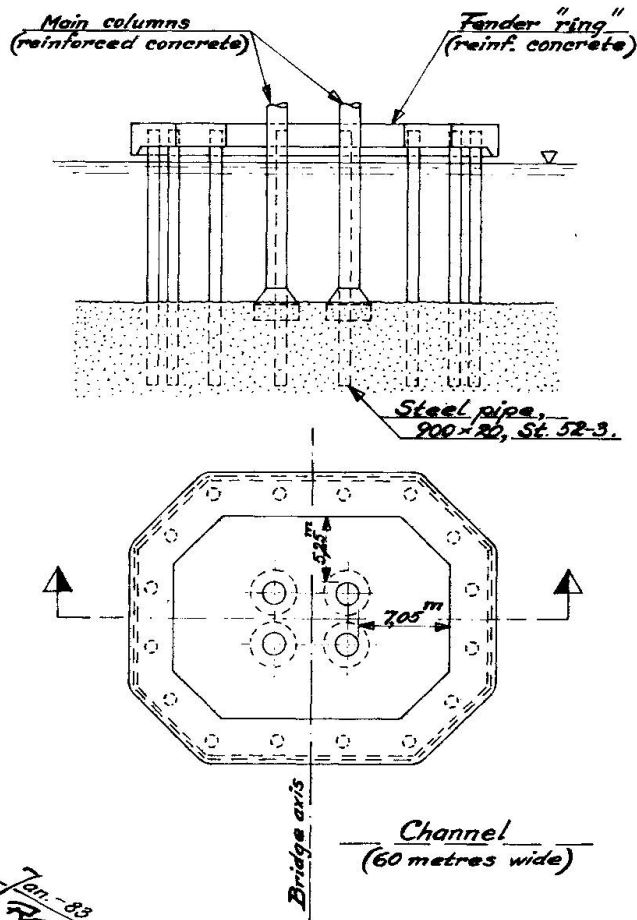
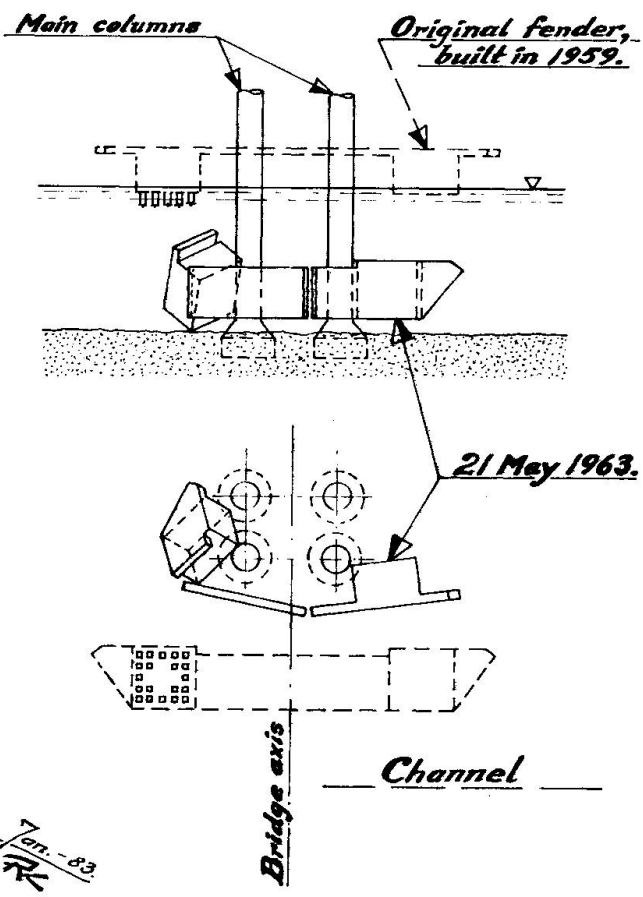
On the 21 May 1963 the western fender suffered the same fate as its easterly twin. M/S "Rotesand", a 1560 dwt ore-ship, then ran foul of the fender which collapsed and had to be removed. Fig. 4 shows the fender structure after the breakdown.

Fig. 4 Tromsø Bridge: Western fender before and after having been destroyed. (The destroyed fender was partly resting on heaps of broken piles, which are not shown on the figure).

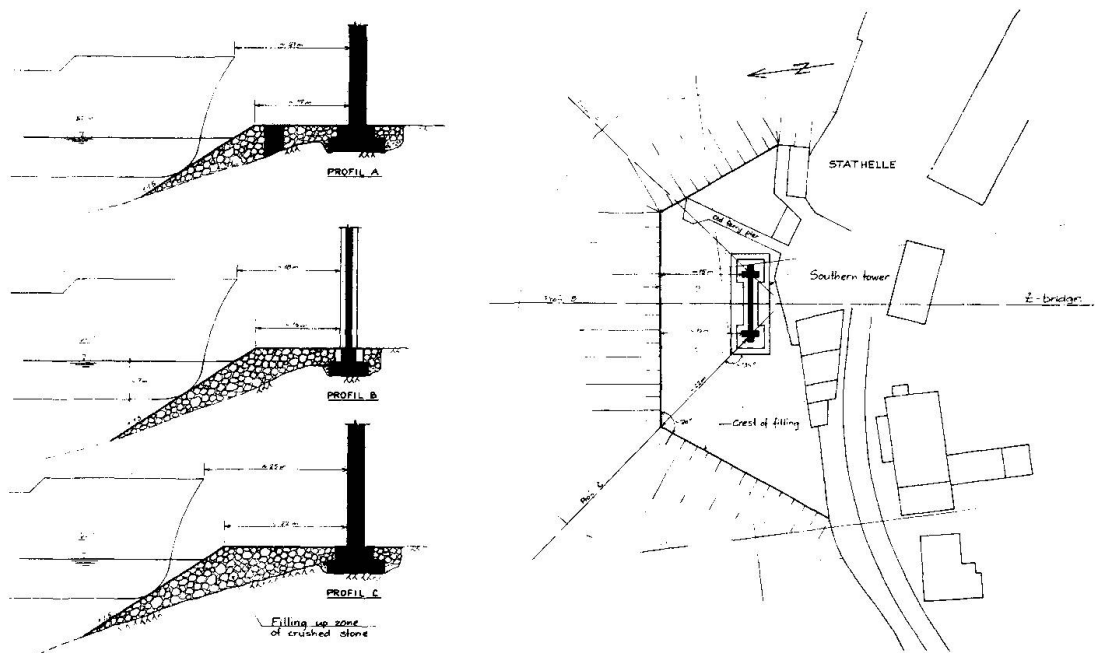
The southern tower of the main span has been regarded as vulnerable to the ship-traffic taking place through the channel. The navigational conditions are not the best ones through the shallow, narrow and tidal waters of the inlet, though certain equipment with regard to surveillance of the ships concerned has been in operation for some time.

Even though, incidents are now and then taking place in the channel including two cases of running aground close by the tower. One of the towerpiers was left with spalled concrete after one of these episodes. In addition three other close by incidents (agrounds within 20m from the tower) have been registered. All the run-agrounds in the bridge area have taken place while ships were leaving the harbour. According to attached figure 7 the tower is obviously most exposed to collision from ships moving in that direction. It should be emphasized that part of the tonnage passing the sound carries dangerous cargo, e.g. gastankers.

Fig. 7 Brevik Bridge; Filling up zone, southern tower

- I A proposed filling up zone as indicated in figure 7, will reduce sailing depths at the southern tower and will also provide an energy absorbing cushion for ships running aground.
- II Installation of warning devices to stop road traffic in case of serious damage to the structure.

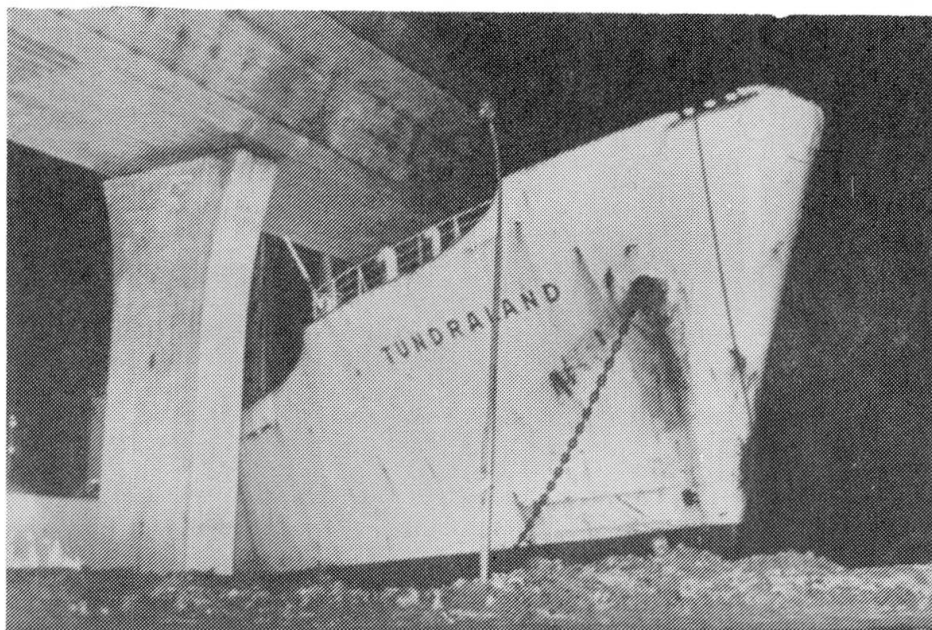
This motorway bridge was finished in 1975. It is a concrete box-section construction with spans around 50m. Close to the bridge is a quay in use for larger ships. In 1978 a ship of 4572 dwt was not able to reverse the engine. However, by very good seamanship the ship was grounded after manouvering between two columns. The superstructure of the ship only caused minor damages to the edges of the box-section. Fig. 8.

Fig. 8 Drammen Bridge; Nearly catastrophe
