Theme A: Case stories of recent ship collision accidents

Case Stories of Recent Ship Collision Accidents

Ship Collisions with Danish Lighthouses

Newport Brückenzusammenstoß

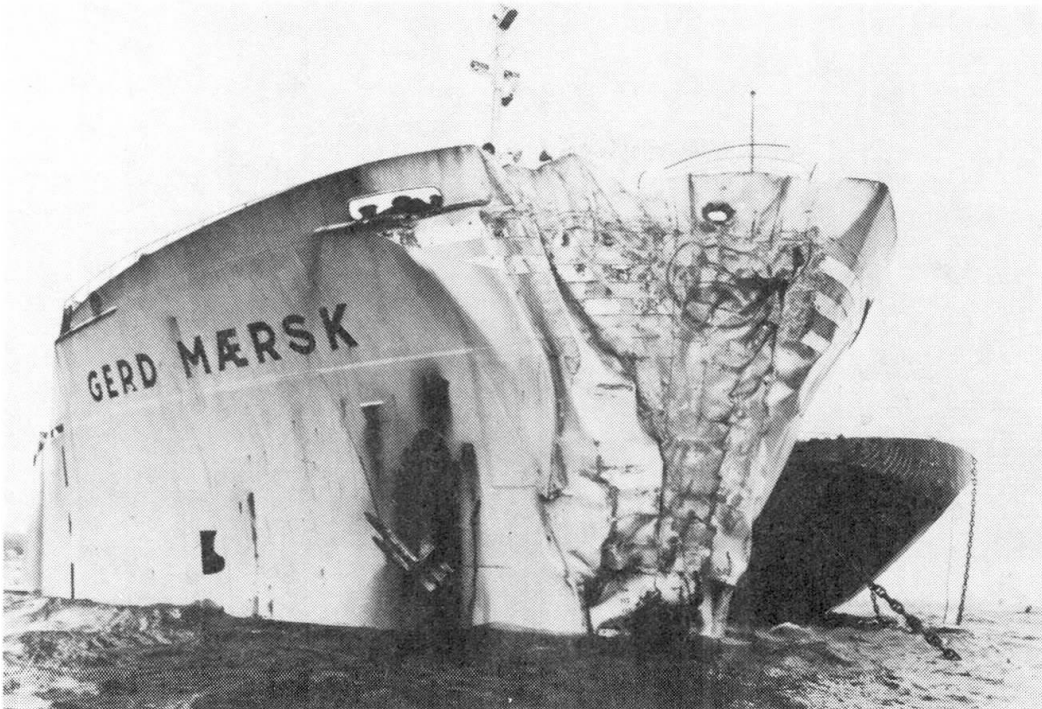
Fig. 2. Collision damage to tanker.

In 1981 a main tower pier of the 488-m Newport suspension bridge in Rhode Island, USA, was struck head on by a fully laden 45,000-ton tanker. The ship was shortened 3.5 m through bow crushing, but the bridge pier suffered only superficial damage. Details of bridge design and accident are given, and forces developed during the collision are derived.

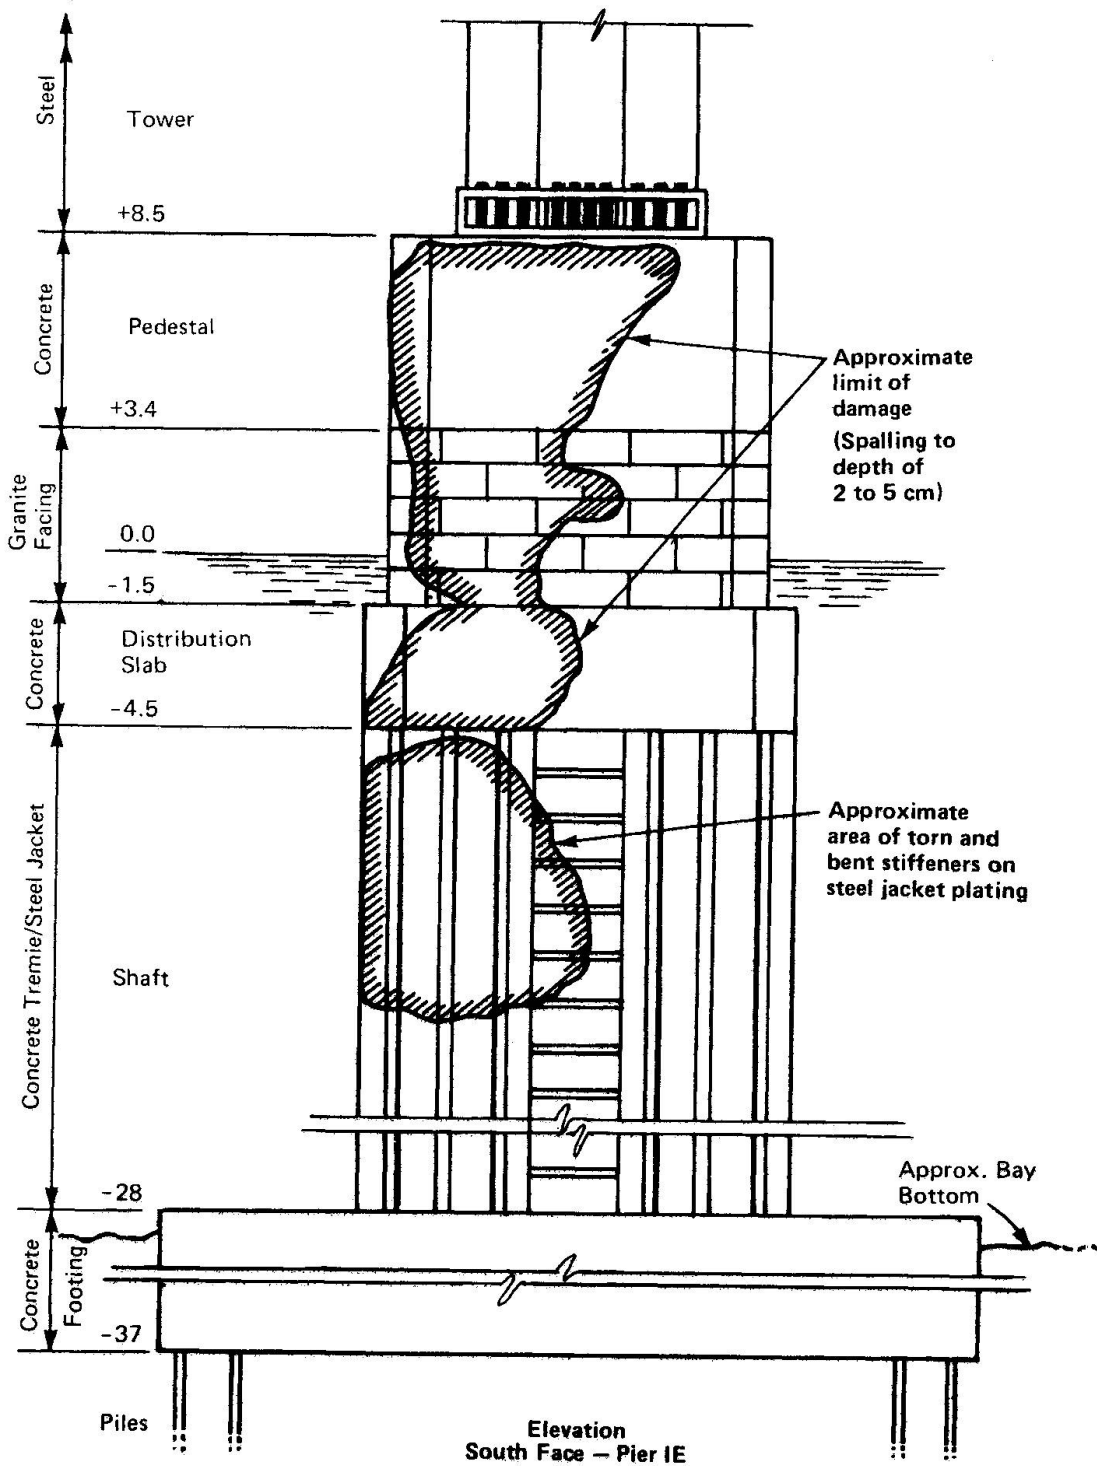
Fig. 4. Pier damage above and below waterline.

Damage to the bridge was negligible. The pier suffered no displacement or rotation, and there was no misalignment of the roadway deck joints or any other superstructure elements. The side of the pier suffered extensive surface scrapes, gouges, and spalls of the concrete (Fig. 3) to a depth of 2 to 5 cm over an area roughly 7 m wide by 20 m high, approximately equally above and below the water line (Fig. 4).

There were a number of superficial tears in steel plating of the underwater caisson structure, but no damage to the concrete behind the plating. A spectacular blotch of gray paint decorated the side of the pier for several days before falling off.

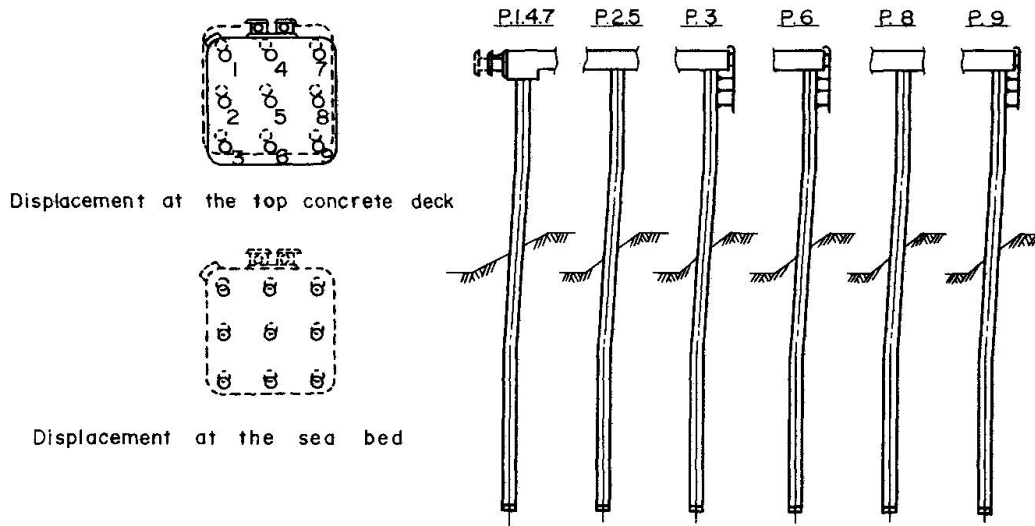
Fig.5 Deformation of Dolphin B-3

The results of our inspection carried out immediately after the accidents are briefly as follows: (See Fig.5)

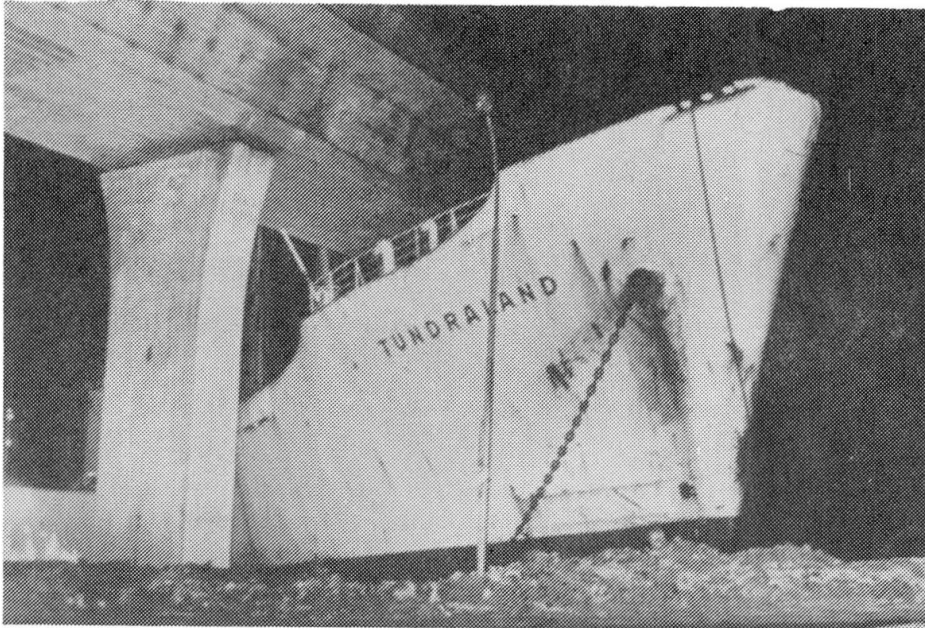
Fig. 8 Drammen Bridge; Nearly catastrophe

This motorway bridge was finished in 1975. It is a concrete box-section construction with spans around 50m. Close to the bridge is a quay in use for larger ships. In 1978 a ship of 4572 dwt was not able to reverse the engine. However, by very good seamanship the ship was grounded after manouvering between two columns. The superstructure of the ship only caused minor damages to the edges of the box-section. Fig. 8.
