Zeitschrift: IABSE reports = Rapports AIPC = IVBH Berichte
Band: 42 (1983)

Case Stories of Recent Ship Collision Accidents

Ship Collisions with Danish Lighthouses

Newport Brückenzusammenstoß

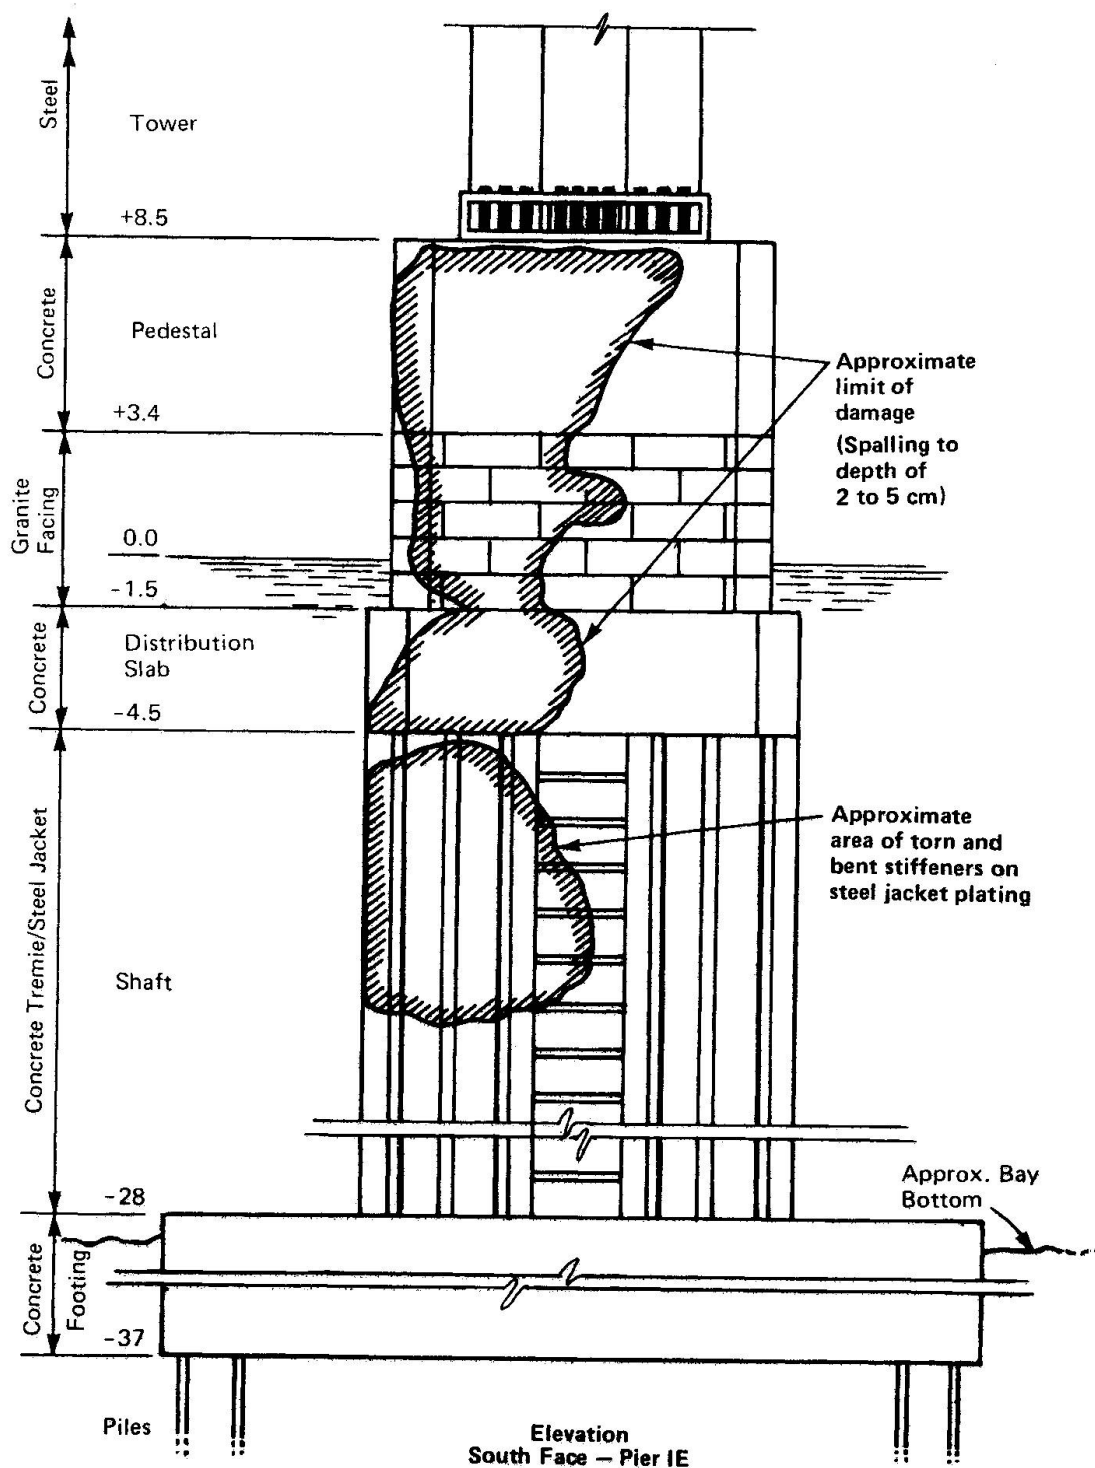
Fig. 4. Pier damage above and below waterline.

Damage to the bridge was negligible. The pier suffered no displacement or rotation, and there was no misalignment of the roadway deck joints or any other superstructure elements. The side of the pier suffered extensive surface scrapes, gouges, and spalls of the concrete (Fig. 3) to a depth of 2 to 5 cm over an area roughly 7 m wide by 20 m high, approximately equally above and below the water line (Fig. 4).

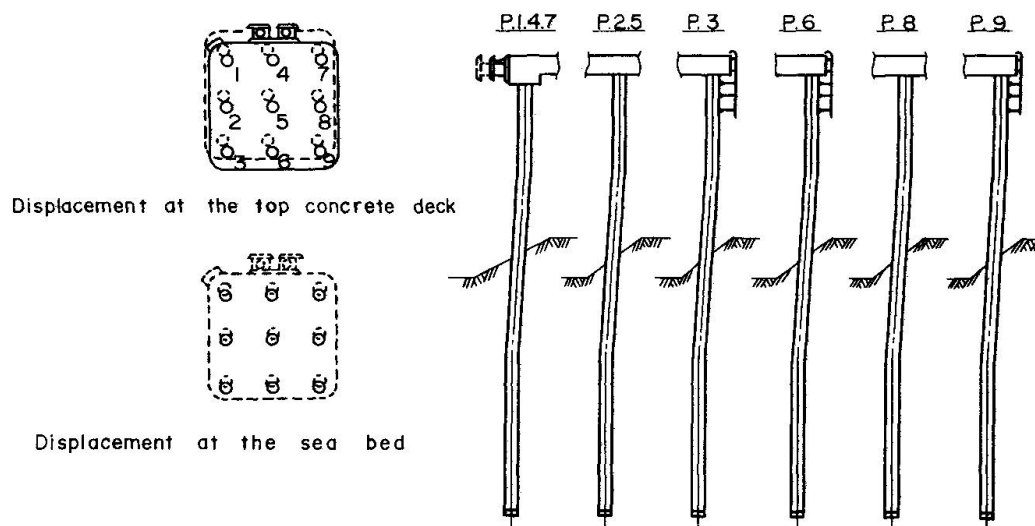
Fig.5 Deformation of Dolphin B-3

The results of our inspection carried out immediately after the accidents are briefly as follows: (See Fig.5)
