# Ship collisions with Danish lighthouses

Autor(en): **Mikkelsen, Aksel**

Zeitschrift: **IABSE reports = Rapports AIPC = IVBH Berichte**

Band (Jahr): **42 (1983)**

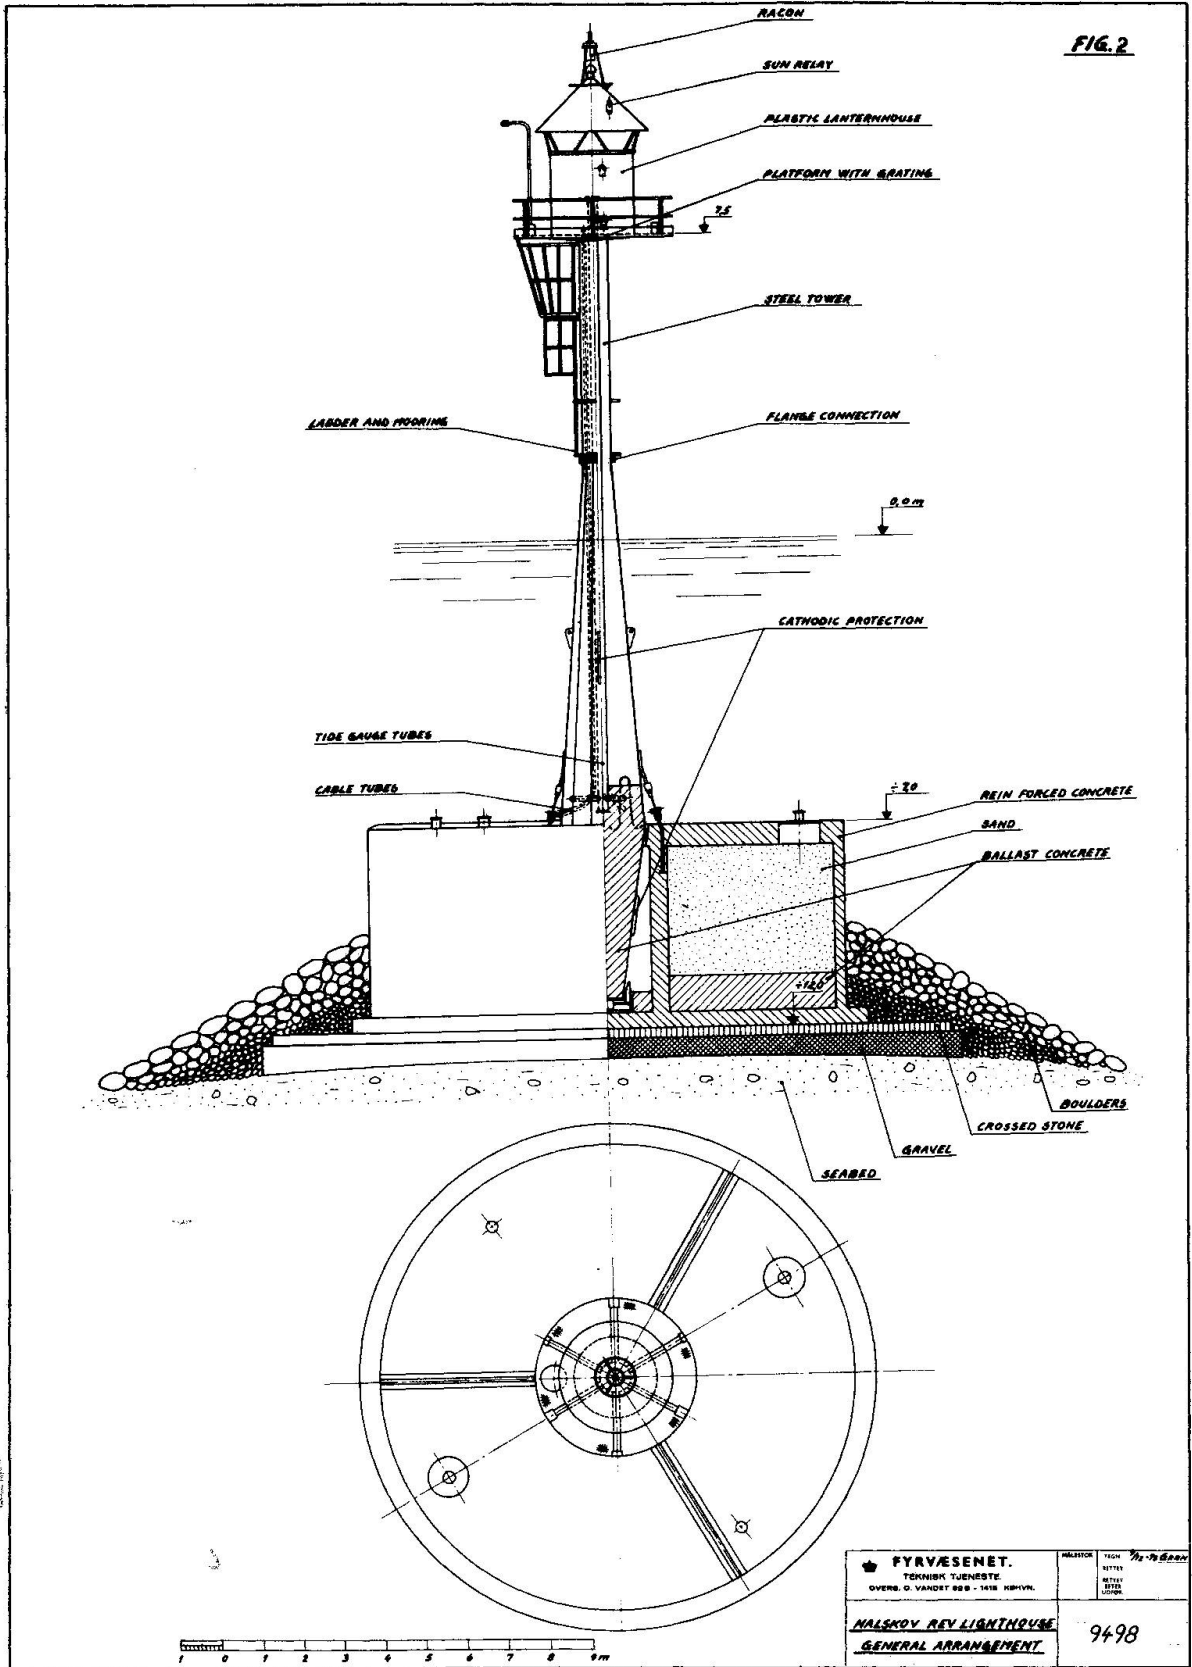
**Fig. 2** Lighthouse. General arrangement

On account of the rather heavy drifting of ice in Danish waters, the lighthouses have been made as slender as possible in the area near the waterline. At a water depth of between 5 and 7 m, the steel lighthouse structure has been anchored in a round concrete caisson placed on a level layer of gravel on the sea bed.

At a height of approx. 10 m above sea level, a glasfiber reinforced plastic lantern house has been placed containing the light-house equipment which is based on gas and a battery-operated racon.

The lighthouses have been designed in such a way that if they are run into, damages to the ship should be as insignificant as possible, as this would be less costly, less dangerous to the crew, and reduce the risk of oil pollution.
