Ship Collisions with Danish Lighthouses

Aksel MIKKELSEN
Civil Engineer
Administration of Navigation
and Hydrography
Copenhagen, Denmark

Since 1972, fourteen small lighthouses have been built in the Great Belt at water depths ranging between 8 and 17 m. Many of them have since then been exposed to ship collisions. Two of them, situated closely to the planned site of the Great Belt Bridge, have for instance been run into three and four times, respectively. The conclusion of the collision cases must be said to be negligence.

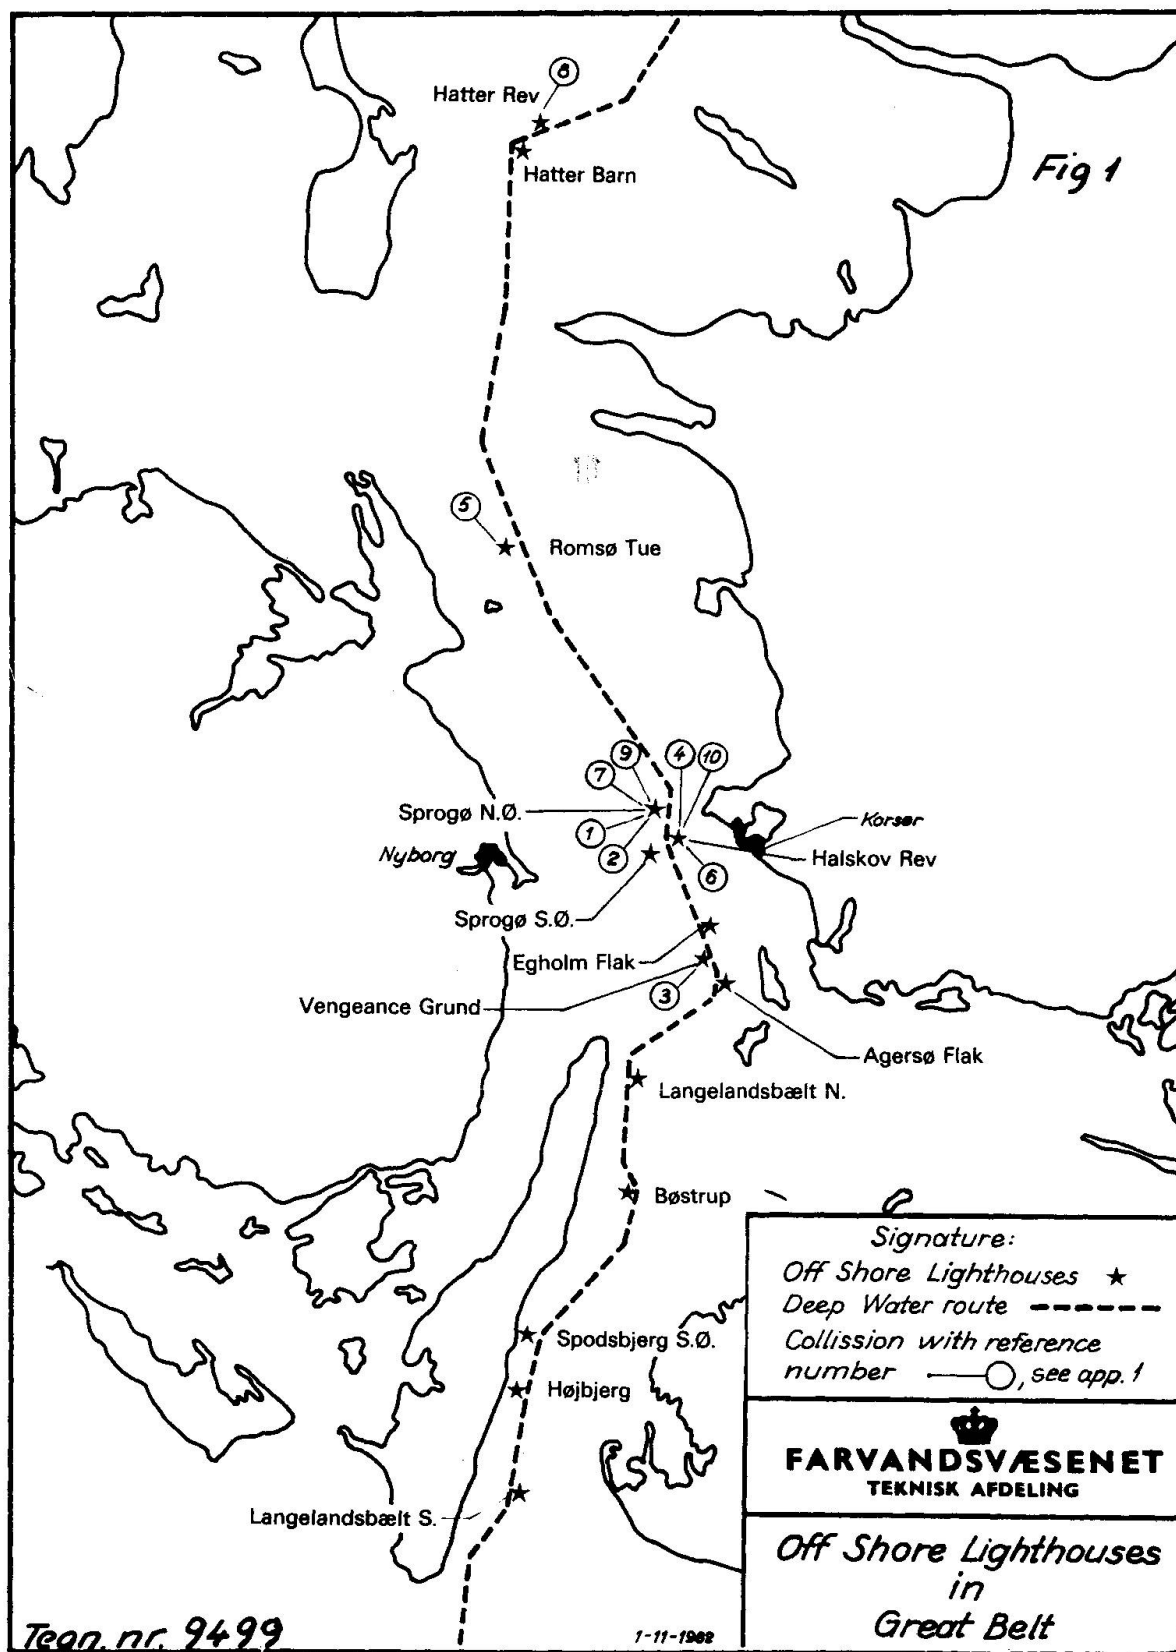
Fig. 1 Location of lighthouses in Great Belt

The placing of the lighthouses became a compromise between the best position for navigation purposes and the most advantageous technical solution. The lighthouses are placed as close to the deep fairway as possible, and preferably where there are bends or turns of the route.

In the placing of the two lighthouses, Halskov Rev and Sprogø N. Ø., it was taken into consideration - following consultation with the Great Belt Commission at that time - that the lighthouses were to assist navigation when vessels had to pass under the Great Belt Bridge, if this should become a reality.
