Recovery and repair of the Second Narrows Railway Bridge

Zeitschrift: **IABSE reports = Rapports AIPC = IVBH Berichte**

Band (Jahr): **42 (1983)**

Recovery and Repair of the Second Narrows Railway Bridge
R habilitation et r paration du pont ferroviaire de Second Narrows
Wiederherstellung und Reparatur der zweiten Eisenbahnbr cke
von Second Narrows

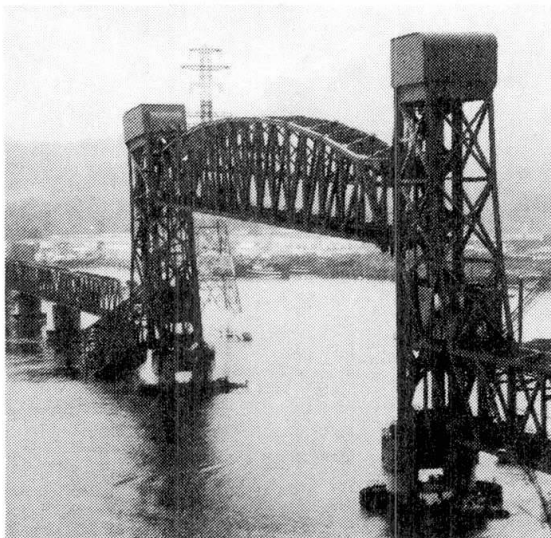
Figure 1

Although the ship was moving dead slow the impact knocked the north end of the span clear of the pier and displaced it laterally the width of the bridge (Fig. 1) by pivoting around the central wind post of the main pier.

The wind post prevented complete displacement of the span as the 12-64 mm anchor bolts in the pier members were sheared. The span was skewed approximately 90° to the axis of the bridge and the north end dropped to a gravel bar at the foot of the pier.

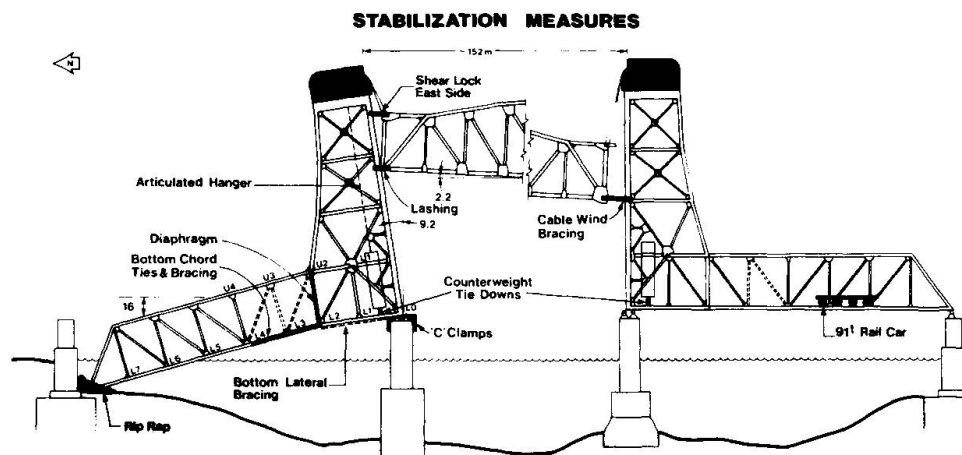
Figure 2

The initial appraisal of damage indicated a dramatic series of instantaneous failure mechanisms. The severe damage was limited to the bottom chord and web system between panel points (p.p.) L2 and L4 (see Fig. 2 for p.p. numbering). This damage permitted the remaining portion of the span to rotate against a plastic hinge which formed in the top chord at U2. An examination of the point of impact of the vessel at L3 failed to show any vertical striations in the paintwork indicating the explosive suddenness of the lateral displacement. Except for one member in the immediate area of impact, the top lateral system was undamaged, as was the portal bracing system.

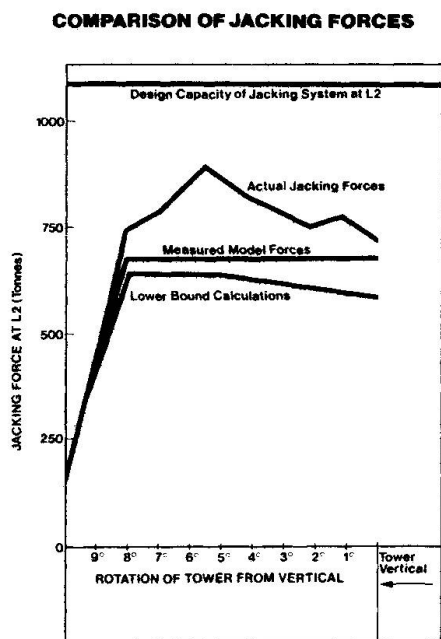
Figure 4 shows the accuracy that the various analyses achieved by plotting the jacking forces at L2 as the tower rotated to the vertical. The lower bound calculations were derived from measured forces and theoretical analysis and, as can be seen, are very close to the forces predicted by model analysis.

The actual values had a disturbing peak in them which was caused by a jammed shear lock. Without this occurrence it is believed that the measured values would have paralleled the model values closely. Even with the jamming, the maximum jacking forces did not come close to the upper capacity provided in the recovery scheme.

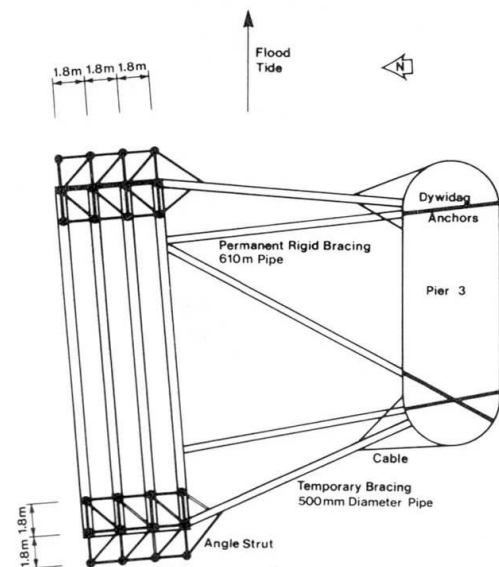
Figure 6

Figures 6 and 7 show the final configuration of the L2 bent. The table beside Figure 7 lists the variety of oscillations observed in the bent during construction. The amplitudes in most cases are visual estimates and therefore, are not too accurate. The measurement that is guaranteed, however, is the Stage 1 plus or minus 900 mm value. In this case the piles were driven at 1800 mm centres and during oscillations actually made contact with each other. Tidal flow and frequency were accurately measured. Vibrations only occurred for about 1 to 2 hours during every other tide during a two week period. It was unfortunate that the construction schedule did not fully coincide with the tidal cycle. Attempts to damp out the oscillations with ropes attached to the piers were unsuccessful. It was fortuitous that the oscillations almost always occurred after the dayshift was complete (7 p.m. to 9 p.m.) or before it started (3 a.m. to 5 a.m.) and work could always continue on bent completion during daylight hours with no oscillations. The Stage II oscillations came as a considerable surprise since group oscillation was considered to be unlikely. The east pile group survived the first set of oscillations, but top bracing of the west group was partially destroyed and was subsequently re-installed.

Temporary 500 mm dia. tube struts were installed from the bents to the piers which eliminated the violent crossflow vibrations but replaced them with plus or minus 76 mm in-line vibrations.

The jacking bent was completed as designed with 600 mm dia. pipe bracing and no serious vibrations were detected thereafter.

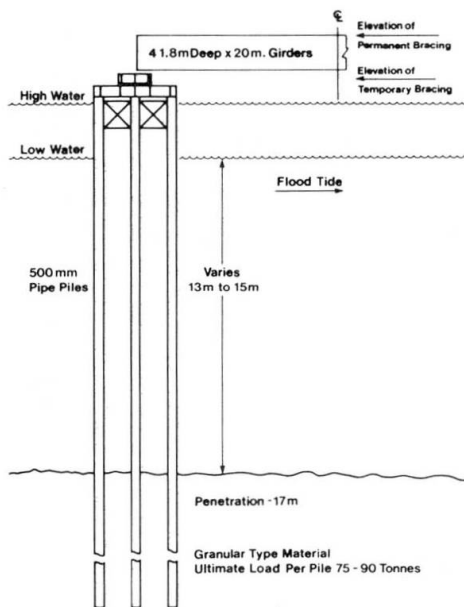
Figure 7

STAGE	HALF AMPLITUDE	DIRECTION	CYCLES/MINUTE	CURRENT (KNOTS)
I	900 mm	N/S crossflow	35	4 to 6
II East	220 mm	N/S crossflow	50	4 to 5
II West	450 mm	Do	35	4 to 5
III	75 mm	E/W in line	50	2 to 5
IV	75 mm	Do	50	2 to 5
V	7.5 mm	E/W	180	5.4
	2.5 mm	Bowstring	180	4.0
	.75 mm	E/W Random	Random	4.0
