**Artikel:** Recovery and repair of the Second Narrows Railway Bridge  
**Autor:** Jamieson, Donald H. / Calder, David G.  
**DOI:** <https://doi.org/10.5169/seals-32400>

**Recovery and Repair of the Second Narrows Railway Bridge**  
R  habilitation et r  paration du pont ferroviaire de Second Narrows  
Wiederherstellung und Reparatur der zweiten Eisenbahnbr  cke  
von Second Narrows

The paper describes the damage caused by a ship collision with the Canadian National Railway Lift Span in Vancouver, British Columbia. The theoretical and practical consideration of the stabilisation and recovery schemes are discussed and the equipment and procedures used in the twenty weeks it took to restore the train service are described in detail.

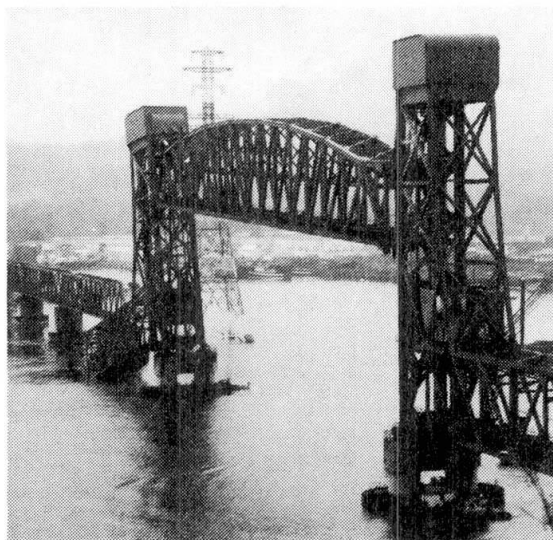
Figure 1

Although the ship was moving dead slow the impact knocked the north end of the span clear of the pier and displaced it laterally the width of the bridge (Fig. 1) by pivoting around the central wind post of the main pier.

The wind post prevented complete displacement of the span as the 12-64 mm anchor bolts in the pier members were sheared. The span was skewed approximately  $90^\circ$  to the axis of the bridge and the north end dropped to a gravel bar at the foot of the pier.

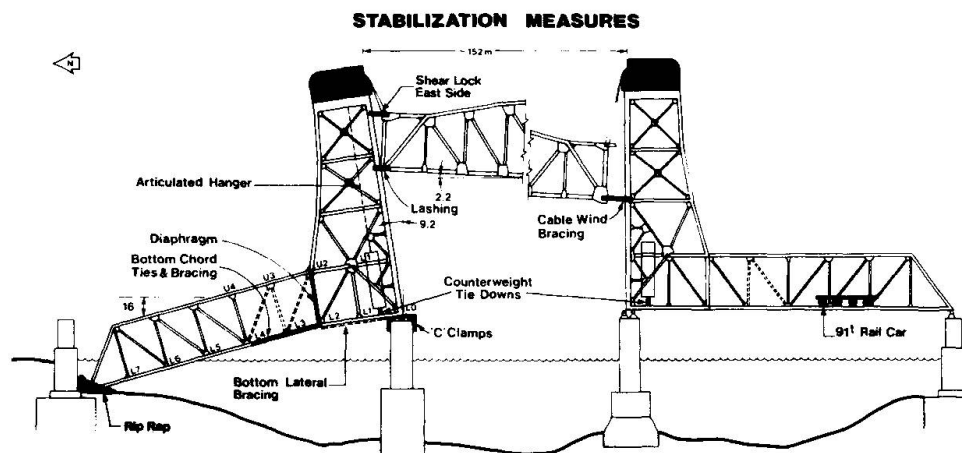
Figure 2

The initial appraisal of damage indicated a dramatic series of instantaneous failure mechanisms. The severe damage was limited to the bottom chord and web system between panel points (p.p.) L2 and L4 (see Fig. 2 for p.p. numbering). This damage permitted the remaining portion of the span to rotate against a plastic hinge which formed in the top chord at U2. An examination of the point of impact of the vessel at L3 failed to show any vertical striations in the paintwork indicating the explosive suddenness of the lateral displacement. Except for one member in the immediate area of impact, the top lateral system was undamaged, as was the portal bracing system.

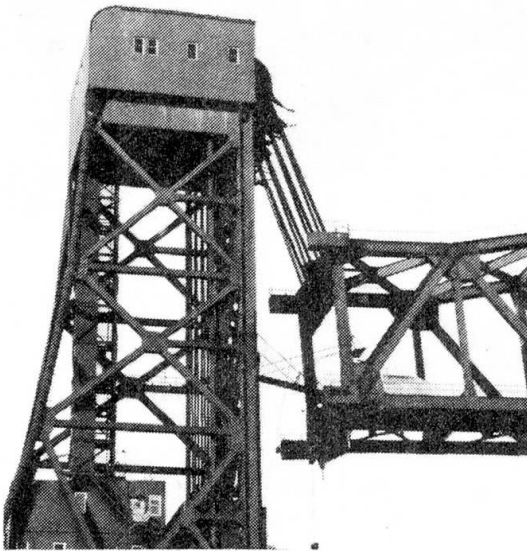
Figure 3

The tower lost substantial support as the bearings were displaced to the extent that they were partially projecting over the N.E. and S.W. edges of the main pier. In this precarious state of equilibrium the lift span, which had been torn from the vertical tower guides (Fig. 3) was left hanging, hammock-like, from the lift ropes.

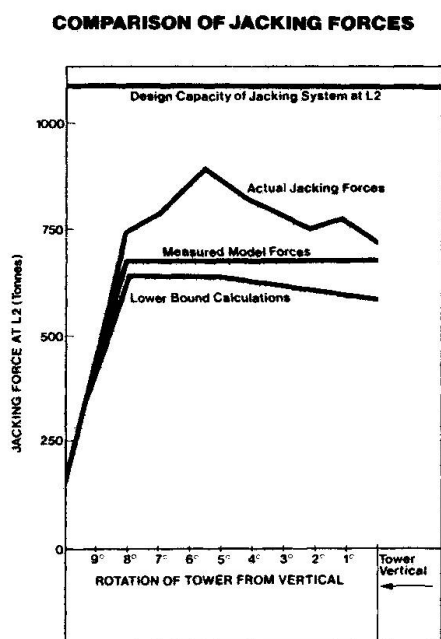
Figure 4 shows the accuracy that the various analyses achieved by plotting the jacking forces at L2 as the tower rotated to the vertical. The lower bound calculations were derived from measured forces and theoretical analysis and, as can be seen, are very close to the forces predicted by model analysis.

The actual values had a disturbing peak in them which was caused by a jammed shear lock. Without this occurrence it is believed that the measured values would have paralleled the model values closely. Even with the jamming, the maximum jacking forces did not come close to the upper capacity provided in the recovery scheme.

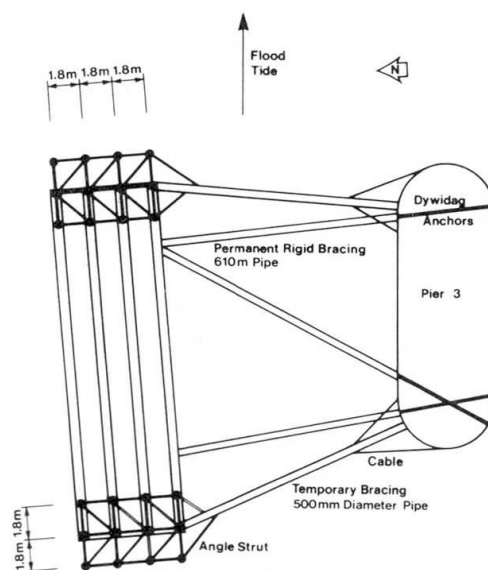
Figure 6

Figures 6 and 7 show the final configuration of the L2 bent. The table beside Figure 7 lists the variety of oscillations observed in the bent during construction. The amplitudes in most cases are visual estimates and therefore, are not too accurate. The measurement that is guaranteed, however, is the Stage 1 plus or minus 900 mm value. In this case the piles were driven at 1800 mm centres and during oscillations actually made contact with each other. Tidal flow and frequency were accurately measured. Vibrations only occurred for about 1 to 2 hours during every other tide during a two week period. It was unfortunate that the construction schedule did not fully coincide with the tidal cycle. Attempts to damp out the oscillations with ropes attached to the piers were unsuccessful. It was fortuitous that the oscillations almost always occurred after the dayshift was complete (7 p.m. to 9 p.m.) or before it started (3 a.m. to 5 a.m.) and work could always continue on bent completion during daylight hours with no oscillations. The Stage II oscillations came as a considerable surprise since group oscillation was considered to be unlikely. The east pile group survived the first set of oscillations, but top bracing of the west group was partially destroyed and was subsequently re-installed.

Temporary 500 mm dia. tube struts were installed from the bents to the piers which eliminated the violent crossflow vibrations but replaced them with plus or minus 76 mm in-line vibrations.

The jacking bent was completed as designed with 600 mm dia. pipe bracing and no serious vibrations were detected thereafter.

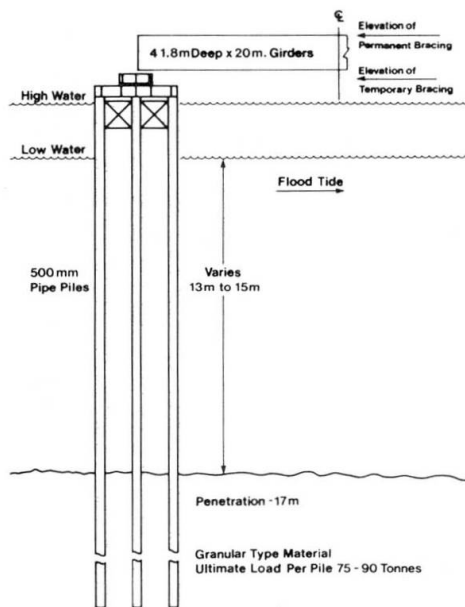
Figure 7

STAGE	HALF AMPLITUDE	DIRECTION	CYCLES/ MINUTE	CURRENT (KNOTS)
I	900 mm	N/S crossflow	35	4 to 6
II East	220 mm	N/S crossflow	50	4 to 5
II West	450 mm	Do	35	4 to 5
III	75 mm	E/W in line	50	2 to 5
IV	75 mm	Do	50	2 to 5
V	7.5 mm	E/W	180	5.4
	2.5 mm	Bowstring	180	4.0
	.75 mm	E/W Random	Random	4.0
