Techniques for Testing, Analyzing and Rehabilitation of Terra-Cotta

Sven E. THOMASEN

Consultant
Wiss, Janney, Elstner Assoc.
Emeryville, CA, USA

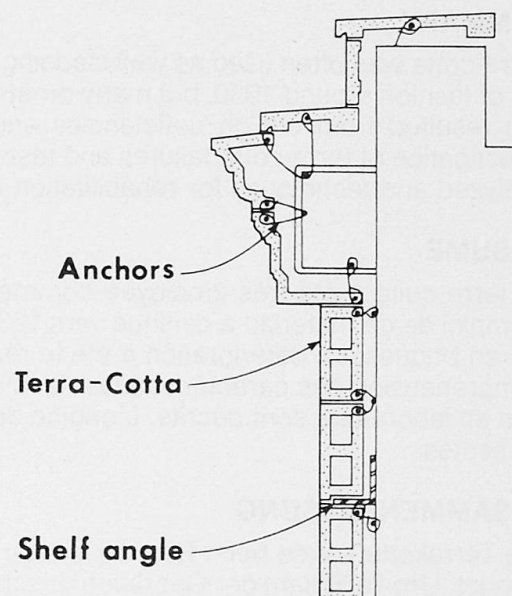
Fig. 1: Terra-Cotta Anchors

The typical terra-cotta cladding material is about 10 cm thick and from 1000 to 2000 cm² in surface area. The blocks were fabricated by hand pressing the clay into wood forms. The back is open with internal webbing to stiffen the block. The glaze, an aqueous solution of metal salts, was sprayed or brushed on the unfired clay. It was fired to cone 4 to 5 (about 1130°C), resulting in good glaze hardness and high clay strength. The blocks were supported vertically at each floor level by shelf angles. Z-shaped steel straps were fastened into slots in each block and anchored the terra-cotta horizontally to the back-up walls of masonry or concrete. Ornamental units generally had multiple anchors, as seen in Figure 1.

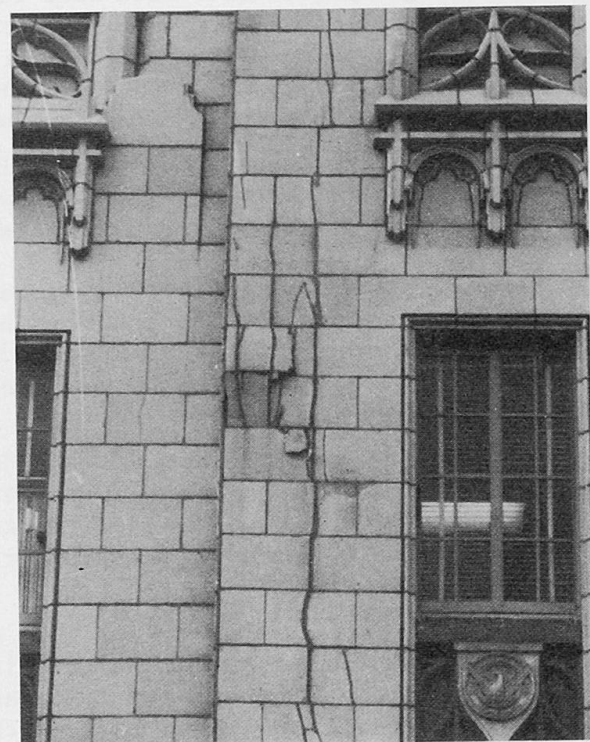
Fig. 2: Expansion failure

Terra-cotta buildings with concrete frames often experience long-term shrinkage of the frames, but most terra-cotta failures result from temperature and moisture expansion of the clay body. Thermal and wet/drying cycles are often associated with permanent lengthening of the terra-cotta blocks, and this, plus the absence of expansion joints in the facade, creates high compressive stresses. Failure can be in the form of buckling of block units, as seen in Figure 2, or crushing at the base of the facade where expansion stresses are combined with compressive gravity loads.

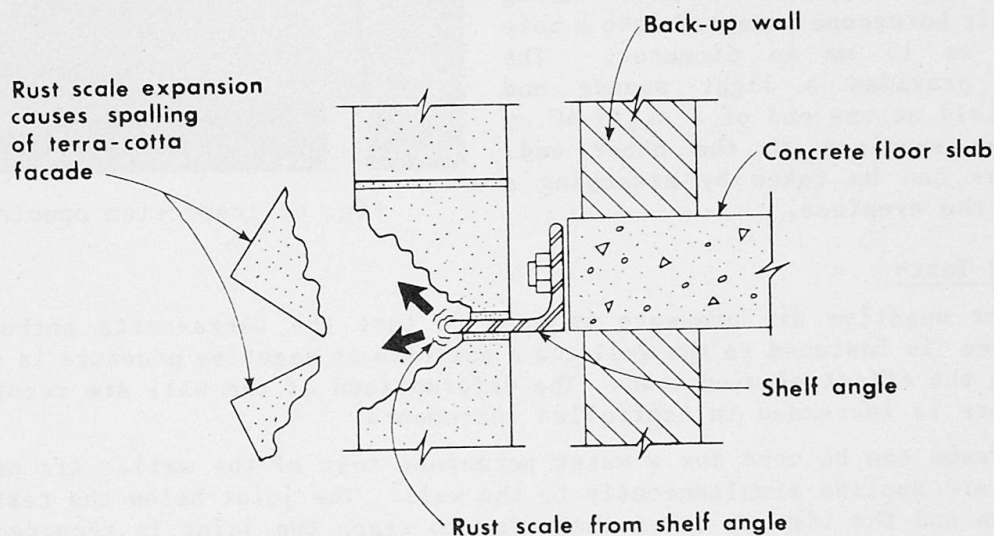
Spalling of the glaze and cracks caused by expansion allows water to enter the wall and results in further damage to the terra-cotta from freeze/thaw action. The moisture corrodes the anchors and the pressure from the volume expansion of the rust cracks the blocks, as seen in Figure 3.

Fig. 3: Terra-cotta spalling caused by corrosion of shelf angle.

Corroded or missing shelf angles and wall anchors are replaced. New anchors and angles should be given rust protection or be of stainless steel, especially in walls with past leakage problems. Consideration should also be given to installing flashing and weep holes in the wall cladding.

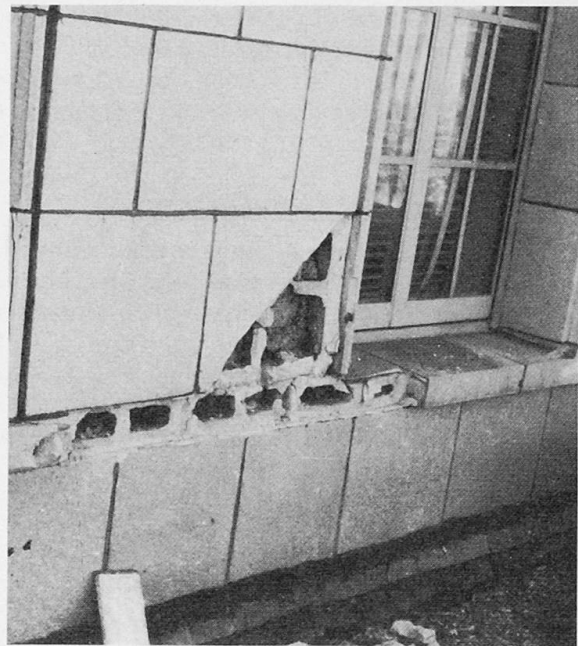
Fig. 4: Inspection opening

Inspection openings, as seen in Figure 4, are the best method to verify the location and the condition of the wall supports, and especially, to detect corrosion of the embedded metal anchors.

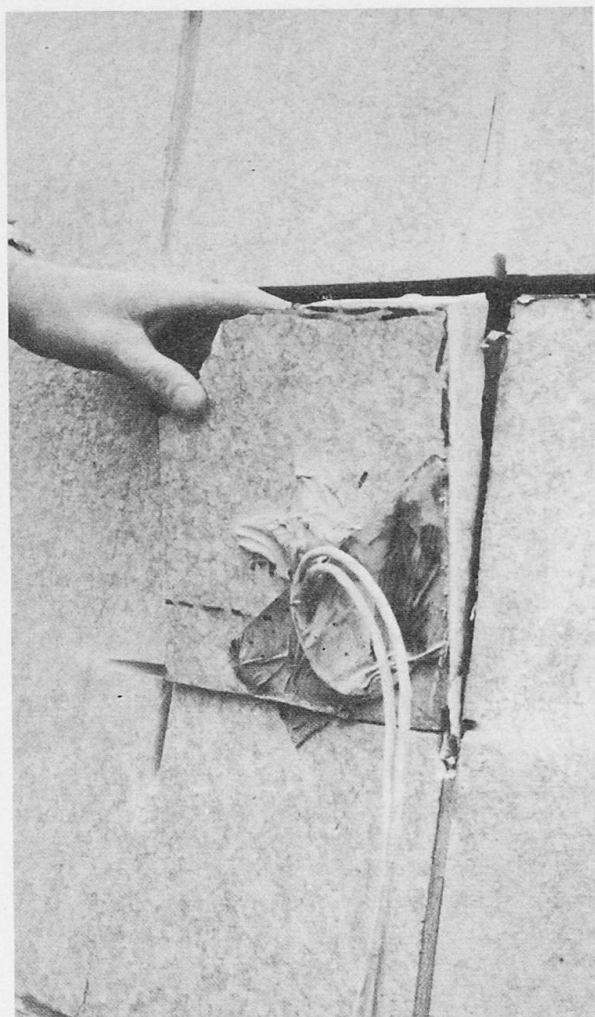
Electrical resistance strain gages are attached to the terra-cotta surface and the gages are read. Then the terra-cotta block, with the gages attached, is cut loose from the wall and the gages are read again, as seen in Figure 6. The change in gage reading is a measure of the strain in the block. The stress in the block is found by multiplying the measured strain difference by the modulus of elasticity, as determined by laboratory tests.

Fig. 6: Terra-cotta block, with strain gages attached, is cut loose.

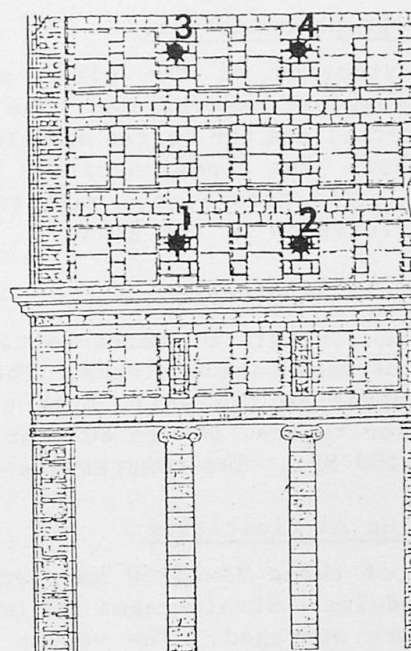
Fig. 5: Strain relief test

Expansion of the terra-cotta and absence of expansion joints often cause high compressive stresses in the cladding. Strain relief testing is the best method to measure the magnitude and direction of the built-up stresses, as seen in Figure 5.

STRAIN RELIEF TEST DATA				
GAGE	VERTICAL		HORIZONTAL	
	STRAIN μ cm/cm	STRESS kPa	STRAIN μ cm/cm	STRESS kPa
1	450	9315	50	345
2	283	5858	24	497
3	320	6624	30	621
4	171	3540	7	145

Compressive vertical stresses as high as 23 MPa have been recorded. This is close to the compressive strength of the terra-cotta wall. From multiple strain measurements, a stress map can be made for the exterior elevation. The map is used to evaluate if cutting of expansion joints into the facade will relieve the built-up terra-cotta stresses.

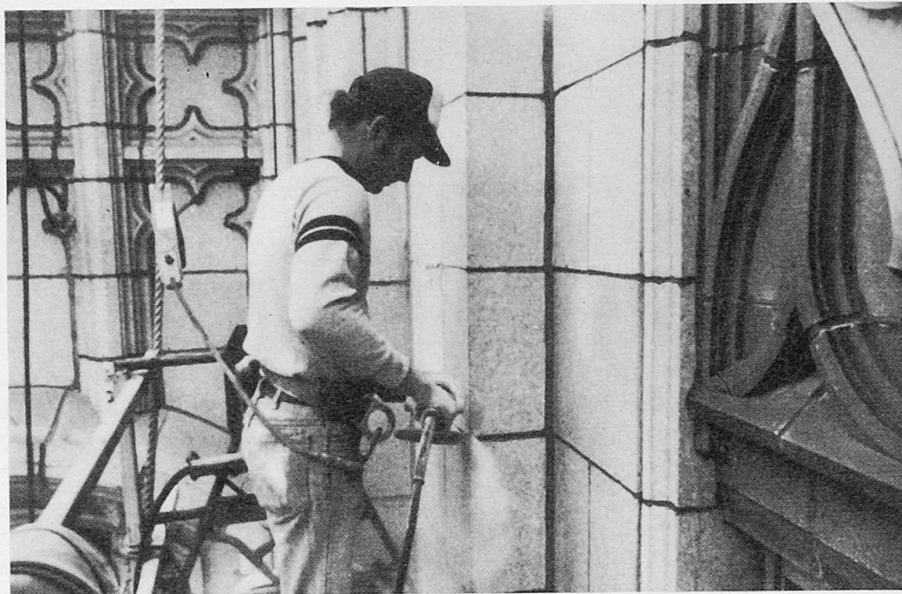
Fig. 7: Cutting of new expansion joints.

Vertical expansion joints are generally cut near corners and wall returns, while horizontal expansion joints are cut below relieving angles, as seen in Figure 7. The joint location is determined from stress measurements of the terra-cotta. The joints are made watertight with elastomeric sealants. Cutting of expansion joints can disturb the fastening of the terra-cotta and will often require the installation of new anchors.
