## Collapse of the Bridge at Pulle

### Daniël VANDEPITTE

### SUMMARY

The bridge at Pulle and its sudden failure after 8 years of service are described. The mechanism of the collapse is explained. As the investigation showed, the failure was due to the organizational set-up. The lessons that can be learnt from the collapse of the bridge at Pulle are not strikingly novel.

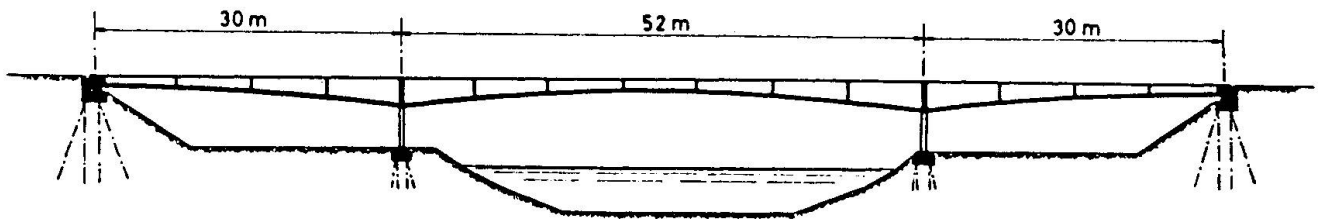
Fig. 1

The bridge at Pulle carried the Antwerp-Liège motorway across the Nete canal. Its spans were 30 m, 52 m and 30 m long (fig. 1). The concrete superstructure had 11 continuous prestressed longitudinal girders. The abutments and the piers were small concrete bodies supported by concrete piles. An unusual feature was the shortness of the piles under the piers: those under the east pier were only about 2.5 m long. This was due to the fact that a layer of sand was come upon which was so dense that the contractor was unable to drive the piles through it. The bridge at Pulle and 19 other bridges had been designed and built simultaneously under pressure of time in order to enable a section of the Antwerp-Liège motorway to be opened for traffic before a certain date. If the geotechnical report had reached the designers in good time they would probably have designed the piers with spread footings resting directly on the soil.

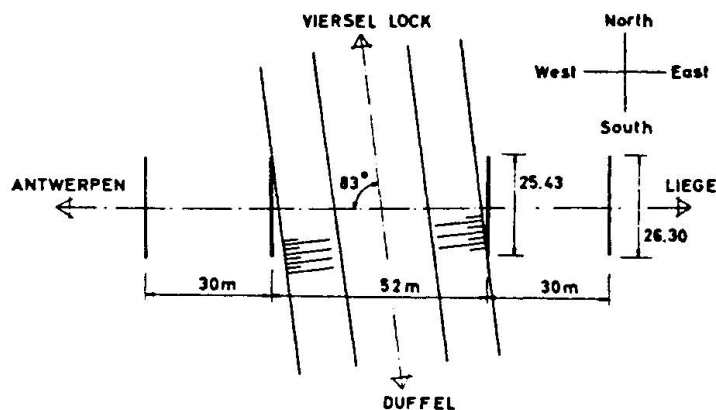
Fig. 2

The angle between the centre-line of the bridge and that of the canal was  $83^\circ$  (fig. 2). The centre of the east pier coincided at its southern end with the crest of the theoretical talus profile. Figure 3 is a vertical cross-section showing the relative position of the southern end of the east pier and the bank of the canal, drawn with its theoretical shape. The side slopes of the cutting were not protected by a lining of any kind. The newly completed bridge at Pulle was subjected to loading tests in September 1958. Its behaviour under a live load almost equivalent to the full (unfactored) design live load was entirely satisfactory.

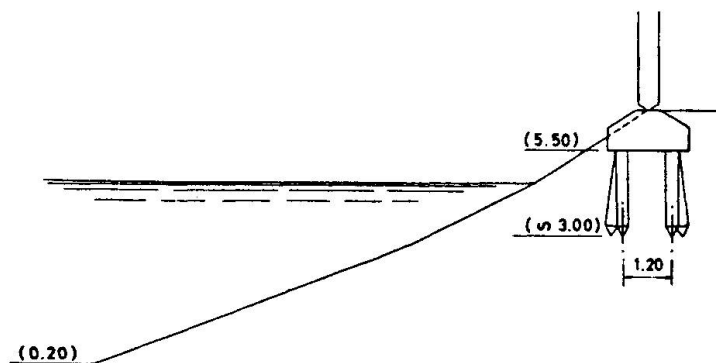
Fig. 3

The scour gradually removed the soil near the points of the left hand piles in figure 3. As a consequence the carrying capacity of those piles decreased. Figure 5b shows the configuration of the piles, the east pier and the concrete rocker bearing corresponding with an assumed 12 cm settlement of the piles on the canal side. The resulting inclination of the rocker increases the load acting on the left hand piles, thus accelerating the subsidence and the whole displacement of the body of the pier. Hence, once the settlement of the piles and the movement of the pier had begun, its horizontal displacement increased so rapidly that the foot of the rockers soon slid off the pier and that the main girders came crashing down.

- 1) Piles long enough to extend a few metres below the theoretical level of the bottom of the canal.
- 2) Canal banks efficiently protected against scour under the bridge and on either side of the bridge.

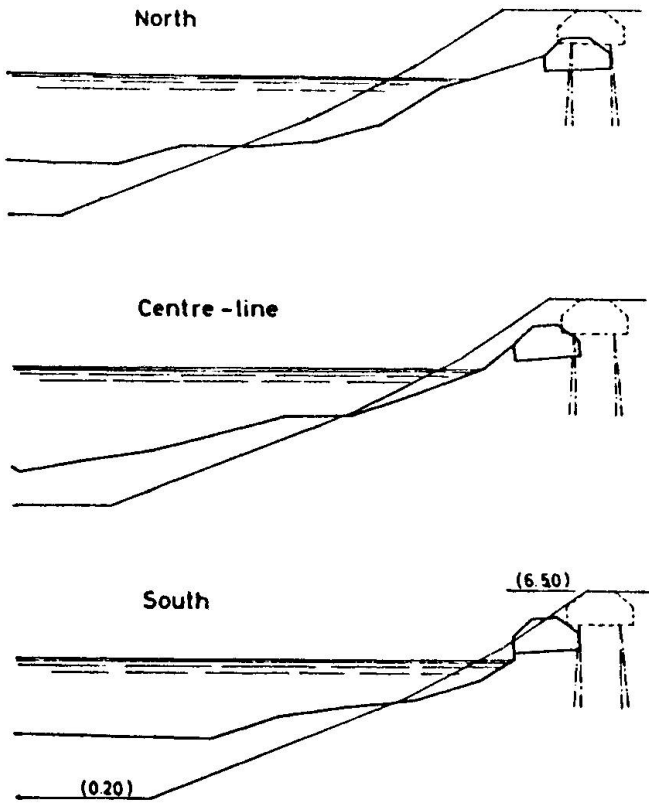
Fig. 4

possessed the necessary strength and that it had not been weakened by corrosion. Measurements revealed that the east pier had moved considerably towards the canal, settled and tilted. This is visible in figure 4, which consists of 3 cross-

sections and which shows the theoretical and the actual profiles of the canal, and the initial and the actual positions of the east pier. The amplitude of the displacement of the east pier was the greatest at its southern end.

The east talus of the canal was in very bad shape over the width of the bridge and also immediately to the south of it. The severe local scour which the east bank had undergone was mainly due to the proximity, just to the north of the bridge, of the Viersel navigation lock in the Nete canal. Barges awaiting their turn to lock through halted under the bridge or just to the south of the bridge, alongside of the east bank. When their turn came they started off and it is easy to imagine that the stir caused by their propellers a few metres from the bank slowly eroded the unprotected talus.

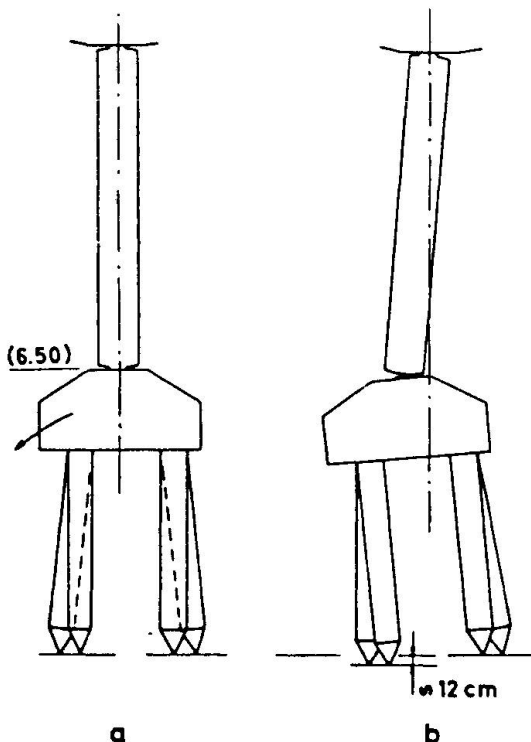
Fig. 5

So the cause of the collapse was erosion of the east bank of the canal in the immediate vicinity of the points of the canalside piles under the east pier. The bridge would not have failed if *either one* of the following situations had obtained :
