Artikel: Collapse of the bridge at Pulle
Autor: Vandepitte, Daniël
DOI: <https://doi.org/10.5169/seals-36651>

Collapse of the Bridge at Pulle

Daniël VANDEPITTE

The bridge at Pulle and its sudden failure after 8 years of service are described. The mechanism of the collapse is explained. As the investigation showed, the failure was due to the organizational set-up. The lessons that can be learnt from the collapse of the bridge at Pulle are not strikingly novel.

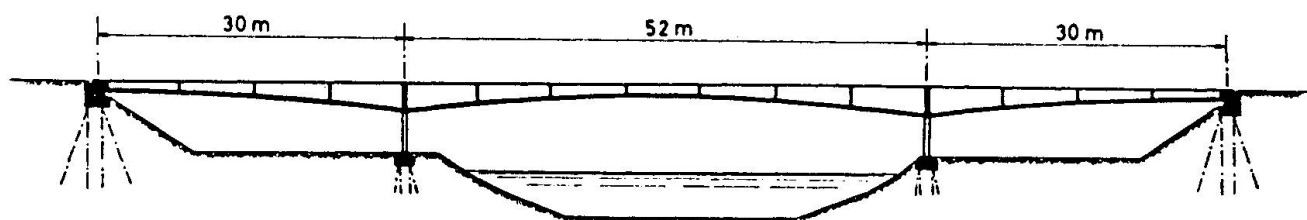
Fig. 1

The bridge at Pulle carried the Antwerp-Liège motorway across the Nete canal. Its spans were 30 m, 52 m and 30 m long (fig. 1). The concrete superstructure had 11 continuous prestressed longitudinal girders. The abutments and the piers were small concrete bodies supported by concrete piles. An unusual feature was the shortness of the piles under the piers: those under the east pier were only about 2.5 m long. This was due to the fact that a layer of sand was come upon which was so dense that the contractor was unable to drive the piles through it. The bridge at Pulle and 19 other bridges had been designed and built simultaneously under pressure of time in order to enable a section of the Antwerp-Liège motorway to be opened for traffic before a certain date. If the geotechnical report had reached the designers in good time they would probably have designed the piers with spread footings resting directly on the soil.

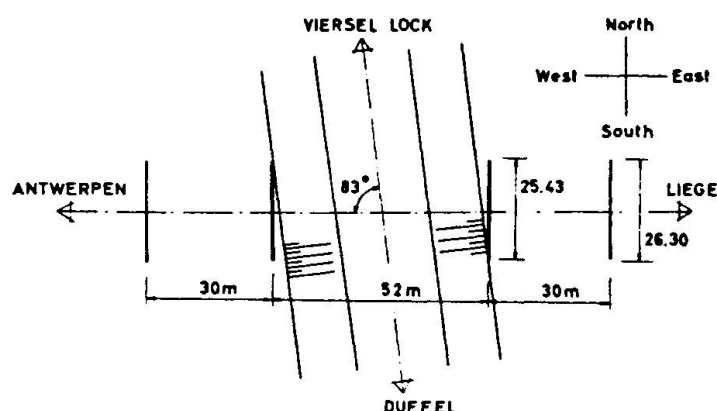
Fig. 2

The angle between the centre-line of the bridge and that of the canal was 83° (fig. 2). The centre of the east pier coincided at its southern end with the crest of the theoretical talus profile. Figure 3 is a vertical cross-section showing the relative position of the southern end of the east pier and the bank of the canal, drawn with its theoretical shape. The side slopes of the cutting were not protected by a lining of any kind. The newly completed bridge at Pulle was subjected to loading tests in September 1958. Its behaviour under a live load almost equivalent to the full (unfactored) design live load was entirely satisfactory.

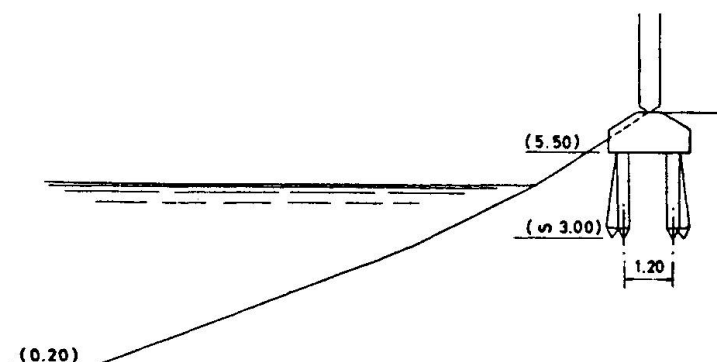
Fig. 3

The scour gradually removed the soil near the points of the left hand piles in figure 3. As a consequence the carrying capacity of those piles decreased. Figure 5b shows the configuration of the piles, the east pier and the concrete rocker bearing corresponding with an assumed 12 cm settlement of the piles on the canal side. The resulting inclination of the rocker increases the load acting on the left hand piles, thus accelerating the subsidence and the whole displacement of the body of the pier. Hence, once the settlement of the piles and the movement of the pier had begun, its horizontal displacement increased so rapidly that the foot of the rockers soon slid off the pier and that the main girders came crashing down.

So the cause of the collapse was erosion of the east bank of the canal in the immediate vicinity of the points of the canalside piles under the east pier. The bridge would not have failed if *either one* of the following situations had obtained :

- 1) Piles long enough to extend a few metres below the theoretical level of the bottom of the canal.
- 2) Canal banks efficiently protected against scour under the bridge and on either side of the bridge.

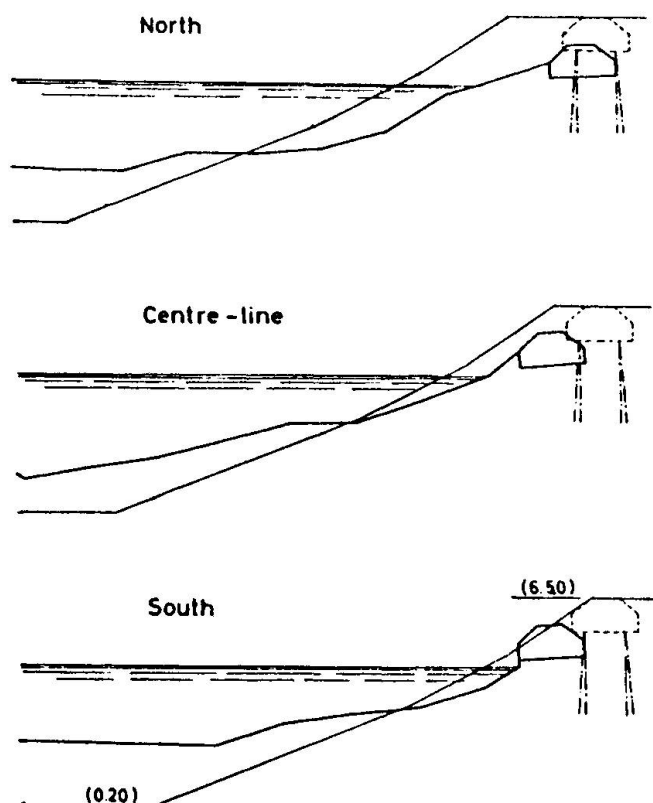
Fig. 4

possessed the necessary strength and that it had not been weakened by corrosion. Measurements revealed that the east pier had moved considerably towards the canal, settled and tilted. This is visible in figure 4, which consists of 3 cross-

sections and which shows the theoretical and the actual profiles of the canal, and the initial and the actual positions of the east pier. The amplitude of the displacement of the east pier was the greatest at its southern end.

The east talus of the canal was in very bad shape over the width of the bridge and also immediately to the south of it. The severe local scour which the east bank had undergone was mainly due to the proximity, just to the north of the bridge, of the Viersel navigation lock in the Nete canal. Barges awaiting their turn to lock through halted under the bridge or just to the south of the bridge, alongside of the east bank. When their turn came they started off and it is easy to imagine that the stir caused by their propellers a few metres from the bank slowly eroded the unprotected talus.
