Zeitschrift: **IABSE reports = Rapports AIPC = IVBH Berichte**

Additional Insulation of Flat Roofs with Thin-Walled Metal Structures

Ingemar HÖGLUND

Patrick ANDERSSON

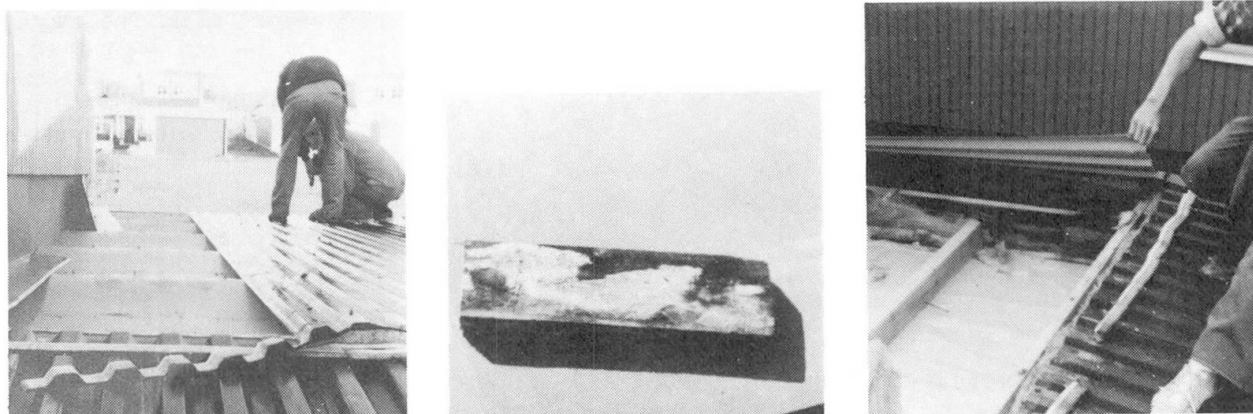
Fig. 1 Moisture damaged flat roof with metal sheeting. Moisture penetration from both the inside and the outside. The fibre board hung down, thus blocking the vented air space. The moisture content in the construction increased and caused mould and rot damage. (Example 1.)

The investigation covered an estate of terraced houses in central Sweden built in 1973-74, comprising about 100 houses. The roof covering is metal sheeting and the pitch is only about 4° . The roof is ventilated and the ventilation is at right angles to the pitch. For the original roof construction and rebuilt roof see Figs 3 and 4. During the very first winter moisture patches appeared in the roof and walls. We established that the damage was due to moisture penetrating from both within and without.

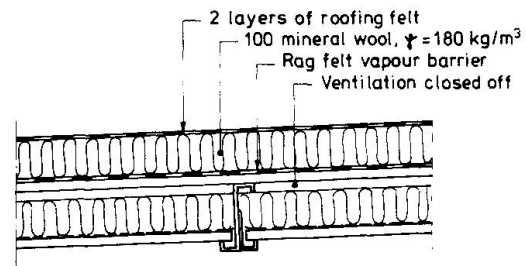
During the winter months dripping from the ceiling caused a problem. This was due to moisture transport by air convection caused by leaks between the vapour barrier in the ceiling and the structural beams. Since the construction does not contain organic material, damage to the ceiling was restricted to impaired heat

insulation. However, for practical and hygienic reasons the "rainfall" from the ceiling could not be tolerated. The problem was solved by using external additional insulation, see Fig. 7.

Fig. 7 Roof construction after rebuilding. A vapour barrier of rag felt was glued to the roof to prevent air convection. Dripping from the ceiling has stopped.

After additional insulation of the roof in spring 1983 dripping from the ceiling stopped and the roof now functions perfectly. Moisture and temperature are measured in the roof to check the moisture content there. See Fig. 8.
