Zeitschrift:	IABSE reports = Rapports AIPC = IVBH Berichte
Band:	52 (1986)
Artikel:	Tsing Yi south bridge assessment
Autor:	Beard, A.S. / Tung, H.S.S.
DOI:	https://doi.org/10.5169/seals-40340

Tsing Yi South Bridge Assessment

A.S. BEARD

H.S.S. TUNG

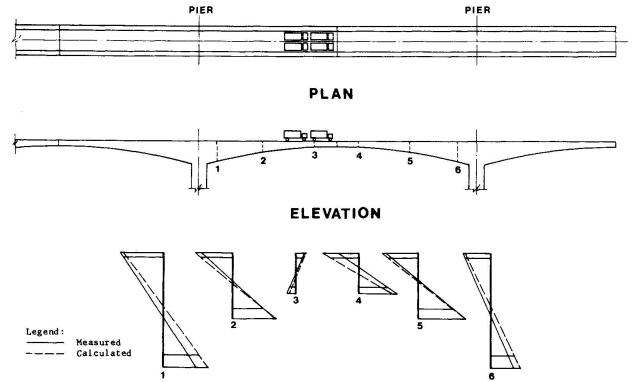
Figure 2

Next, vibrating wire strain gauges were attached to the concrete surface at three cross-sections on each of the two cantilevers and a series of load tests were carried out. In these tests four fully laden bulk cement carriers were parked on the deck in various patterns and readings of the strain gauges were taken. The deck was also levelled. Upon removal of each test loading the superstructure quickly rebounded to its original level. The results of analyses of the bridge under the various loading patterns agreed well with the test readings, and it was concluded that the bridge was behaving elastically. Typical results are shown in Figure 2.

MEASURED AND CALCULATED STRAINS
