Artikel: Fatigue damage and repair of steel railway bridges in Japan

FATIGUE DAMAGE AND REPAIR OF STEEL RAILWAY BRIDGES IN JAPAN

Fatigue Damage and Repair of Steel Railway Bridges in Japan

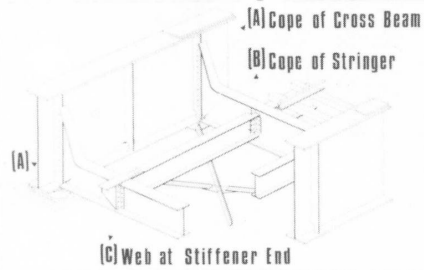
Fatigue damages have been occasionally experienced in structural details of railway bridges, because relatively large train loading is repeated in many cycles. Fig. 1 shows a schematic of the through type steel railway bridge and locations of fatigue cracks, as an example.

THROUGH TYPE GIRDER AND CRACK LOCATIONS

In general, railway bridges are actually subjected to repeated train loading of a magnitude comparable to that assumed in design. In result, some inadequately designed or manufactured structural details have suffered fatigue cracks. In this poster three representative types of fatigue damages shown in Fig. 1 in Poster are dealt with.

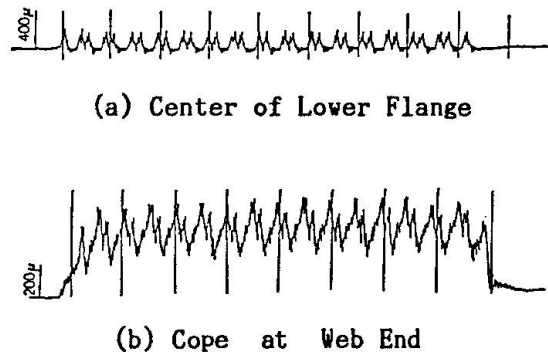
Fig. I Observed Stress Variations at End Floor Beam

As seen in Fig. 2 in Poster, a crack initiated from the cope at the lower corner of floor beam of a through girder bridge. Such cracks have occurred in a few end floor beams and one intermediate floor beam. Their lower flanges were connected by gusset plates with those of the main girders. Fig. I shows an example of the stress variation during passage of a train in the vicinity of the cope. Then, half-scale models, in which the horizontal lengths
