Artikel: Strengthening of a bridge with epoxy beam and prestressed steel
Autor: Engelhardt, Victor L.
DOI: <https://doi.org/10.5169/seals-44304>

Strengthening of a Bridge with Epoxy Beam and Prestressed Steel
Renforcement d'un pont avec de l'époxi et des fils d'acier précontraints
Instandstellung einer Stahlbrücke mit Epoxyharz und Stahldrahtvorspannung

Victor L. ENGELHARDT
Civil Engineer
D.E.R.
Curitiba, PR, Brazil

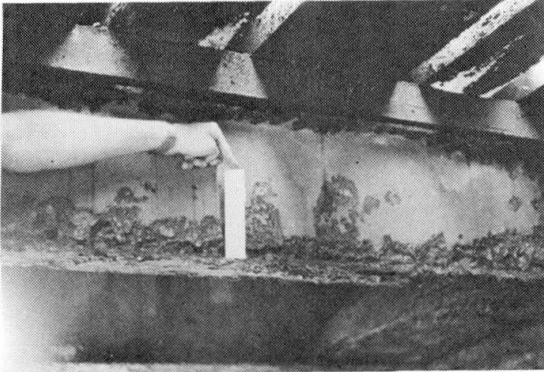
2.2.1 The truss-frame lower chord was almost completely deteriorated due the corrosion.

Fig. 2 Corrosion details

- Cleaning with sand blast all the structure.
- Use new metallic reinforcements mainly in knots and superior chord.
- Through the profiles that composed the lower chord an epoxy beam was constructed with 40 steel wires $\phi 5 \text{ mm}$ which was slightly prestressed in order to neutralize the traction in the lower chord due the structure's own weight. The epoxy mix that filled the space inside the prestressed wires and the original profiles in addition to its great resistance for compressing and traction efforts due to its high adherence power, worked in order to form an unique block composite by old structure and reinforcements introduced.
- The compression tensions obtained with the samples moulded with the mix utilized in the rehabilitation were greater than ones obtained in the laboratory experiments as shown by the values indicated below:

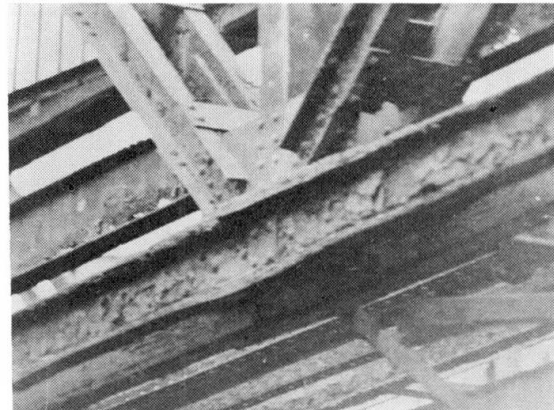
2.1.2 The truss-frame lower joints were seriously damaged by the corrosion.

Fig. 3 Lower joints

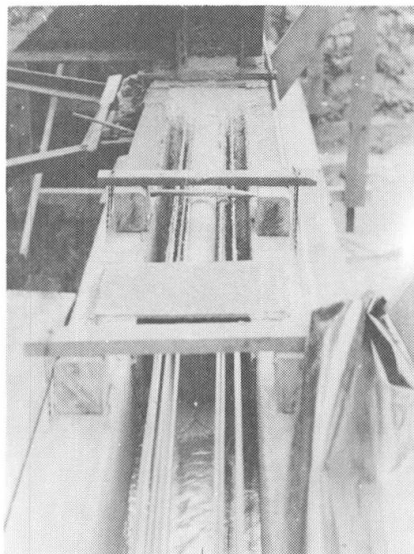
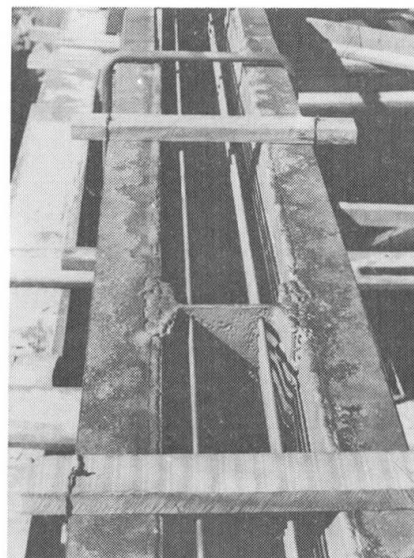
Fig. 4 and 5 Execution details

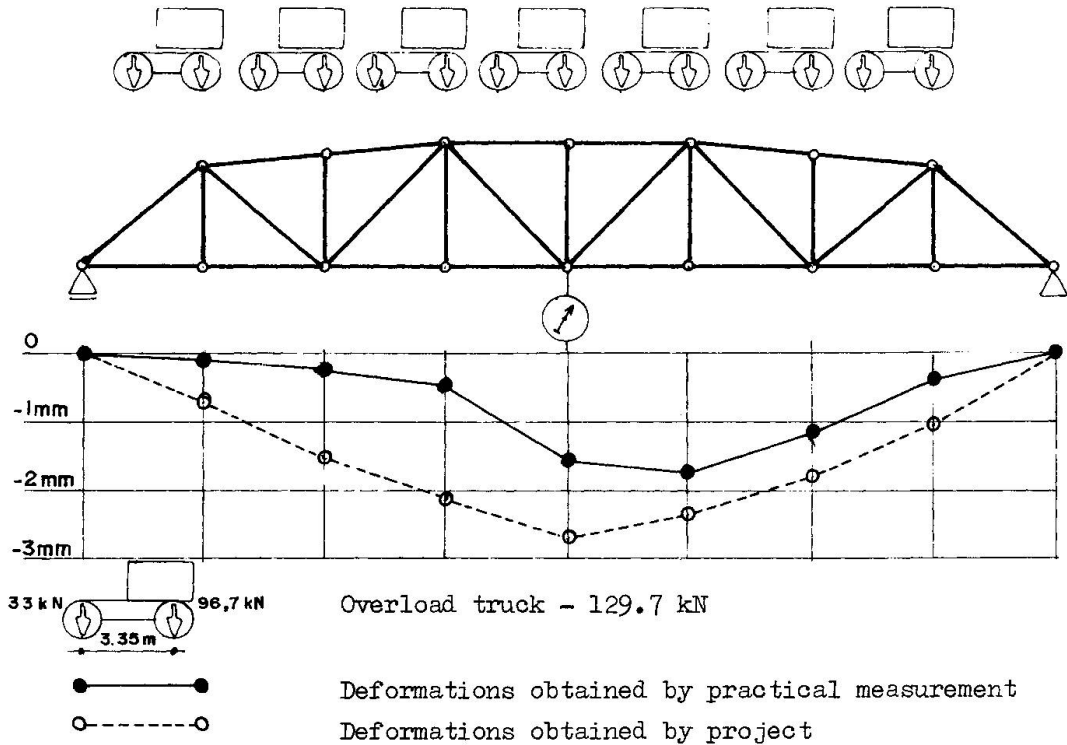
In order to check the structure's behavior another serie of tests were executed with an overload truck weighting 129.7 kN, in january 1989.

The tests were realized with the truck parking in 7 stations, at same time the deformations were indicated through a deflectometer (accuracy 1/100 mm) installed in the middle of the bridge.

With these results were possible to confront the deflections obtained by project and practically. We can observe in figure above that the deformations measured were always smaller than the theoretical deformations, consequently showing the good performance of the structure.
