**Zeitschrift:** IABSE reports = Rapports AIPC = IVBH Berichte  
**Band:** 57/1/57/2 (1989)

**Artikel:** Assessment of existing structures for their rehabilitation  
**Autor:** Brito, Jorge de / Branco, Fernando / Batista, A.R.  
**DOI:** <https://doi.org/10.5169/seals-44314>

## **Assessment of Existing Structures for their Rehabilitation**

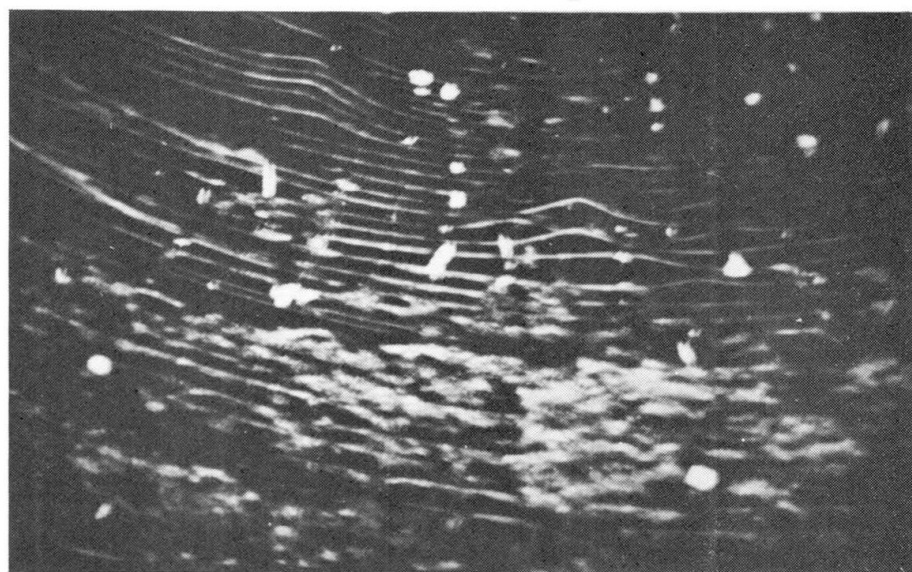
Area D - very high degree of concrete degradation, loose and twisted reinforcement (Fig. 1).

Fig. 1 [2] Damage in the cross-section of the tunnel (Area D)

Some steel cores from the various areas were also taken out and tested. Only the reinforcement in Area D showed some decrease in its mechanical characteristics ( $f_{s0,2k} = 350$  MPa < 400 MPa). As its residual extensions were substantial, the reinforcement was replaced. Adhesion tests were also performed before repair took place.

Area D - the reinforcement was replaced, about 3 cm of the surface concrete were removed and the cover was replaced by shotcreting. To efficiently verify the bond between old and new concrete, some cores were taken out and tested to quantify the bond strength of the joint. The ultimate shear stress was about 2,3 MPa, similar to that of 0,00the concrete used in the tunnel construction.

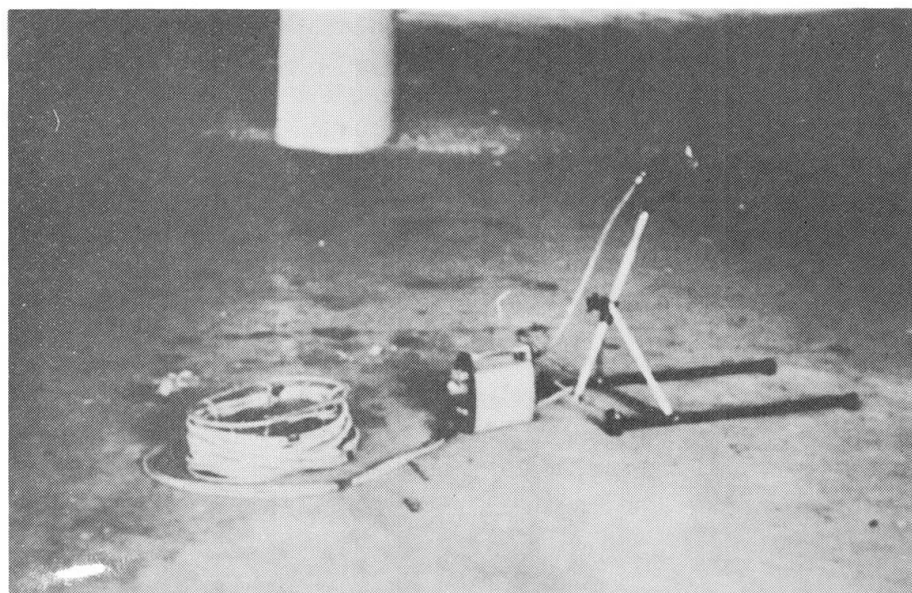
- groove making in concrete beams to determine the number and size of the reinforcement.
- non-destructive in-situ testing using X Rays to detect and identify the reinforcement in some slabs (Fig. 2). It proved to be efficient in the analysis of slabs up to 30 cm deep with the equipment used and the safety conditions imposed [3]. The radiographies showed the reinforcement layout and size.

According to the results obtained, it was not possible to guarantee analytically the safety factors in the dimensioning of the slabs with the new in-service loads. It was then decided to resort to a full scale load test of the slab with the least favourable conditions. The load consisted of water contained by a small wall specially built for the effect (Fig. 2).

The results showed a good behaviour of the slab with almost no visible cracking for the future in-service loads with a factor  $\gamma_f = 1,25$ . One of the main reasons for this was the good quality of the mortar layers used on top of the slabs that functioned monolithically with the concrete. There was then no need to strengthen the slab.

Fig. 2 X Ray equipment and full scale load test of slab
