Vibration Fatigue of Steel Bridges of the Bullet Train System

Kenji SAKAMOTO

Chitoshi MIKI

Fatigue cracks caused by out-of-plane vibration were observed in steel bridges of the Tokaido Shinkansen. Crack growth behaviour, measured cyclic stresses, evaluation of fatigue damage, and retrofitting methods are described.

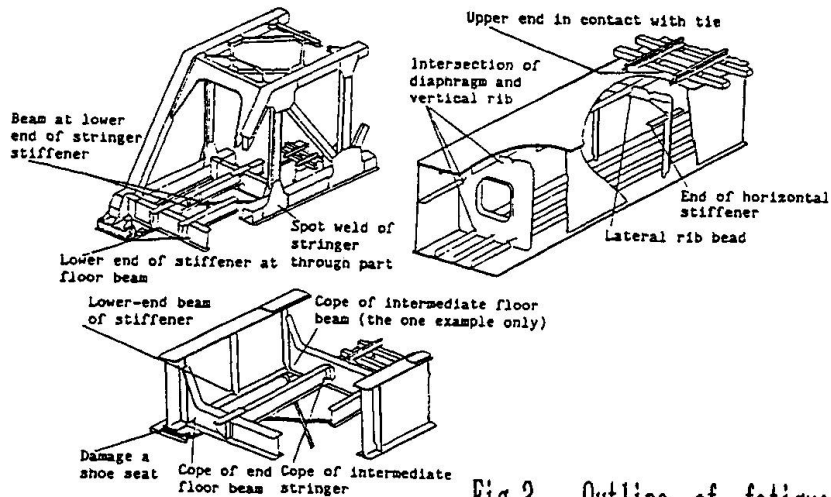
Fig.3 Outline of fatigue damage

In the process of their service, however, some types of fatigue damage have been observed as shown in fig.3. No fatigue damage due to low fatigue strength has not observed in main members where fatigue was assessed in the design stage. However, fatigue cracks which are the result of secondary stresses and displacement induced stresses are often discovered in such various structural elements as girder webs, stringer webs, floor beam webs, side walks, connections of attached facilities and diaphragms. One of these fatigue crackings which occurs relatively frequently and whose cause has not been made much clear is a fatigue crack which occurs on a web plate at the lower end of a stiffener (hereinafter referred to as the "lower end of a stiffener"). This fatigue cracks is in parallel with the lower flange.

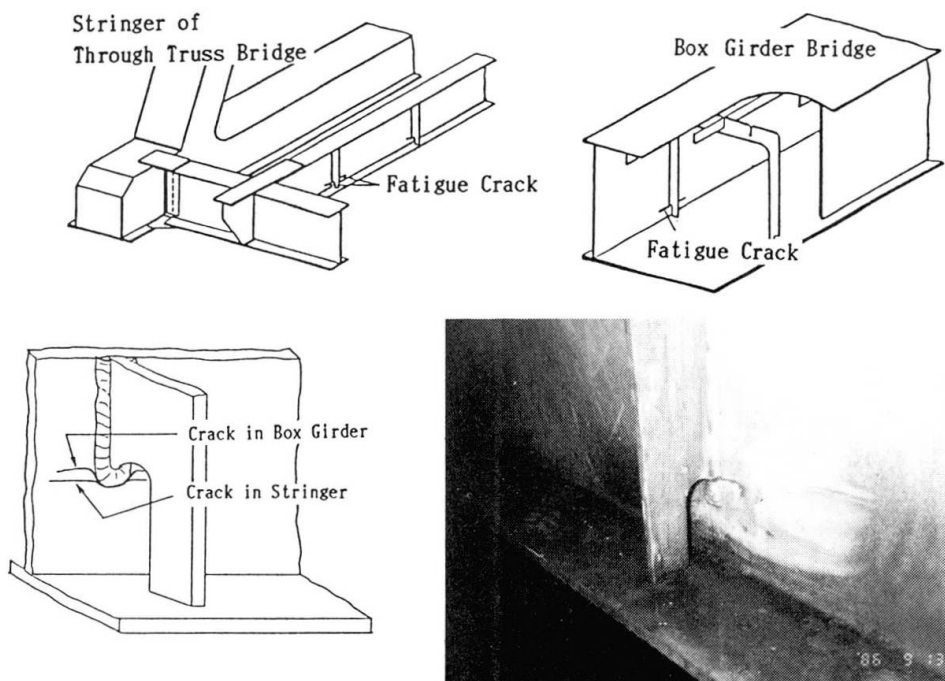
Fig.4 Fatigue crack at stiffener end

Fig. 4 shows cracked girder web. This type of fatigue cracks occurred at the lower end of the stiffener on girder webs of box girder bridges and stringer webs of through truss bridges. Characteristically, no crack has occurred at the end of the stiffener to which floor beams or sway bracings are connected. These fatigue cracks began to be observed in 1978. To date, cracks have been observed in about 10,000 details of about 200 box girder bridges and in about 100 details of five through type truss bridges. Countermeasures were taken against all parts of through type truss bridges which were considered to undergo cracking.

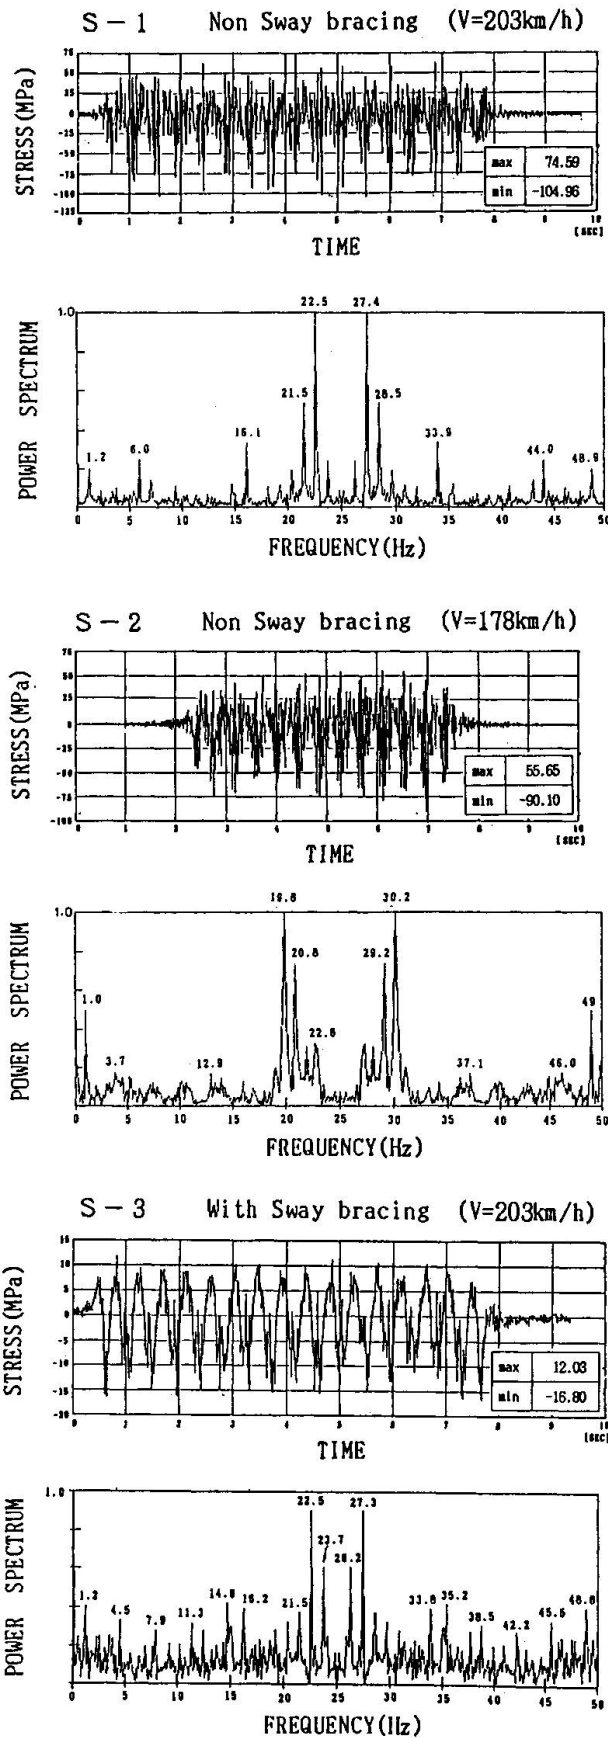
Fig. 7 Representative stress wave in Bridges measured

Fig.7 shows a typical stress records on the stringer web and the results of frequency analysis. S-1 and S-2 are stress records at same point of stiffener end detail without sway bracing when a train passed away at a speed of 203 km/h and 178 km/h respectively. S-3 is a stress by train passing at a speed of 203 km/h at a position to which sway bracing is connected. Train speeds were obtained, using a strain gauge fitted to the track. Major results of this test can be summarized as follows;

As obviously shown by the comparison between S-1 and S-3, at the detail where sway bracing exists, stress amplitude is smaller than where sway bracing does not exist, and the high-frequency component is also smaller. This is considered to be due to horizontal vibrations of the lower flange.

Stresses in S-1 is the largest measured value in this structure and its stress waveform exhibits a resonating behavior. However, S-2, the stress waveform of a low-speed train ($v=178$ km/h) does not produce as large stress as S-1 ($v=203$ km/h). Therefore, horizontal vibration of the lower flange was induced only by the passage of high speed trains. In order to examine this resonating behavior, a stress was separated into the in-plane component and the out-of-plane component as shown in Fig.8. Its results indicate that the stress at the lower end of the stiffener without sway bracing detail is mainly caused by out-of-plane distortion of the web plate. From this, it seems possible to say that the source of a predominating stress which occurs at the lower end of a stiffener is horizontal vibrations of the lower flange.

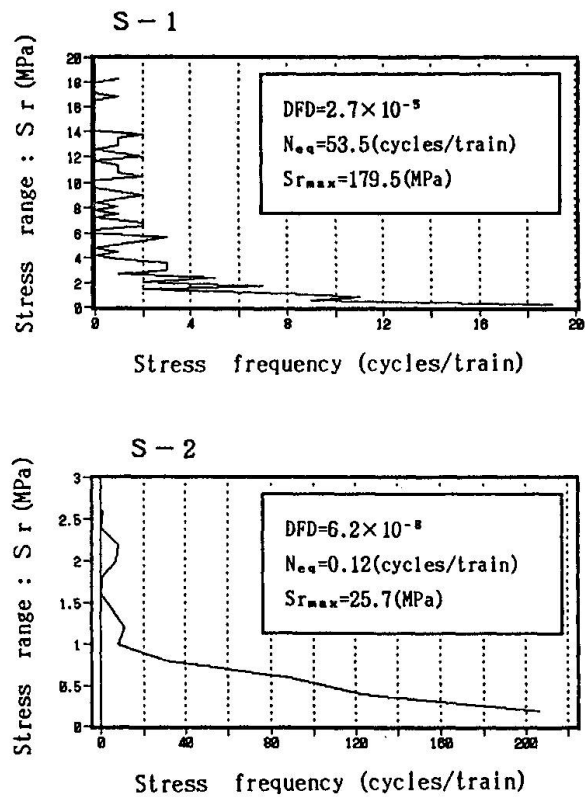
Fig. 9 Stress frequency and Degree of Fatigue damage (DFD)

Fig.9 shows the stress histogram and the degree of fatigue damage of each stress component. The results suggest that fatigue cracks occurred in several years under S-1 stress history.

However, S-2 shows not so high degree of damage.

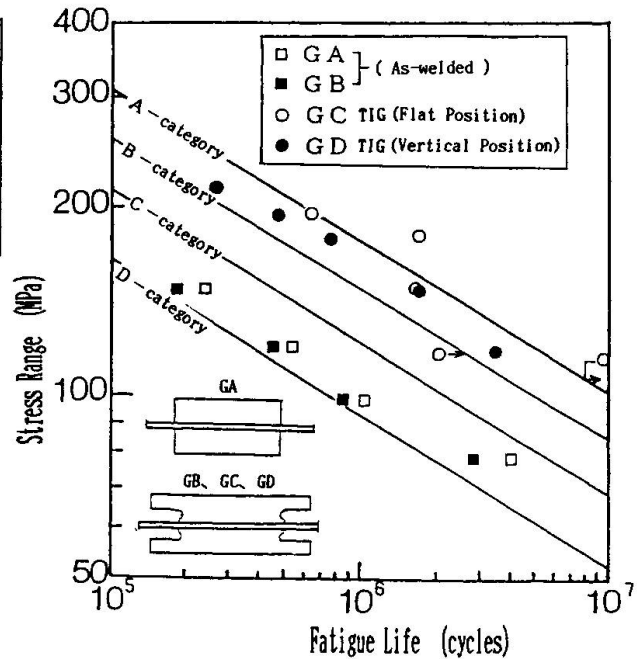
Fig.11 Results of fatigue test

The result of fatigue testing is shown in Fig. 11. It was found that the fatigue strength of as-welded specimens slightly exceeded the category D of the design curve, while the fatigue strength of TIG dressed specimens exceeded the category B curve. The TIG dressing improved the shape of the toe of weld which affects occurrence of a crack and reduces stress concentration, thus improving fatigue strength.
