Artikel: Strengthening of an unreinforced masonry building
Autor: Heintz, Jon A. / Wosser, Thomas D.
DOI: <https://doi.org/10.5169/seals-55176>

Strengthening of an Unreinforced Masonry Building Renforcement d'un immeuble en maçonnerie non armée Verstärkung eines unbewehrten Mauerwerkbaus

50 Green Street is a historic brick building located in San Francisco's warehouse district. Originally built for warehouse and manufacturing use, the massive structure possessed many of the deficiencies common to unreinforced masonry construction. The strengthening scheme was sensitive to the architectural fabric of the building and included steel knee-braced frames, steel tension-rod roof diaphragm strengthening, and a pioneering effort incorporating the use of "CenterCore" reinforcement in the existing brick walls. The owner was actively involved in the process and his special concerns for cost, time, appearance, and tenant disruption were incorporated as the system evolved.

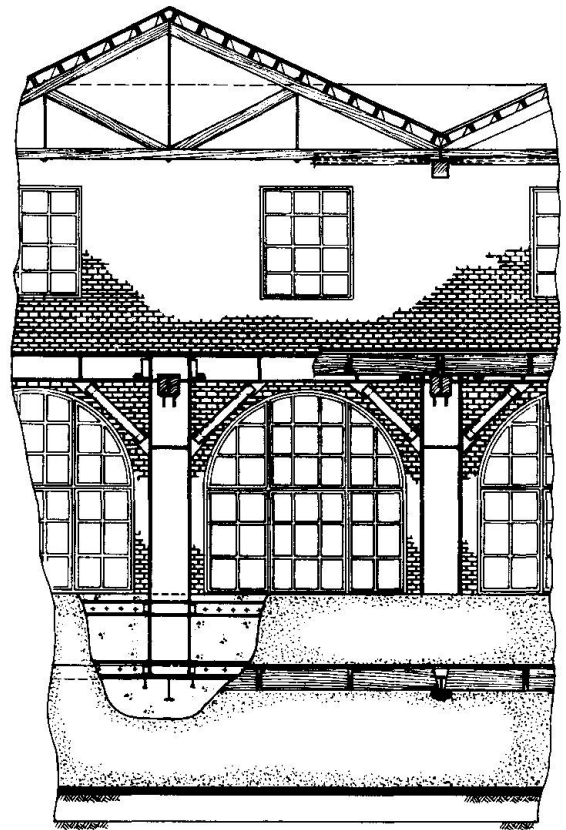
Fig. 2 Drawing of Knee-Braced Frame System

A steel knee-braced frame was selected to supplement the longitudinal walls. A relative rigidity analysis was performed using the structural analysis program, RISA-2D, to verify that the knee-braced system would draw load from the existing brick walls. The resulting W36x150 column members are stiffness controlled. They are embedded in a concrete foundation wall that extends up to the sill of the arched windows, providing a fixed base and shortened effective story height. Centered on the arched piers, the new columns must support the existing floor girders that frame into the wall at the same location. The girders were shored, cut back from the wall to erect the columns, and then seated on a bracket welded to the column web.

The most critical connections occurred along the length of the drag strut which delivered load to the knee-braced frames located at one end of the building. The drag consists of a large tube section running along the wall just below the floor joists. At each pier the existing wood girders interrupted the continuity of the drag. Horizontal slots were drilled through the girders to allow splice plates to pass through and weld to the tube on either side. The drag strut also served as a horizontal strong-back, anchoring the walls to the heavy floor girders for out-of-plane loads. Diaphragm to wall connections were made using threaded epoxy anchors, installed after the drag strut was in place. The anchors were drilled to within 5 cm of the exterior surface of the wall, and were responsible for both in-plane shear transfer and out-of-plane wall anchorage.

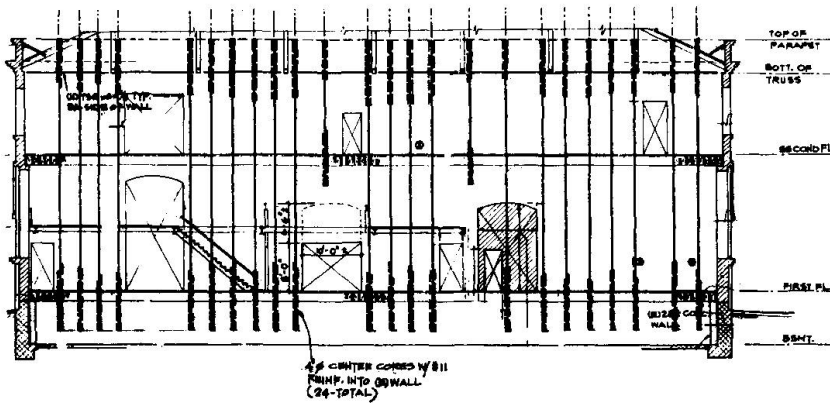
Fig. 3 Interior Elevation of CenterCore Locations

In the transverse direction, a more favorable pier configuration existed, allowing the use of the existing brick walls for transverse lateral force resistance. To strengthen the walls, deformed reinforcing bars were installed using the CenterCore technique. Cores were added at wall locations that were highly stressed for in-plane shear, and at window and door jambs to provide trim reinforcement wherever possible. CenterCores provided reinforcement to stabilize the slender interior walls for out-of-plane forces, and were designed using standard reinforced masonry principles.

The CenterCore technique involves core drilling vertically through the wall from parapet to foundation, and installing grouted reinforcing bars. Coring specifications allowed a tolerance of two inches out of plumb at the base of the wall, 15 meters below the top of the parapet. Occasional repairs to wall surfaces were required when the bit broke through the side of the wall after being forced off line by unexpected iron embedded in the wall. A dry coring method was selected to avoid the disruption of water associated with wet coring operations. This resulted in dust migrating through micro-cracks in the walls during coring operations. Dust became so severe that the entire length of each wall within the building was wrapped in plastic and ventilated with negative air machines to prevent infiltration throughout the tenant spaces. Based on lower unit cost and superior performance noted in the Breiholz report, polyester based resins were specified for grouting the cores. The resin

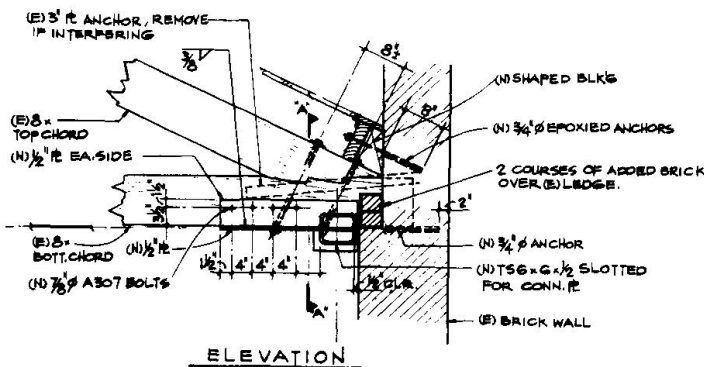
Fig. 4 Roof Diaphragm Connection at Truss

To avoid the new roof membrane, a steel tension rod diaphragm was installed at the bottom chord of the roof trusses. Slotted tube connections, clevises, and turnbuckles allowed fit up tolerance and angular adjustments during erection. In anticipation of inevitable variations in field conditions, a liberal safety factor was incorporated into the design. This came in handy when existing conditions were not "square" and eccentricities had to be built into the system. Particularly challenging, were connections between the new steel elements and the integral wood trusses. Connection brackets were prefabricated, and consisted of vertical tabs for bolting into the side of the truss, welded to horizontal gusset plates. Extra bolt holes were provided in the tabs in case non-typical truss connections interfered with a prefabricated bolt location.
