Zeitschrift: IABSE reports = Rapports AIPC = IVBH Berichte
Band: 73/1/73/2 (1995)

Artikel: Riveted steel repair methods at a historic train station
Autor: Anderson, Neal S. / Klein, Gary J.
DOI: <https://doi.org/10.5169/seals-55254>

Riveted Steel Repair Methods at a Historic Train Station

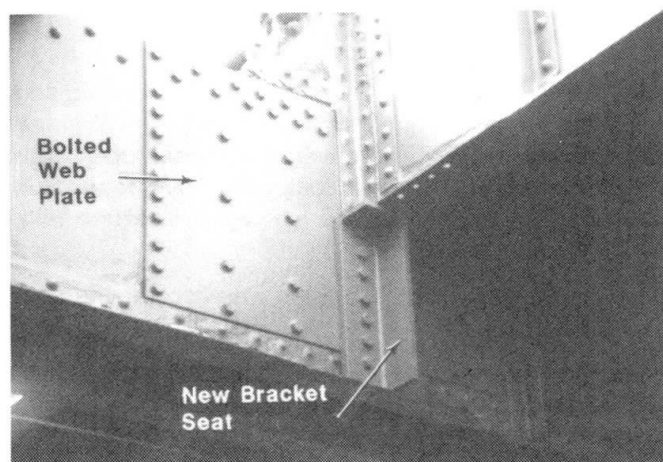
Reusing existing rivet holes for bolting provided an efficient repair means to address difficult repair situations containing many interferences, as shown in Figure 2. The rivet pattern was field measured before fabricating repair plates or flange angles. Additional bolts and interior stitch fasteners used on these repairs were field drilled. On bolted repairs without existing rivet holes, new holes were field drilled in the existing steel using the new repair plate with holes as a template.

Fig. 2 Bolted web and bracket seat repairs using existing and new holes

Supplementing members to strengthen deteriorated connection regions or provide alternate load paths was a repair method used on numerous floor beams at the trainshed, as an economical alternative to member replacement. In its most basic form, this repair consisted of adding bearing brackets or stiffeners below deteriorated framed beam connections (Figure 2).

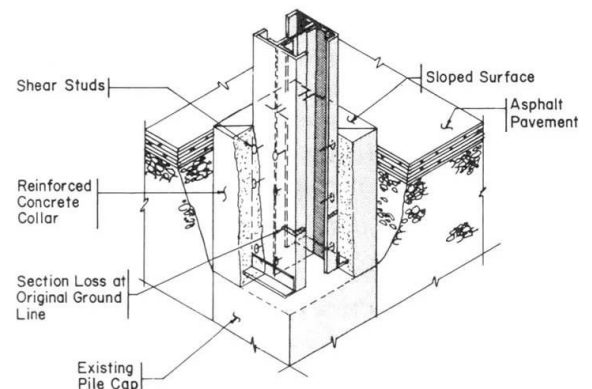
Fig. 3 Composite concrete column encasement

To address column base corrosion, the column bases were excavated to their foundation and steel studs were attached. Concrete column encasements were then cast to the final grade elevation, while founded on the footing. The composite column encasement provided a supplemental load path for any minor section loss and gave the deteriorated column steel additional protection (Figure 3). At locations of severe section loss, welded and bolted repair plates were installed prior to stud installation.

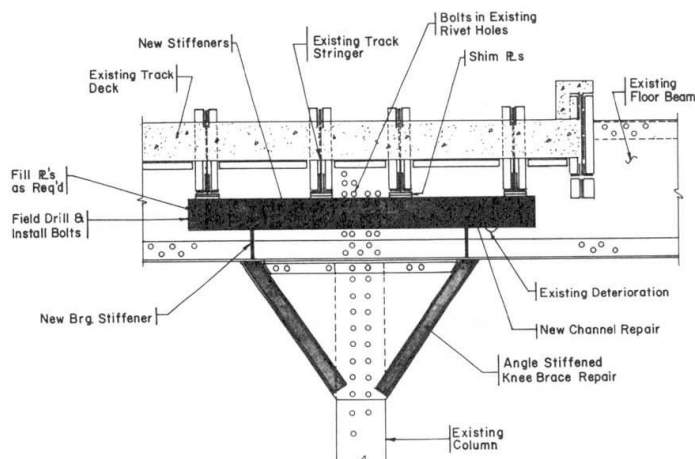
Fig. 4 Alternate load path repair utilizing a channel and stiffened knee brace plate

Figure 4 illustrates an example of two innovative means used to supplement the column to floor beam connection region by providing an alternate load path. At many locations, this connection experienced various degrees of deterioration, and using standard repairs was very impractical. Each trainshed column contained a knee brace plate directly below the floor beam connection. Instead of using a bolted web plate in this region with extensive shoring, the knee brace plate was stiffened with angles to give an alternate load path. Besides providing lateral resistance, the knee brace plates were activated to carry a portion of the gravity load.

Another repair shown in Figure 4 consisted of placing a channel against the deteriorated floor beam web. This repair supplemented the existing connection region by providing an alternate live load path that bypassed the original connection; additional live load was transferred to the stiffened knee brace below.

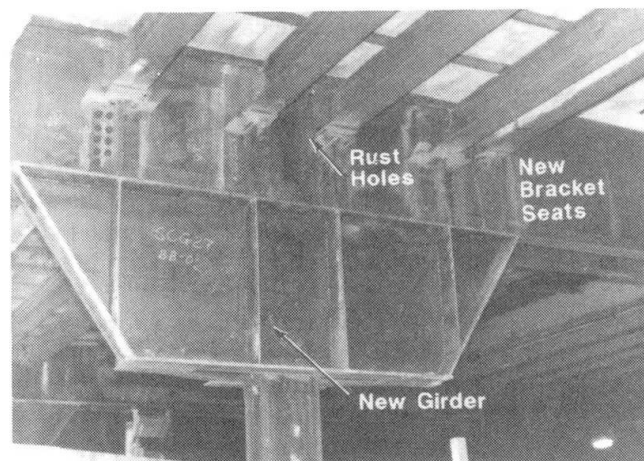
Fig. 5 Supplemental girder below the existing floor beam

New sister girders (Figure 5) were used where web deterioration on floor beams was quite extensive, and transverse framing members and the concrete trackbed precluded using bolted web plates. The sister beams were installed from below when the track above was closed.
