Zeitschrift: IABSE reports = Rapports AIPC = IVBH Berichte

Artikel: Structural evaluation of the leaning bell tower of S. Stefano, Venice

Autor: Bettio, Carlo / Bolognini, Luca / Modena, Claudio

Structural Evaluation of the Leaning Bell Tower of S.Stefano in Venice

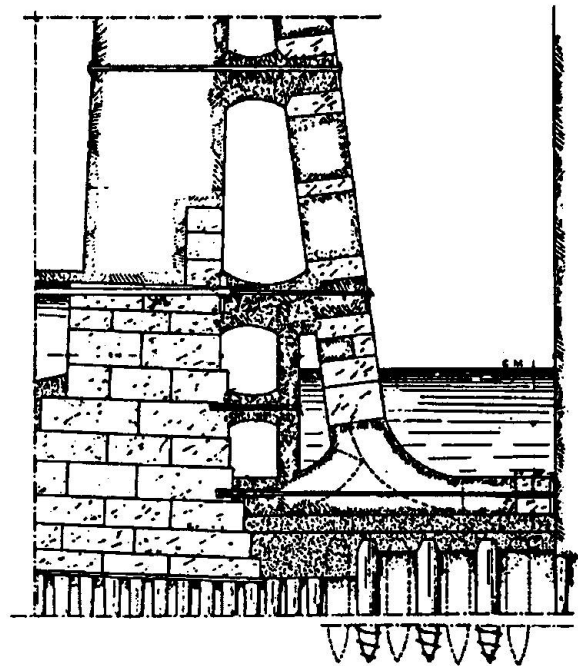
Fig. 2 Detail of the strengthening works executed in 1903-1905

Several steel ties were installed at different levels, starting from the foundation. The masonry walls were extensively repaired and strengthened by means of local reconstructions and injections of cement-water admixtures. The original foundations were first strengthened and then widened over the channel-bed constructing a 50 cm thick concrete slab over a concrete piling. New strong masonry buttresses were built with cement mortar, inclined with respect to the vertical direction as indicated in figure 1. They were securely connected to the tower walls and to the foundations, in the second case through masonry arches (Fig. 2).

The structural behavior of the tower was in this way substantially modified. The variation of the inclination was since then efficiently counteracted, even if not eliminated as expected by the designer, by the new structures as demonstrated by the sudden reduction of the increasing rate of the inclination. A mechanical pendulum was in that occasion installed to control the effectiveness of the interventions.

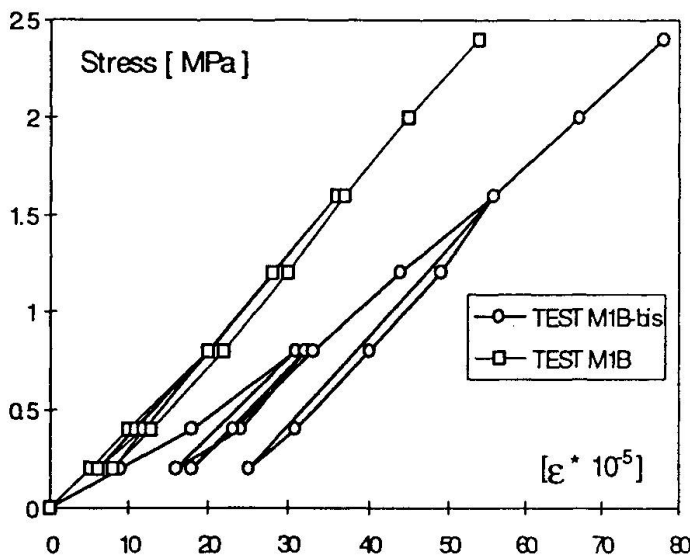
Fig. 3 Stress-strain diagram measured on the external leaf (M1B) and in the internal leaf (M1B-bis)

The masonry constructed in the XV century exhibits a mean modulus of elasticity in the vertical direction of about 4000 MPa (in the 0.4-0.8 MPa range of applied stresses) while the upper part of the tower, built in the middle of the XVI century, show an higher deformability with a mean value of the modulus of 2800 Mpa.

One of the tests was performed both in the external leaf and in the inner core of the XV century masonry. The comparison of the stress-strain curves (Fig. 3) clearly show the difference in the deformability, the inner core modulus is however greater than 2800 MPa and the behaviour is approximately linear-elastic until the maximum imposed stress level of 2.4 MPa.

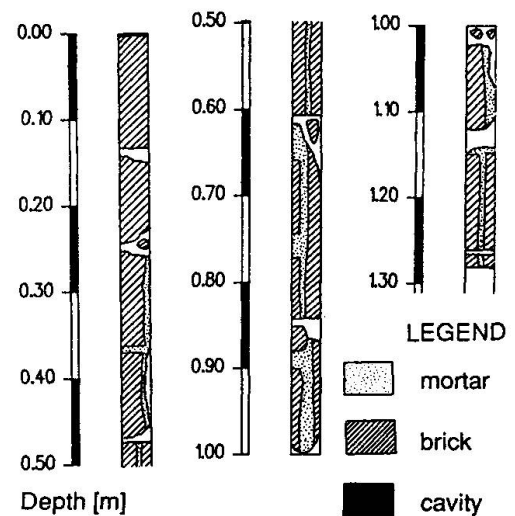
Fig. 4 Typical "through-the-thickness" masonry composition

A typical example of masonry composition is shown in Figure 4, where the inner core of the wall appears similar in composition to the outer leaf and almost without voids and cavities.

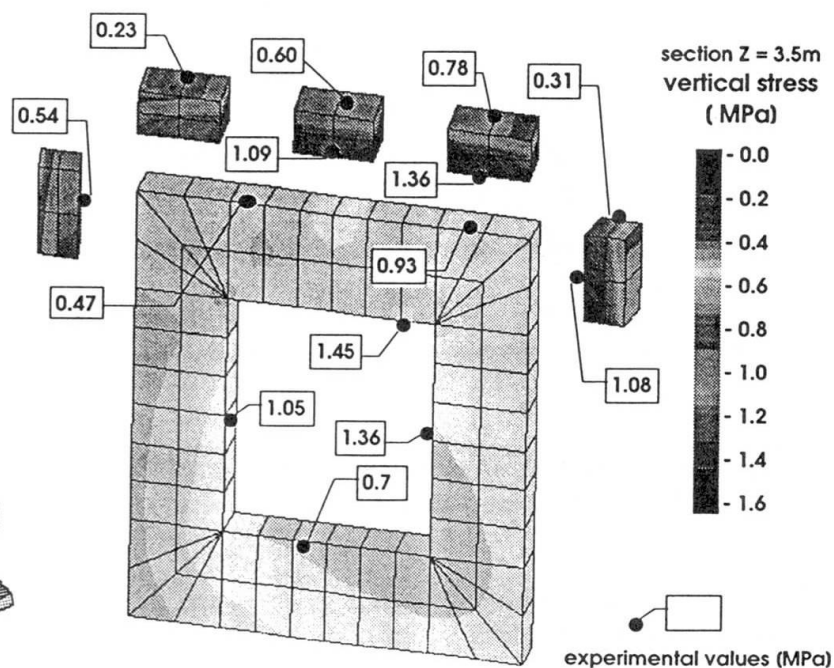
Fig. 6 Experimental and numerical stresses (horizontal section)

Figure 6 shows one example of comparison between theoretical and experimental distribution of normal stresses due to gravitational load. As it can be seen, a fairly good agreement exists between the experimental and theoretical results, except for local inconsistencies which can be explained taking into account the material inhomogeneity, experimentally demonstrated but not yet included in the model. The state of stress is in general compatible, with acceptable safety margins, with the compressive strength of the masonry.

The analysis of the model reproducing the configuration before 1903 (i.e. without buttresses) with the present inclination, shows that the compression stresses would be very close to the masonry strength.

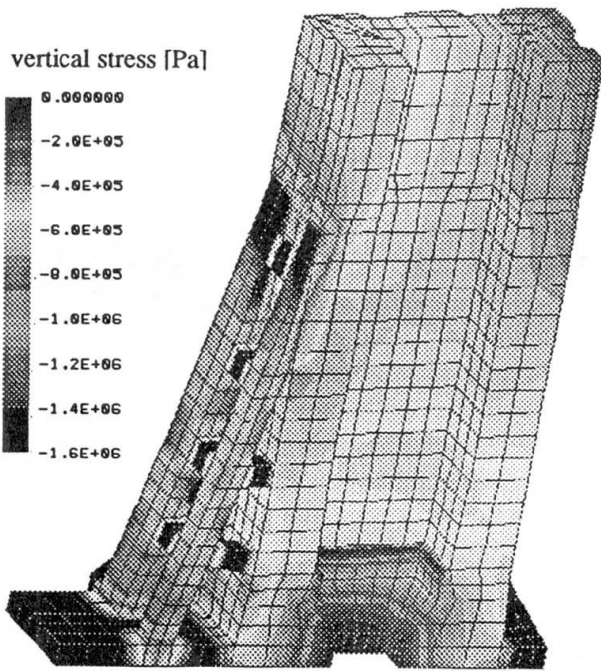
Fig.7 Vertical stresses at the base of the numerical model (vertical section)

On the model thus calibrated static analyses were performed in both linear and non-linear ranges of material behavior mainly to indagate the influence of the buttresses on the distribution of the internal stresses (Fig.7).

The comparative analyses demonstrated that, as there are not no-tension zones, the influence of the material non-linearity is negligible.

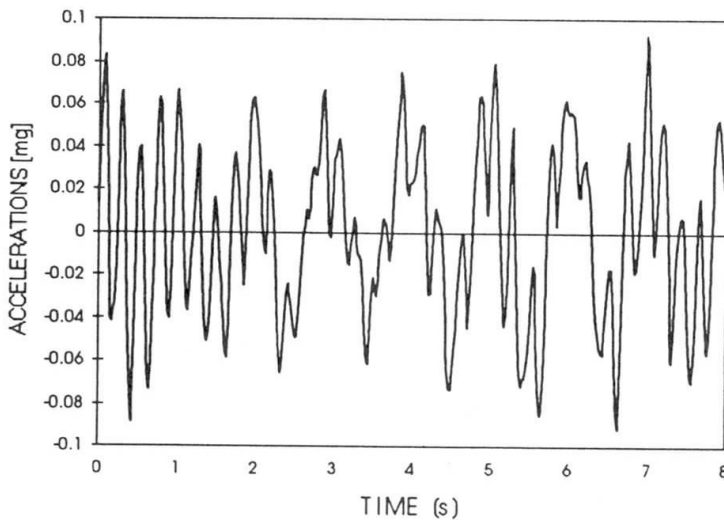
Fig. 8 Wind induced vibrations

From the analysis of wind induced vibrations the first five vibration modes of the structure (two flexural modes in both North-South and East-West direction and the first torsional mode) were determined [2].

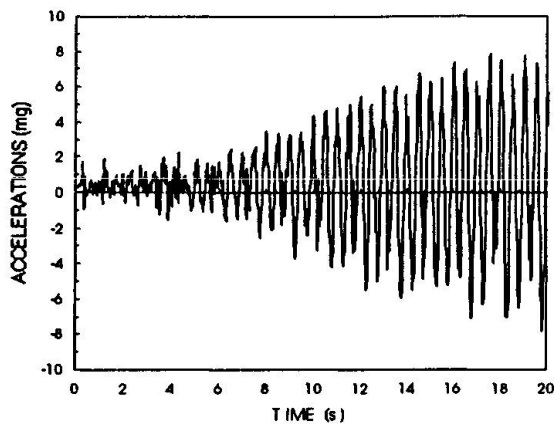
The analysis of horizontal forces associated with bells (strike rate of 40 impacts/min. and swing angle of about 90°) showed that the third harmonic component of the force predominates and it is very close to the frequency of the first flexural mode of vibration of the structure causing a dangerous resonance phenomena. The effects measured on the structure

were vibrations clearly perceptible to the persons [1] with a displacement amplitude of over 1 mm. In Figure 9 and 10 a typical record of an acceleration time-history and the correspondent evolutionary power spectra are displayed, from which the above consideration were derived. Finally, the mechanical pendulum was restored allowing for a new measure of the inclination, which demonstrated that since 1933 the inclination increased at a rate of 1.3 mm per year.

Fig. 9 Vibrations induced by bell movements
Acceleration Vs Time diagram

Fig. 10 Vibrations induced by bell movements:
Short Time Fourier Transform

The problem of the stability of the foundations has not been however definitively solved, and adequate investigation and intervention must be carried out within the above indicated time limit. Moreover, the bell system must be changed in case it will be used again in order to avoid the previously mentioned resonance problems.
