Structural Rehabilitation of a Reinforced Concrete and a Prestressed Concrete Bridge

G. CROCI
Professor
University of Rome
Rome, Italy

Two examples of works on reinforced and prestressed concrete bridges are described, each involving different aspects of problems faced by the maintenance programs that the Italian Roadway Board has carried out in recent years. The first case involves an old reinforced concrete bridge whose heavily damaged structures required radical repairs and anti-seismic measures. The second case concerns prestressed concrete span cantilever cables to be inserted in the cross section in order to restore safety margins and correct some of the deflections due to creep.

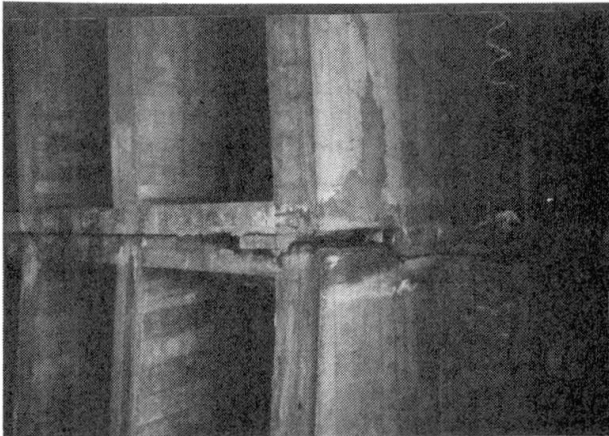
On account of the severe environmental conditions (marine salts in the rain water, wide temperature ranges, heavy traffic) and poor maintenance, the degradation has affected mainly structural elements such as the Gerber joints, in which the steel bars are completely uncovered and deeply corroded

photo 4 - Fiumara di Gallico Viaduct
Gerber joint (lower view)

(photo n. 4-5). The seat of the supported beams - which is further restricted by degradation - is so reduced as to cast doubt on the stability of the beams. Weathering has also removed the concrete bar covering in many areas of the decks, particularly on the west side, towards the coast. A detailed program of in situ tests (pull-out tests, carbonation tests, microdrilling and sampling of concrete, endoscopic tests, etc.) on the structure was carried out to evaluate the actual state of alteration of the material, their strength and the efficiency of the supports apparatus.

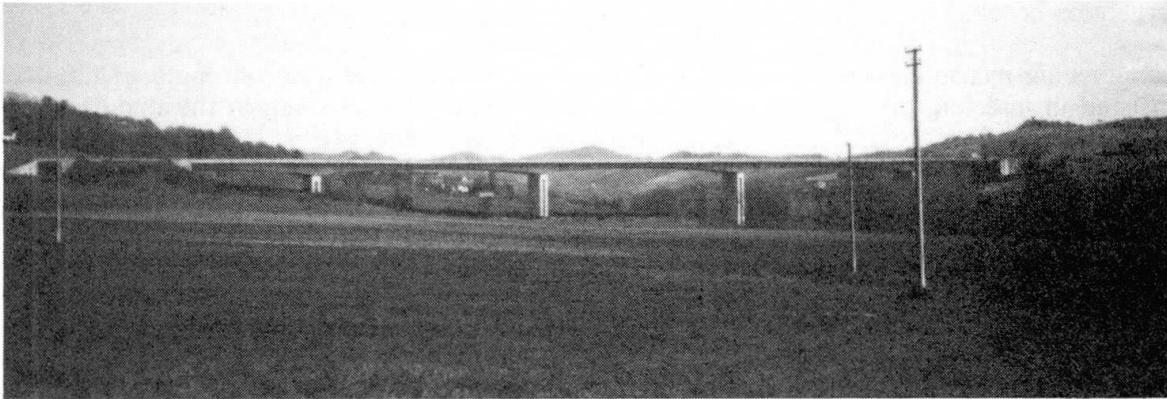
photo 10 - Reggia Viaduct - General view

the piers and on the abutments are simple supports. In order to avoid hyperstatic components during prestressing of the sewing cables of the central span, some provisional hydraulic jacks were inserted into the middle of that span. The cross section consists of a 3-cell box girders, 4.9 meters high at the level of the piers and 2.3 meters high in the midspan and on the supports of the abutments. Over the years the bridge has suffered some deflections in the lateral spans (piers 1-2 and 3-4), with a maximum amplitude of about 15 cm, while the central span shows no or minimum deflection (figure 11). These deformations called for a general re-examination of the structure, though they did not compromise the use of the viaduct.

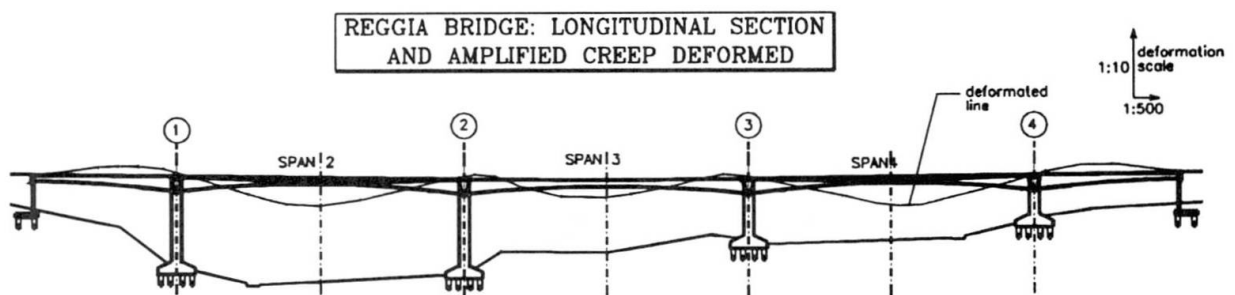
FIGURE 11

The phenomena observed are related to creep processes that cannot easily be predicted at the design stage. On account of the construction method, based on a cantilevered section-by-section procedure that involved building a structure with provisional boundary conditions that differed from the final ones, the creep effects have produced a redistribution of the stress for permanent loads and, in particular, an increase in positive bending moments in the middle of the spans and a reduction near the piers (figure 12). The individual sections of the cantilevers were poured in different stages, with non-homogeneous pouring and weathering conditions, so that they presented different creep functions. Even minor uncertainties in calculating the dead or prestressing loads could also have led to considerable variations in the creep deformations, bearing in mind the effective reciprocal influences between the creep and the steel relaxation of the prestressing cables. Another factor that should be considered is the possible effect of the insertion of provisional hydraulic jacks in the middle of the central span, which may have partially compensated the creep deformations of the third span, jeopardizing the second and fourth spans.

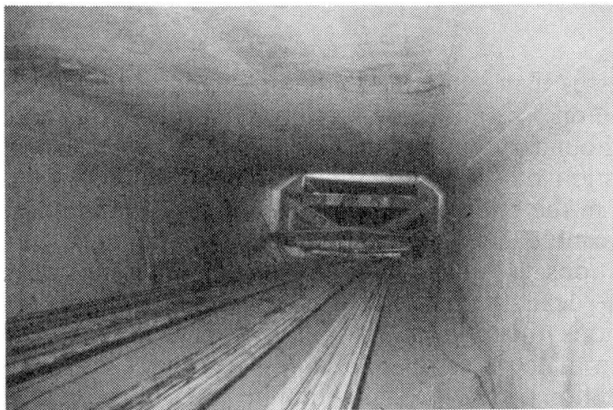
photo 13 - Prestressing cable system and deviation device frame

The strengthening measures were designed to enhance the bending and shear strength of the deck and consisted in inserting prestressing cables in the lower part of the section in the middle of the lateral spans and also, to a lesser extent, in the central span. Prestressing was achieved by inserting new cables within the box-girder and tensioning them prior to the casting the new levelling pavement. The new prestressing forces thus compensate either the creep effects or the loads corresponding to the new pavement. Each cable was protected by a grease sheath and anchored anchored to the diaphragms of the pierheads; they were placed along an almost rectilinear course to reduce the deviation devices. 192 six-inch wobblers were used, to provide an overall force of about 16000 KN for the lateral spans and about 10800 KN for the central one (photo 13).

some cables are continuous from the first pier-head to the last, whilst others have only the length of one of the lateral spans. The only deviation device inside the box-girder, at midspan level (figure 14), consists of a steel frame connected to the ribs of the caisson to which the cable was connected after tensioning, so as to ensure continuity to the transversal section. Three devices were used for each span, one for each of the three cells of the box-girder. The frames were assembled with steel profiles and plates connected by high-strength bolts in order to allow transport and the mounting inside the box-girder. A horizontal strut with St. Andrew's crosses was provided in order to resist to the friction component of the prestressing forces. The work was successfully carried out without restriction traffic and restored about 10% of the previous deformations. The increase in safety levels was assessed at around 30%. Thus the measures adopted significantly increased the durability of the structure by closing the cracks caused by creep. The load test performed on the bridge on completion of the work also showed an increase of the overall stiffness of the whole structure of about 20%.
