Diagnosis, maintenance, retrofitting, repair

Zeitschrift: **IABSE reports = Rapports AIPC = IVBH Berichte**

Collapse and Rehabilitation of Composite Trussed Structures

Major Repairs to Frank Lloyd Wright's Largest House: Wingspread, Racine, WI, USA

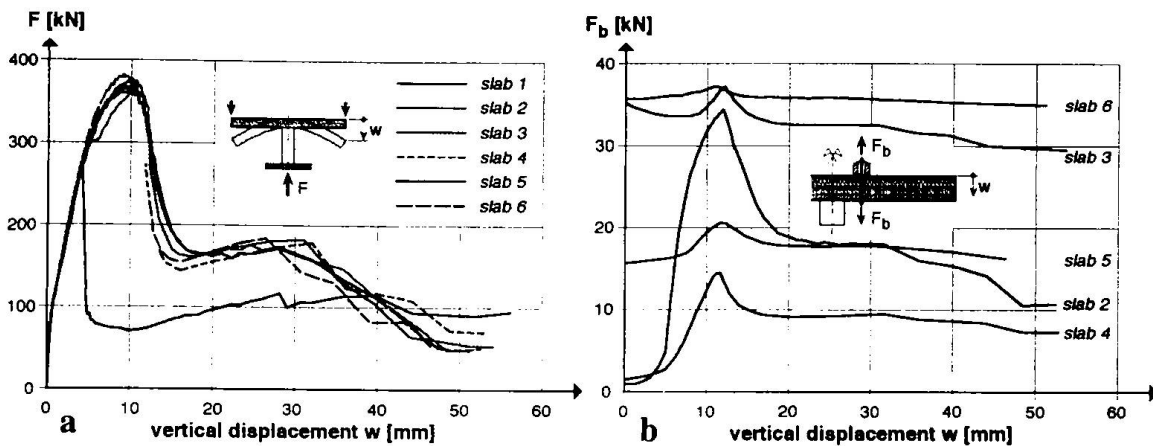
Fig. 1: Load-displacement curves and mean force in the bolts versus vertical displacement

The test results are presented with the load-displacement curve (Fig. 1a) and the mean force in the bolts versus the vertical displacement of the slab (Fig. 1b). It follows that the punching load is increased from 280 kN up to 380 kN or 37% due to the strengthening. The vertical displacement at maximum load is significantly increased by the strengthening as it has more than doubled. It is observed that slab 1 is characterized by a punching cone inclined at an angle of approximately 30° . For all strengthened slabs, the punching cone is formed between the column diameter and the perimeter defined by the bolts. The inclination of the punching cone is approximately 70° (Fig. 2). This means that all the strengthened slabs exhibit a punching failure which is characterized by a punching crack that did not cross the strengthening bolts.

The post-peak descending branch of the load-displacement curve is characterized by a strong reduction of the load carrying capacity with increasing displacement characterizing punching failure (Fig. 1a). After peak, the first drop of the load carrying capacity is about 200 kN for all the slabs (strengthened or not) which indicates that this decrease is due to a similar failure mechanism, that is, the concrete failure.

Injection modifies the slab mode of resistance so that it resists globally resulting in reduction of the stress level in the bolts (compare slab 2 and 4 in Fig. 1b). The injection also improves the serviceability of the slab and provides a protection against corrosion of the bolts.

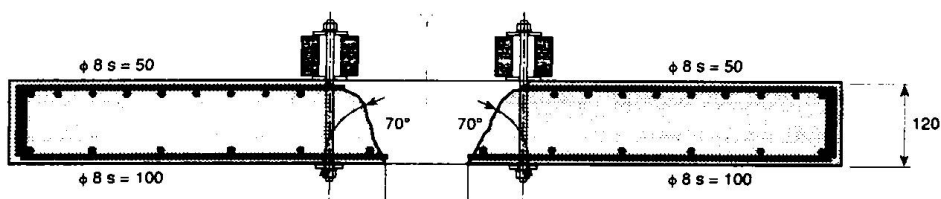
Fig. 2 : Sketch of the punching crack in the strengthened slab

The punching load for the slab without strengthening bolts is predicted with the analytical model developed by Menétrey [2] which leads to $V_{pun}=250$ kN. The punching load of the strengthened slabs with a punching crack inclination of 70° is influenced by the punching and the flexural strength (as proposed by Menétrey [3]) resulting in $V_{fail}=364$ kN.

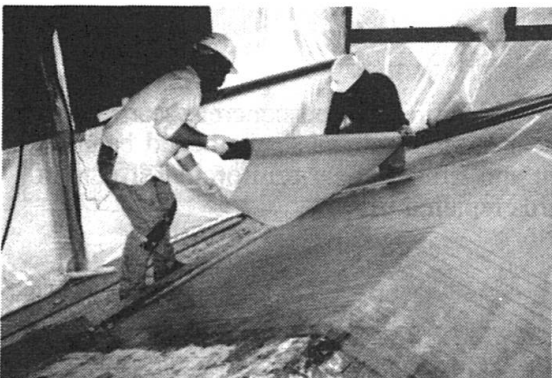
Fig. 1 Installation of Carbon Fiber Fabric

After extensive computer modeling using Finite Element Analysis, it was decided to create a shell structure out of the lower roof by coating the bare wood sheathing with 13 layers (12 mm total thickness) of quad-axial carbon fiber fabric set in a 50%-50% matrix of epoxy resin which was bonded to the wood. Prior to the first layer of carbon fiber installation the wood was thoroughly cleaned and large diameter screws were installed through the sheathing into the rafters at 15 cm on centers in oversized holes flooded with epoxy. Thus the carbon fiber was bonded to the wood sheathing which was in turn acting compositely with the rafters. Each layer of carbon was offset approximately 7-8 cm from the layer below to provide a scarf joint at every lap of fabric. Vacuum bagging was not practical for this on site installation so air bubbles were forced out using toothed rollers. The entire operation was conducted inside an environmentally controlled temporary timber framed structure built over the top of the roof. Upon completion, the composite membrane was post cured at 60° C for 24 hours.

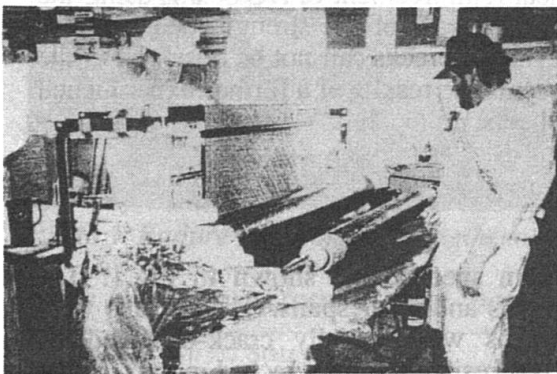
Fig. 2 Impregnating Fabric with Epoxy

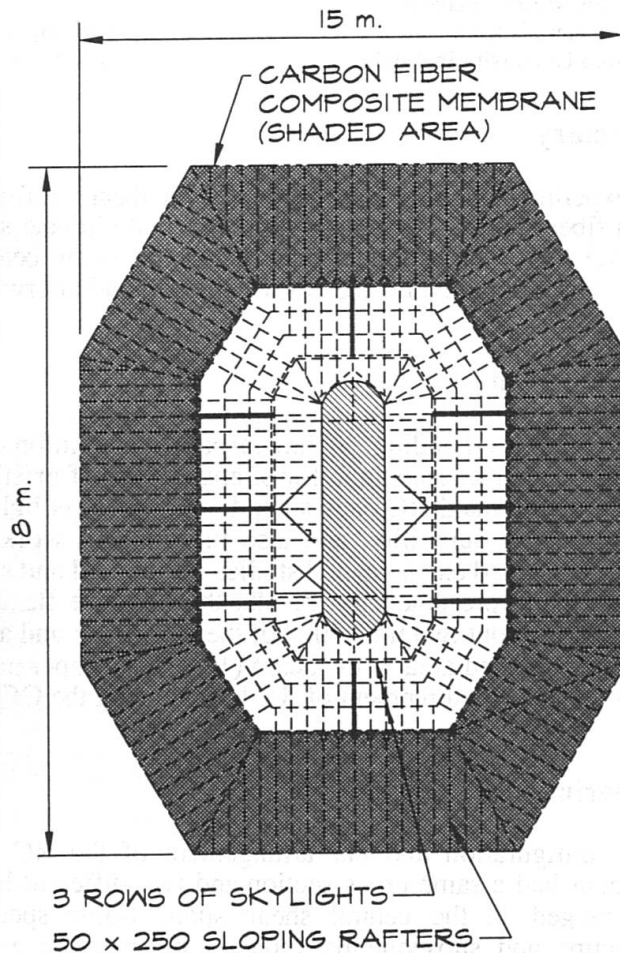
Fig. 3 Roof Framing Plan

Over the years small cracks had appeared in the plaster and wood ceiling of the Great Hall as well as the East Wing. The heavy snows during the winter of 1993-94 however caused a major displacement near the skylight rings in the Great Hall with cracks larger than 40 mm opening. In addition the exterior walls of the East Wing were noticed to be considerably out of plumb due to thrust at the top of the wood stud wall caused by load from the gable roof rafters. Clearly immediate action was necessary to stabilize and repair this structure, now used as a conference center for the Johnson Foundation.
