Structural Rehabilitation of an Industrial Steel Building

Nicolae TARANU, Petru STRATEANU and Dorina ISOPESCU

Department of Civil Engineering
Technical University of Iasi, Romania

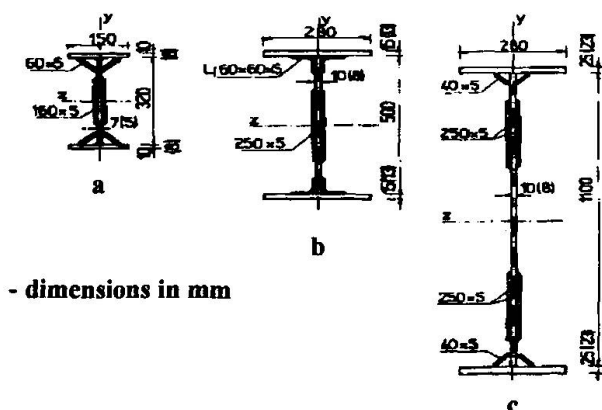
Fig.2 Strengthening solutions of bent elements:
a-purlins; b&c-tapered frame girders

To restore the initial loadbearing capacity of the steel members, the strengthening solutions presented in figs.2 and 3, have been proposed. The strengthening pieces illustrated by dashed areas have been attached to the weakened members after careful cleaning of the corroded elements. The dimensions given in the parenthesis correspond to the corroded areas. After consolidation the ratios between the strengthened sections characteristics (W_1, A_1) and the initial ones (W_0, A_0) have been calculated: purlins, $W_1/W_0 = 1.03$; columns, $W_1/W_0 = 1.04$ and $A_1/A_0 = 1.02$; frame girders, $W_1/W_0 = 1.08$ at midspan, and $W_1/W_0 = 1.02$ on columns.

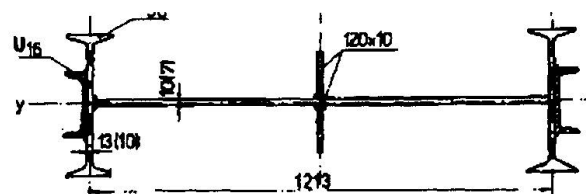
Fig.3 Cross-section strengthening of the main steel columns
