Repairs of coal processing buildings under continuing production

Repairs of Coal Processing Buildings under Continuing Production

In the paper the technology of repair of corrosion damaged, reinforced concrete floor of level +6.00 m in coal processing building. Repair of the floor was carried out under continuing production; no breaks in production occurred. The range and degree of corrosion damage, the methods of reinforcement of load-bearing structure and sealing of tile floor were described.

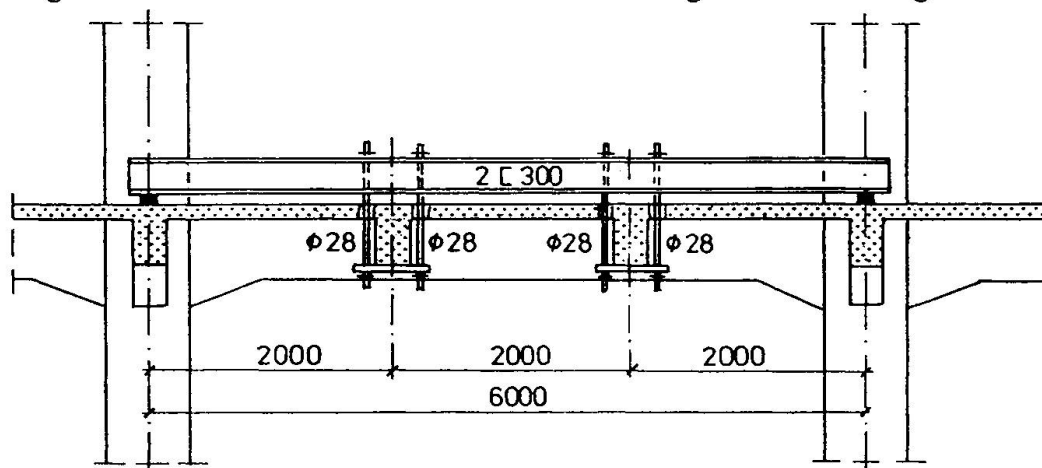
Fig.1 The method of suspending of secondary beams and unloading the stay ropes

Authors suggested to unload the floor with stay ropes and horizontal steel beams. Fig.1 presents the idea of unloading. The feature of this solution was that instead of main beams the secondary beams or floor slab were underslung to traverse beam. This enabled the possibility of free access to parts being repaired. After unloading, the corroded weak concrete was removed without removing reinforcement steel and surface was cleaned using wet sand blasting.

After boarding was made, the removed part of concrete was filled with fast-setting cement. When concrete achieved required strength the boarding and unloading steel construction were dismantled and openings made for strings of suspensions were sealed. The next stage included repairing of damaged floor and sealing of construction to eliminate the leakage. Due to necessity to continue the production and short break of wet processes (48 hours in week) application of standard solutions of watertight insulation could not be taken into account.
