# War and earthquake damage in Dubrovnik: preventive and remedial measures

Zeitschrift: **IABSE reports = Rapports AIPC = IVBH Berichte**

## War and Earthquake Damage in Dubrovnik: Preventive and Remedial Measures

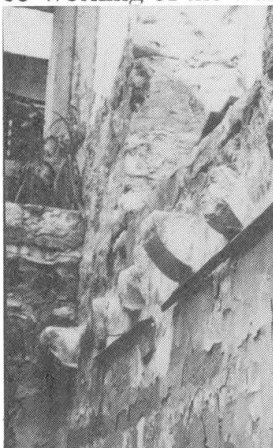
Fig. 1

The main walls of the buildings of Dubrovnik and Ston are usually made of sack masonry, with the timber floors and roofs supported by stone cantilevers inserted in the walls (Fig. 1); this structural solution, because of the lack of connection to the walls, does not help develop the co-operation among the walls themselves, which would allow them to resist the horizontal forces more effectively.

In Dubrovnik the signs of shell impacts are still visible on the fronts of the houses: direct hits struck about 70 % of the 824 buildings of the inner city. Further damage was produced by the fires following to the explosions (Fig. 1): the roofs of 5 buildings were affected by fire and in 9 buildings the roofs and floors were completely destroyed. The damage caused by the earthquake of September 5<sup>th</sup> 1996 (peak ground acceleration of 0.6 g, epicentre 10 km SE from Ston) can be traced, however, to other causes. These are:

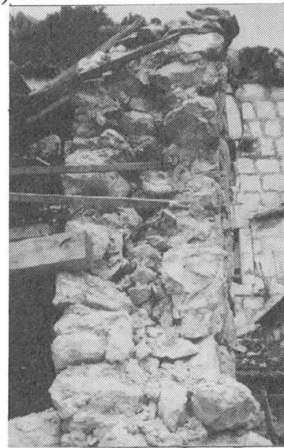
Fig. 2

*Intrinsic weakness of the sack masonry* (weak bond, decay of the mortar): which explains the detachment of blocks in the external skin and the collapse of entire sections of wall. (Fig. 2).

*The materials*: the intrinsic weakness of the sack masonry construction requires, both as a preventive and a remedial measure, the injection of the walls, or, in the case of very loose material, which was very common, the use of grout percolated in from the top; cracks, depending on their width, could be filled with grout or repaired with the technique of "unpicking and sewing". (toothing out and bonding)

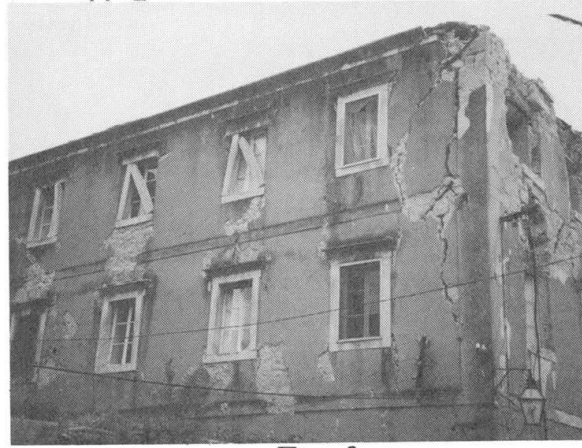
Fig. 3

*Structural weakness of the walls*: in the façades which were almost parallel to the seismic action (left façade in Fig. 3) cracks under the windows, due to the insufficient stiffness of the floor bands (reduced thickness of the zone under the windows, the lack of horizontal ties), were frequently noted; the façades almost perpendicular to the seismic action were often detached due to the inadequate connections to the lateral walls (left façade in Fig. 3).
