Zeitschrift: IABSE reports = Rapports AIPC = IVBH Berichte
Band: 78 (1998)

SESSION 6

Maintenance and repair

Session 6 - MAINTENANCE AND REPAIR

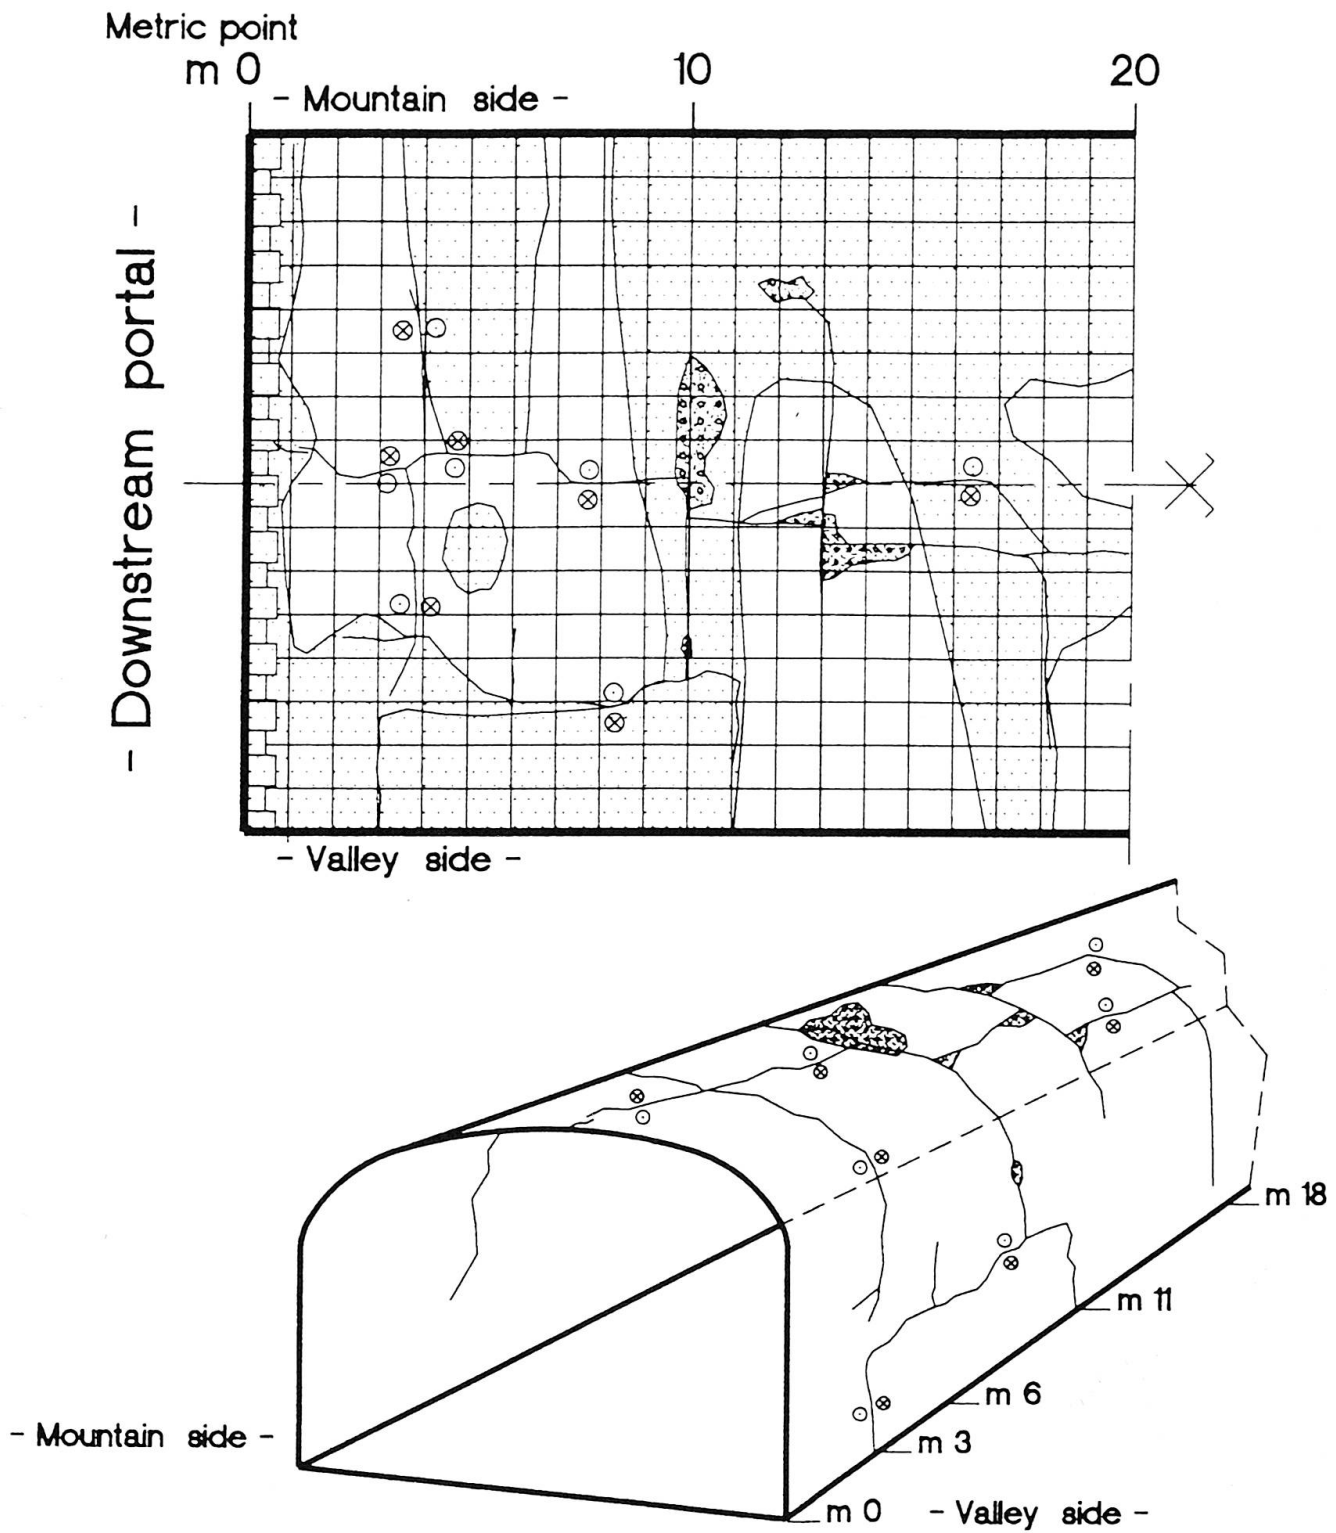
Fig. 1 Representation of cracking affecting a concrete tunnel portal

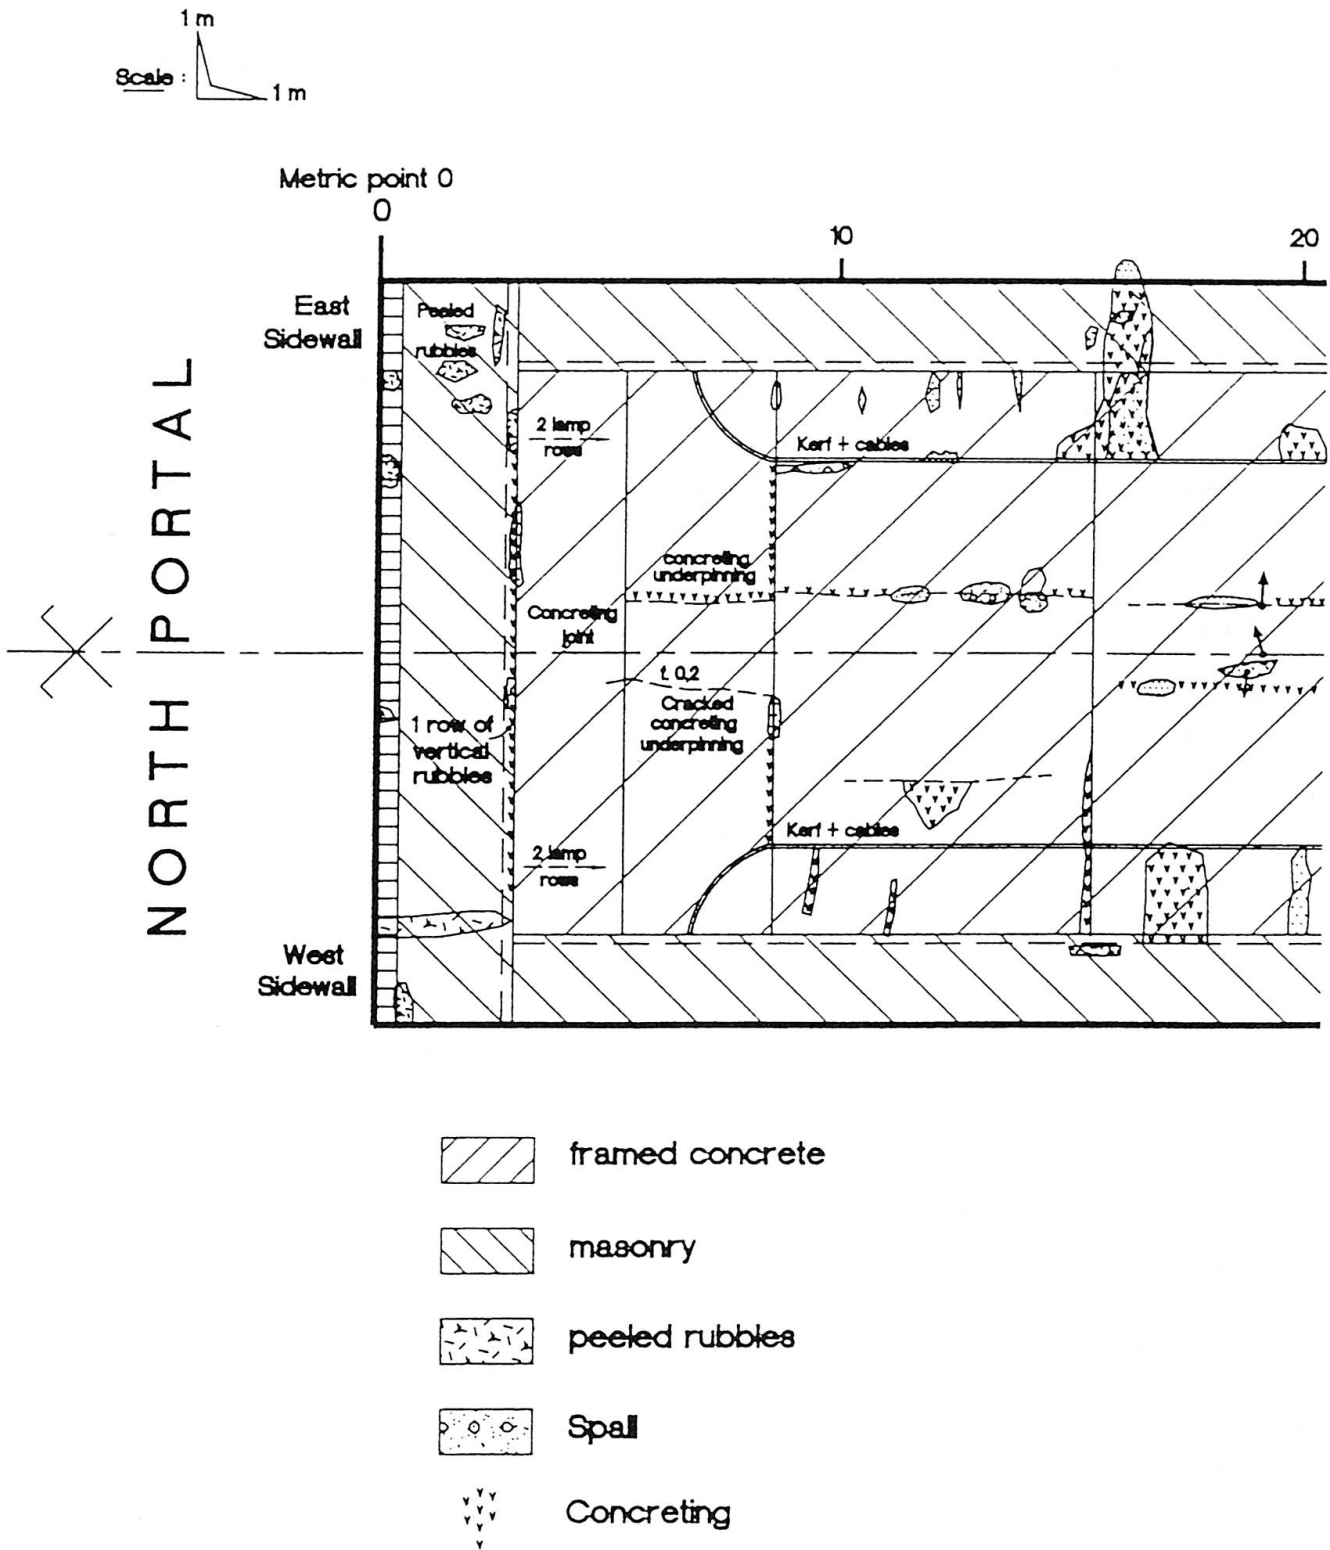
Fig. 2 Excerpt from the intrados survey of SISTERON tunnel, France

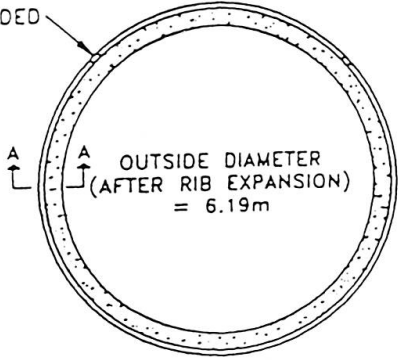
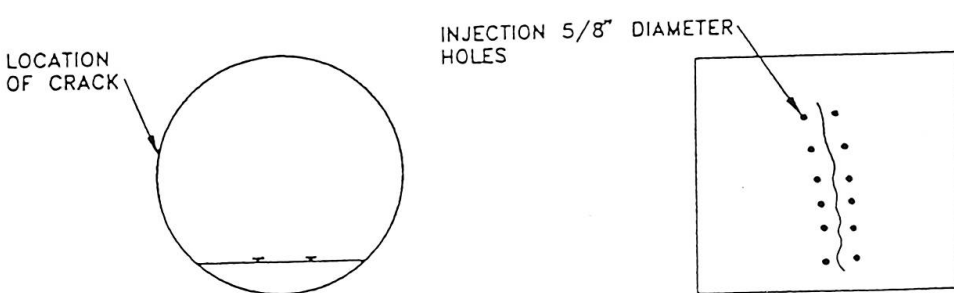
Fig. 4 Example of measures against water leakage in tunnel

| Degree of leakage | DRIP | |
| Location of leakage | SIDEWALLS | |
| Description of trouble caused by water leakage PREVENTION OF DETERIORATION OF ELECTRICAL EQUIPMENT | | |
| Post-repair Inspection Observations CRACKS HAVE MINOR LEAKS AFTER 10 YEARS | | |

| Outline of method INJECTION HOLES ARE DRILLED AT 30° ANGLE TO THE CRACK. HOLES ARE DRILLED ON BOTH SIDES OF THE CRACK AND THEN ARE INJECTED WITH A CHEMICAL GROUT THAT EXPANDS AND SEALS CRACK WHEN IT COMES INTO CONTACT WITH WATER. | | |

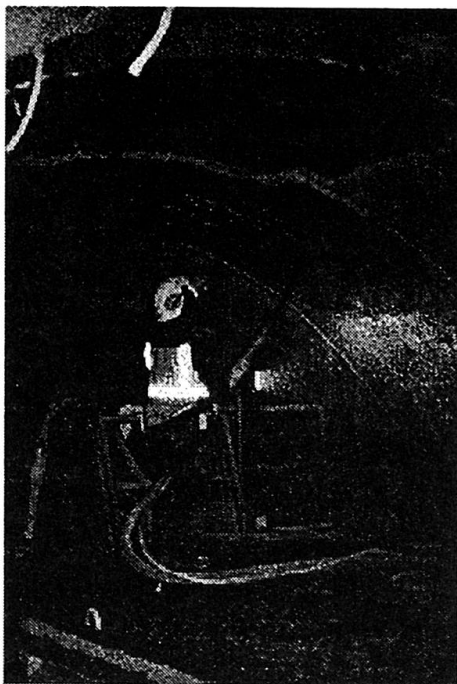
A recent, impressive example is the fire of a lorry-transporting train in the Channel tunnel. The lining was partly damaged or destroyed on a length of 500 m. The repair work consisted of curing the damaged concrete, using a pneumatic hammer and pressure water jets; the reinforcement was kept; it was re-covered with sprayed concrete. The temperature was presumed to exceed 1000°C.

*Fig. 6 Channel tunnel, after the fire of 18 November 1996
Repair of lining with sprayed concrete*

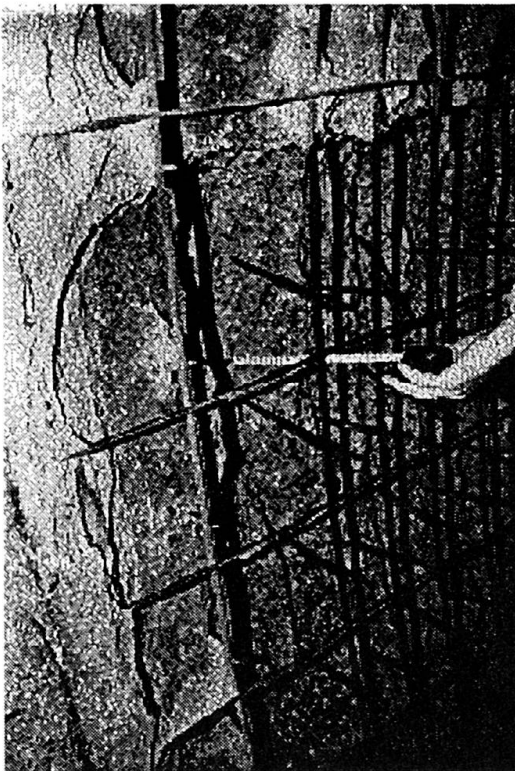
Fig.7 Channel tunnel, after the fire of 18 November 1996.

After curing of the concrete surface spalling, the reinforcement is maintained.

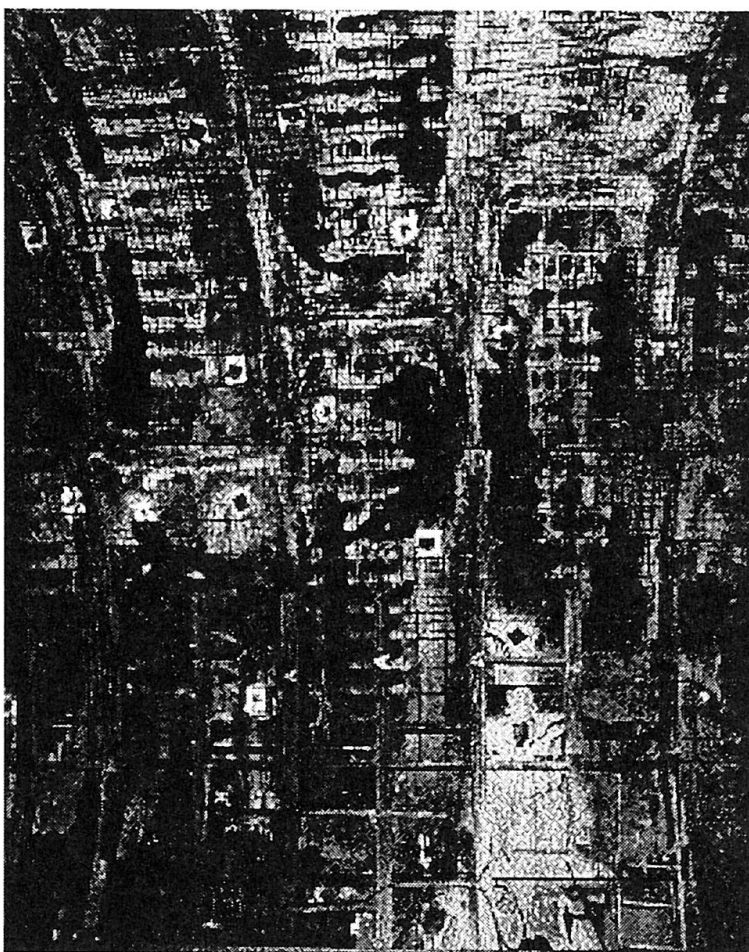
*Fig. 9 Channel tunnel, after the fire of 18 November 1996
Rings 19797 to 800, south side. Middle of Zone 3, the most damaged.
The ribs are being removed, after reinforcing with systematic bolting.*

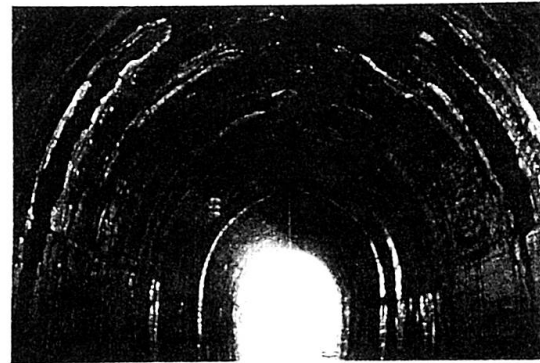
Figure 3. The surface before repair

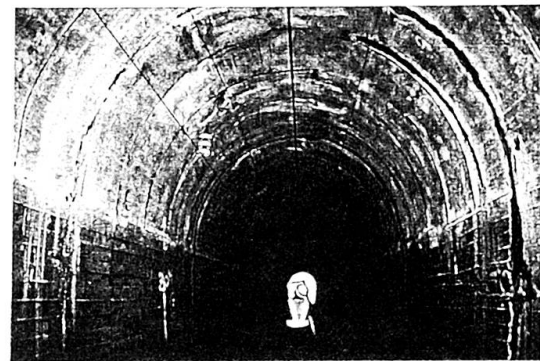
Figure4. The surface after repair

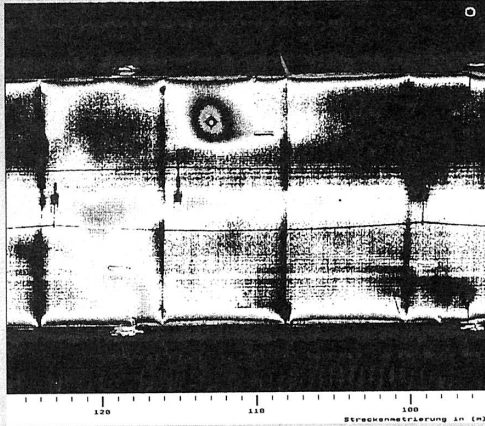
Thermography shows a striking thermal anomaly on the left side wall. Water has intruded into the concrete of the lining.

Drilling: at the depth of 70 cm a strong jet of water exits from the drillhole.

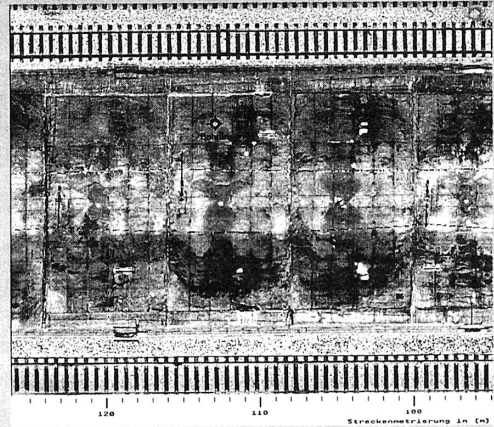
The visual image shows no traces of water on the lining surface.

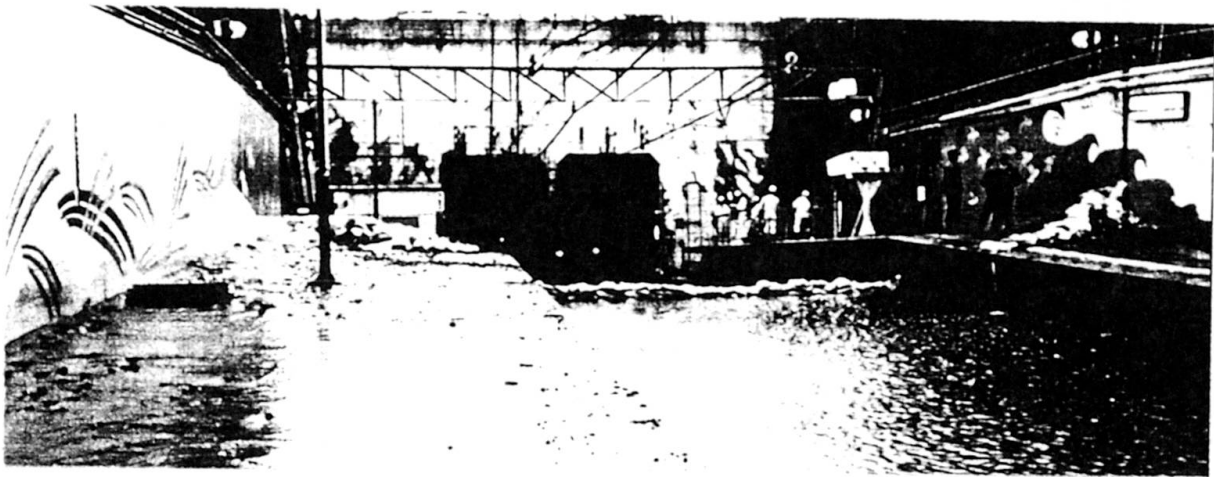
Photo 1 Conditions of Damage

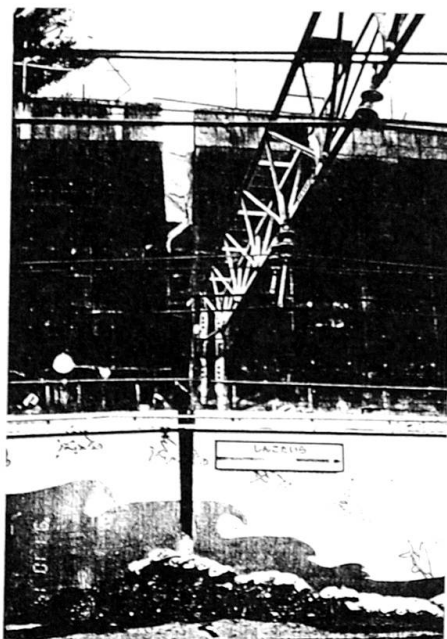
Photo 2 Conditions of Damage

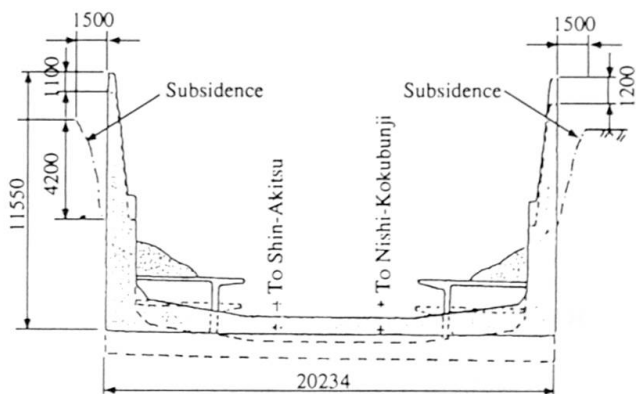
Fig. 1 Conditions of Damage
