**Artikel:** Repair of the Linfjord tunnel, Denmark  
**Autor:** Vejlbj Thomsen, J. / Hededal, Poul  
**DOI:** <https://doi.org/10.5169/seals-59067>

## Repair of the Limfjord Tunnel, Denmark

### **Summary**

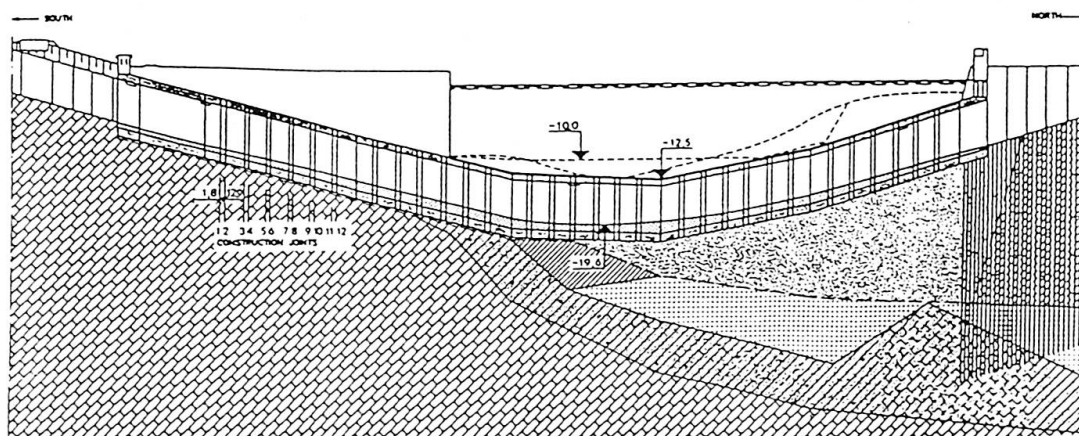
The immersed part consists of five 102 m long precast reinforced concrete units joined together to form a monolithic structure. The units were cast in a dry dock in 12,8 m long sections, separated by 1,8 m wide gaps into which reinforcement bars protruded. The concrete for these gaps was poured after the sections had shrunk.

The leakages were primarily located in the immersed part of the tunnel at construction joints between the 12,8 m sections and the 1,8 m gaps where cracks extend in full depth through walls, top and bottom.

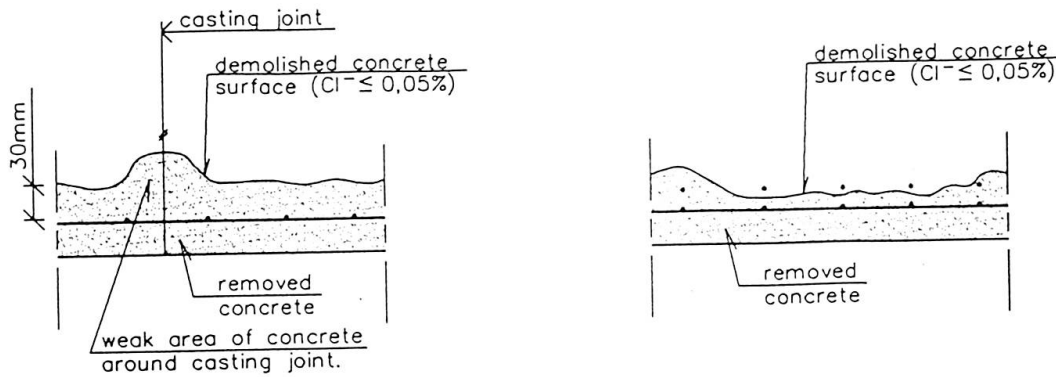
Generally concrete is removed until the amount of chlorides in the concrete is less than 0.05% by weight of concrete, however, never deeper than 30 mm behind the deepest layer of reinforcement unless weak areas of concrete facilitate deeper demolition.

Two typical demolition profile is schematically shown below.

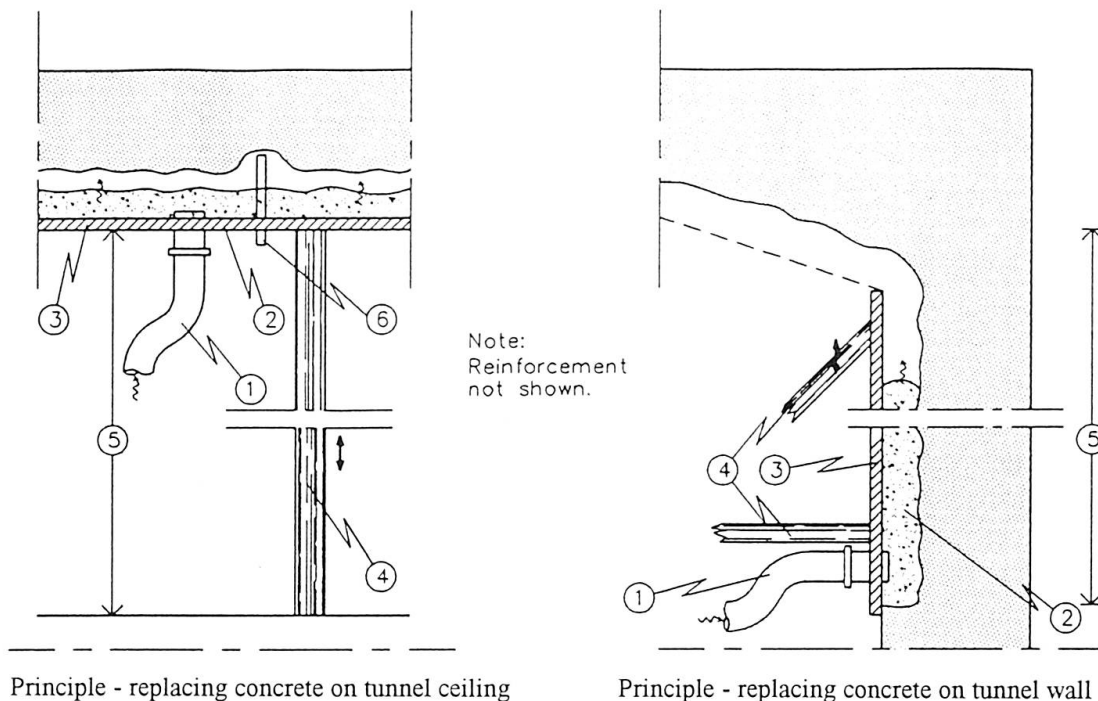
The principle of pumping high-slump concrete is schematically shown on the illustrations below.

- ① Concrete supply, maximum pumping pressure: 1 atm
- ② High-slump concrete
- ③ Form, adjustable in height to comply with varying casting heights, see ⑤. The stiffness and capacity of the form is designed to meet specified requirements on straightness of wall/ceiling at maximum pumping pressure, see ①
- ④ Scaffolding - supporting the form, the scaffolding is accordingly designed to be adjustable in height, and to meet specified stiffness and capacity criteria at maximum pumping pressure. Furthermore, both form and scaffolding is designed to be easily relieved, moved, adjusted and re-established in another location
- ⑤ Casting height varying from approximately 4,5 meters to 5,5 meters
- ⑥ Ventilation tubes to avoid air being enclosed in voids during casting
