Artikel: Rehabilitation of two existing tunnels in West Malaysia: a case study

Autor: Singh, Parnam

Rehabilitation of Two Existing Tunnels In West Malaysia: A Case Study

Parnam Singh
Manager
L&M Structures Sdn
Bhd, West Malaysia

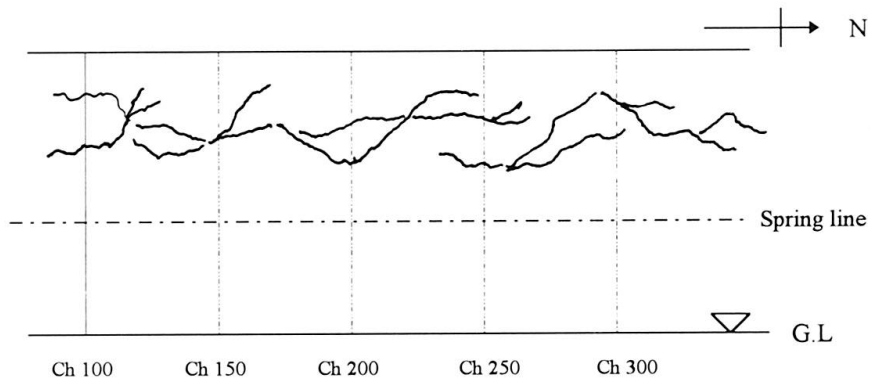
The appearance of cracks in the tunnel lining of both the tunnels was generally of concern to most motorists using the tunnels. However, from the detailed investigation carried out during the assessment programme it was noted that the pattern of cracks was typical of map cracks as shown in Fig. 3. The dry crack pattern was typical for both tunnels and core samples obtained from cracked concrete generally gave details of depth of cracks. Fig. 4 shows typical crack depths as seen in six 50mm core samples obtained from the tunnel linings. A detailed crack mapping exercise was carried out to locate the extent and severity of the cracks according to established chainages along the total length of the tunnels. The cracks were further divided into two main types; dry and wet cracks. Almost seventy percent of the 8500 metres length of cracks measured for both the tunnels fell under the dry crack category. Most of these cracks were contaminated with dirt particles. The remaining cracks were typically wet owing to their depth and location which was close to faults in rocks. The thickness of the tunnel lining varied between almost 850mm at the base

Fig.3 Typical map cracks observed in linings of north bound tunnel

of the tunnel to nearly 300mm at the crown. Most of these wet cracks were contaminated with lime salt deposits.

The dry cracks were first cleaned with a high pressure (1000 p.s.i) water jet using potable water. This was to ensure that the cracked surface was properly prepared prior to the crack repairs. A temporary seal was applied along the length of the cracks leaving masking seals along regular intervals. The temporary seal is an epoxy compound which serves as a barrier to prevent the flow of epoxy from the interior to the surface of the concrete during injection. As soon as the temporary seal was cured, the masking strips were removed exposing cracked concrete at regular intervals which served as entry ports for epoxy injection. The epoxy injection system used for sealing the dry cracks consisted of a low viscosity two component (resin & hardener) epoxy resin which is injected into the cracks using a high pressure, high speed, electromechanical handgun. The primary advantage of this electromechanical system is its ability to mix accurately the two components of the epoxy i.e resin and hardener in the desired ratio eliminating the possibility of inaccurate mix ratios. The epoxy resin is dispensed into the crack via a rubber nipple mounted onto the nozzle of the hand gun. The rubber nipple is pressed against the entry port to allow the entry of the epoxy into the crack. As soon as the epoxy is seen emerging from the adjacent entry port, the flow of the epoxy is temporarily halted by rubbing dry candle wax into the oozing port. Epoxy injection is continued until it appears in the successive entry port. The above steps are repeated until all the entry ports are injected with the epoxy.

The procedure for repairs to wet cracks differs a little from the dry cracks. For wet cracks, 8mm diameter holes are drilled along regular intervals of the crack length to serve as entry ports. Six mm diameter copper tubes approximately 75mm long are inserted into the holes. A temporary epoxy seal is applied to the surface of the cracks to seal off the crack surface between entry ports. The procedure for injection is repeated from the lower most entry port until all successive entry ports are completely injected using the hand gun. The sealing of the cracks using epoxy ensures that the cracks are structurally bonded and free from leaks.

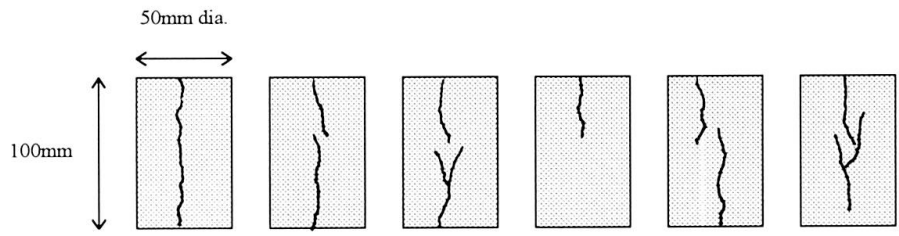
Fig.4 Section through 50mm diameter core samples

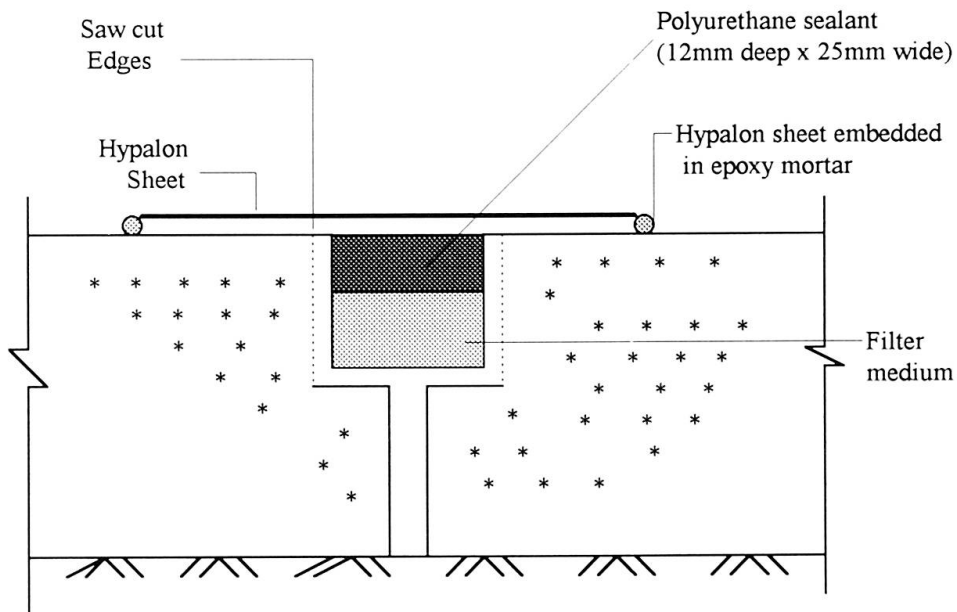
Fig.5 Section through expansion joint

The main defect observed in faulty expansion joints was loose and hardened sealant which had debonded from the existing groove. Some of the joints were affected by seepage of water from behind the tunnel lining. The defective sealant was completely removed to ensure the affected expansion joint was free from loose and debonded material. A chase measuring 25mm wide and 50mm deep was cut along the length of the faulty expansion joint using a diamond saw. The joint was cleaned with a high pressure water jet to prepare the surface for remedial treatment. A filter medium was then installed along the length of the expansion joint to convey trapped water into an adjoining uPVC pipe which was connected to the existing drain. The surface of the expansion joint was then sealed with a 12mm thick polyurethane sealant to prevent seepage of water from the filter membrane. As a protection to the exposed sealant, a hypalon sheet was installed along the length of the joint as shown in Fig. 5.

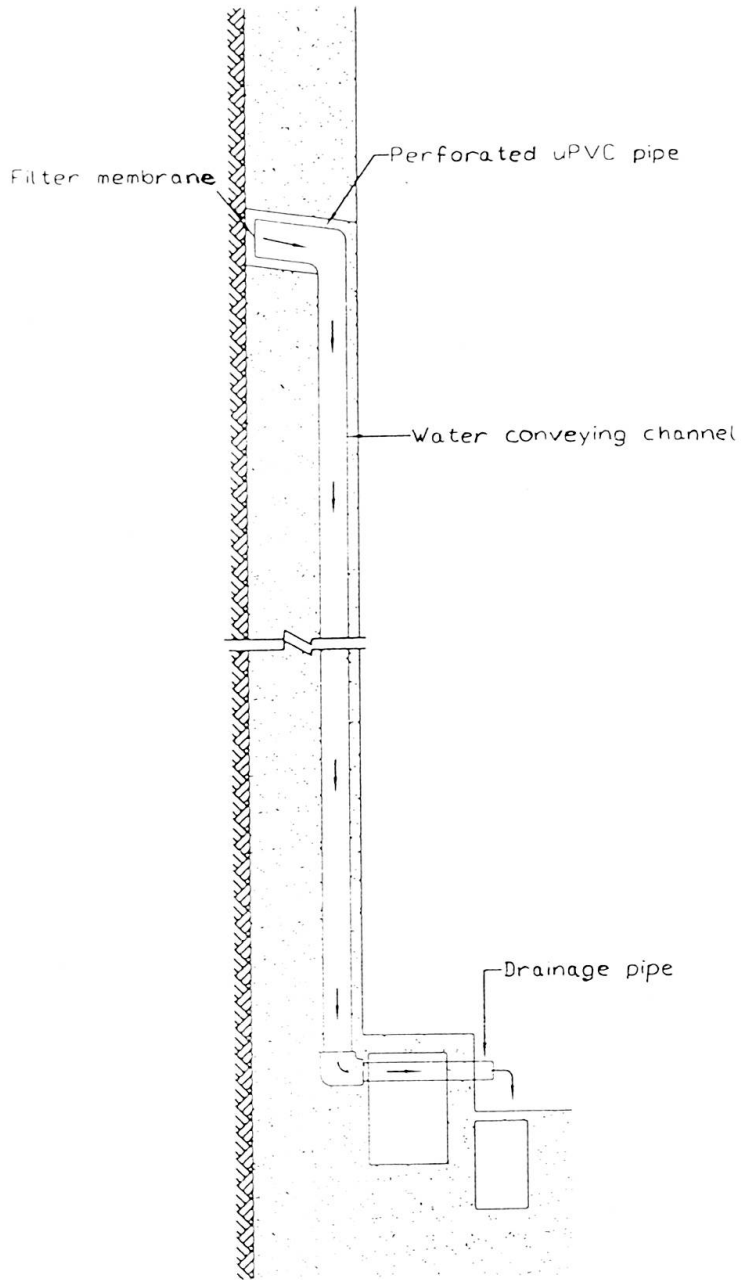
Fig. 6 Section through expansion joint showing drainage system

In expansion joints where excessive seepage of water occurred, additional water relief holes were drilled into the existing concrete lining. A 30mm diameter uPVC perforated pipe was inserted into the concrete lining after cutting a chase. The perforated section of the uPVC pipe was covered with a geotextile to prevent entry of contaminants into the perforations. Water collected in the uPVC pipe was then directed into the existing drains which were located on either sides of the tunnel. The side drains were thoroughly cleaned to ensure these were free from blockages. Fig. 6. shows a typical section of the modified drainage and water relief system.
