## Ten Years' Maintenance of Seto Ohashi Bridges

### Summary

On April 10<sup>th</sup>, 1998, the Seto Ohashi Bridge celebrated its tenth anniversary since its opening. During these ten years, some problems which were due to the initial defects were found. In this paper, the inspection of these bridges is introduced first then some of these problems are reported. These are, the corrosion of main cables of suspension bridges, the damages of cables of cable-stayed bridges due to vibrations, the accident of an inclination of one link type expansion joint, the noise problem of same joints, the noise problem of rolling leaf expansion joints and the noise problem of end links of the Shimotsui-Seto Bridge.

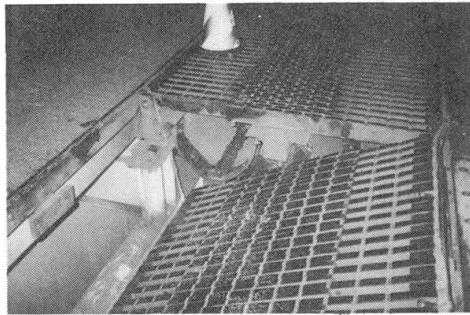
Fig.1 Accident of Link Expansion Joint

On May 3<sup>rd</sup> 1994, there was an accident that one of the link expansion joints of the Iwaguro-jima Bridge inclined and one car was damaged. This accident was due to the fact that the nuts of bolts of the universal joint which connected the expansion joint and the bridge deck loosened and fell. Consequently one end of the joint fell and the whole joint inclined. To prevent same accidents, expansion joint stoppers are installed and cotter pins are applied on all bolts which connect expansion joints and bridge decks. This improvement was finished in March 1995.

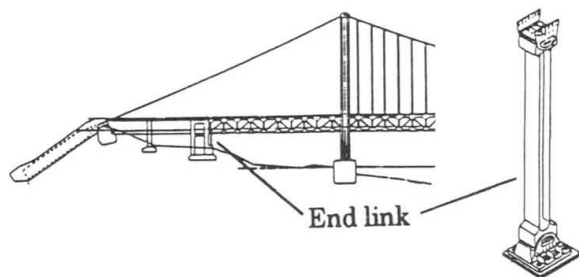
The ends of stiffening truss girders of the three suspension bridges of the Seto Ohashi Bridge are supported upward by end links vertically from beneath the girder. The maximum reaction force of the end link of the Shimotsui-Seto Bridge is 2558 ton, which is about twice larger than other two suspension bridges because this bridge has extended side spans which are not suspended from the main cables. From June 1993, these end links began to make large noises when heavier freight trains passed through the bridge. In January to February 1994, the noise source was closely investigated using the acoustic emission method. It was found that the noise source was the center of the semispherical boss of the lower pivot structure of the end links. The pivot structure consists of a semispherical boss which is embedded on a concrete abutment and a concave semispherical cover which is placed at the end of the link beam and over the boss. It was inferred that the movement of a pivot was not large enough to diffuse solid lubricant embedded in the concave cover, consequently a stick slip phenomenon of metal surfaces occurred and noises were emitted. To prevent this stick slip phenomenon, a hole was bored on a concave cover to reach the center of a boss and liquid lubricant was pressured into the surfaces. This countermeasure worked well and the noise problem was solved. All of the end links of the Shimotsui-Seto Bridge was repaired by this method until 1997.

Fig.2 End link of the Shimotsui-Seto Bridge

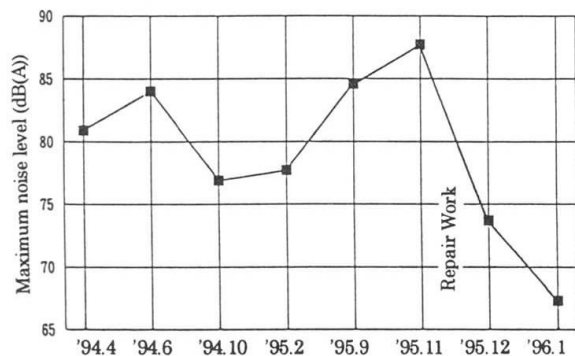
Fig.3 Noise reduction of end link
