# Foundation of bridges on river Ganges in India

Autor(en): **Kumar, Vijay**

Zeitschrift: **IABSE reports = Rapports AIPC = IVBH Berichte**

Band (Jahr): **80 (1999)**

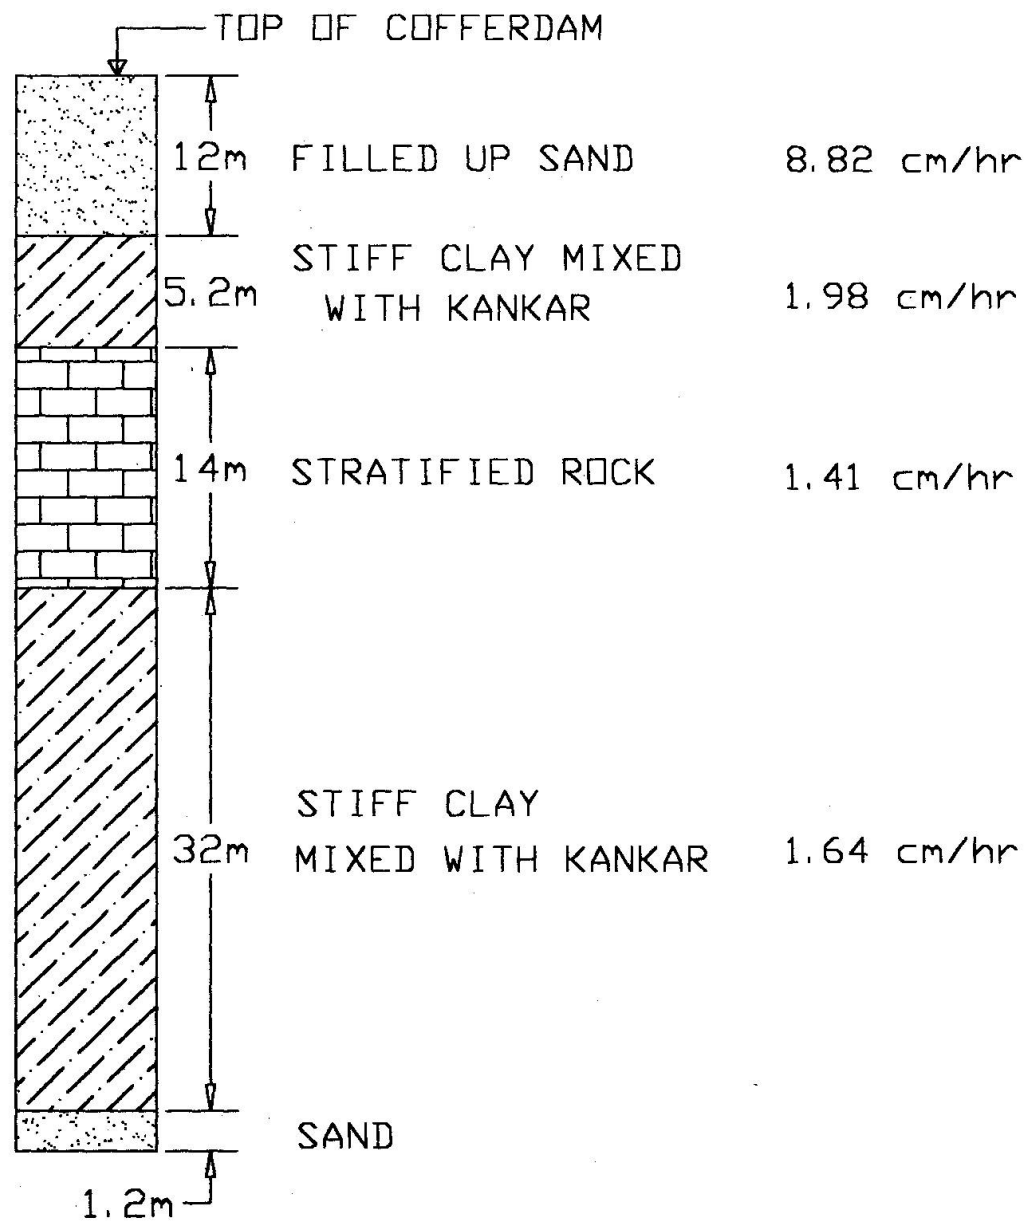
CASE STUDY 1 - DETAILS OF STRATA & RATE OF SINKINGSKETCH 1

The soil strata in general was sandy in the upper layers upto 25-30 m below bed followed by very hard and stiff clay layer, sometimes mixed with kankar. However, in the above location, there was hard clay all through with an intervening layer of hard stone in about 2 m depth. The work of this foundation was started in the month of March by making a 13 m high sheet pile island filled with sand. The curb was cast at the top of this island and sunk through this filled up sand. After the well reached the bed of the river it met with hard and stiff clay strata mixed with kankar. The river bed was sloppy towards one side which resulted in tilting of the well. The well had to be loaded eccentrically against the direction of tilt with about 180 T load. The well was also tied by means of wire ropes with the next well which had already been completed earlier and bottom plugged. The sinking was done by chiselling and grabbing. The weight of the chisel used for this was 2.5 T.

The rate of sinking achieved in this layer was about 1.98 Cm/hr.

The clayey layer was followed by rocky strata at about 18 m below the bed. The well was loaded by concrete blocks of about 180 T and sinking was done by chiselling and grabbing operation.

The rate of sinking achieved in this layer was about 1.41 Cm/hr.

The hard and stiff clay layer which followed after this was dealt with by chiselling and grabbing as above but under loaded conditions with 250 T concrete block over the well. The dewatering of the well was also done to make sump of the required depth to facilitate sinking. The rate of sinking in this third layer was 1.64 cm/hr. The well was finally sunk to its founding level about 65 m below LWL in the sandy strata. The total crane hours for sinking were 3500 hrs.

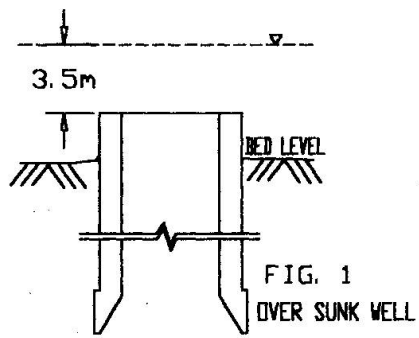
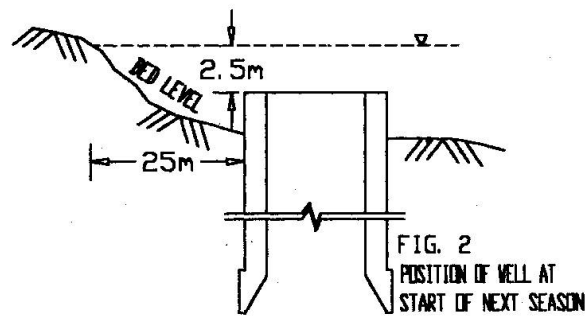
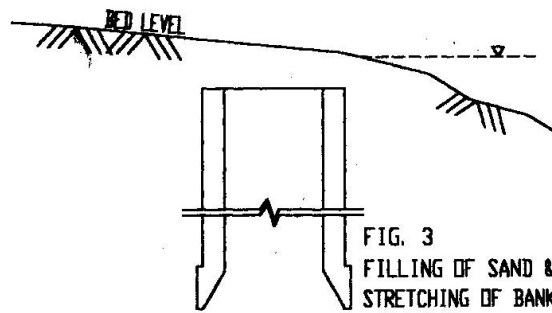
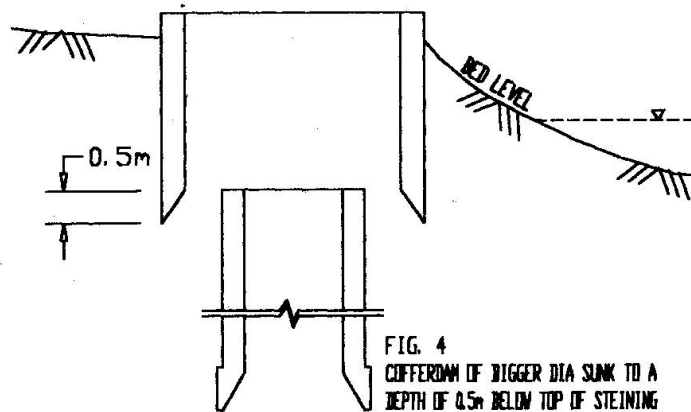
### SKETCH 2

The location of this foundation was in the mid - stream of river Ganges. The diameter of well was 11.66 m with steining thickness as 3.1 m and curb was of height 5.54 m. The curb was proposed to be cast in two lifts of 3.12 m and 2.42 m respectively. Here also, the sheet pile island of 16 m dia was constructed at the location of well in a water depth of about 10m, for laying the well curb at its top. The concreting of first lift involving 180m<sup>3</sup> of concrete was done in 2 days.

After about One and half hour of the concreting, leakage of sand from the island occurred in the upstream side. As a result, the entire curb, after getting tilted towards upstream side, sunk nearly 4.50 m below the water level.

The tilt was corrected by performing the grabbing in between the curb and sheet pile island in the down stream side. After correcting the tilt as above under water, and making the curb vertical, another sheet pile island was made inside the earlier island at a gap of 0.75m. This gap was filled with clay and bags filled with clay. After filling the gap, the dewatering of island was done by means of 4 submersible pumps of 20 KW capacity to a level lower than the concrete level of curb. The shuttering was then erected and reinforcement fixed and immediately concreting of further steining was done. This operation of dewatering and

concreting was continued for nearly 24 hours to complete the concreting of second lift, which also brought the curb top above the water level. The whole process took one complete month. Details shown in the sketch - 2
