Foundation of bridges on river Ganges in India

Foundation of Bridges on River Ganges in India

Vijay Kumar

U.P.State Bridge Corpn.

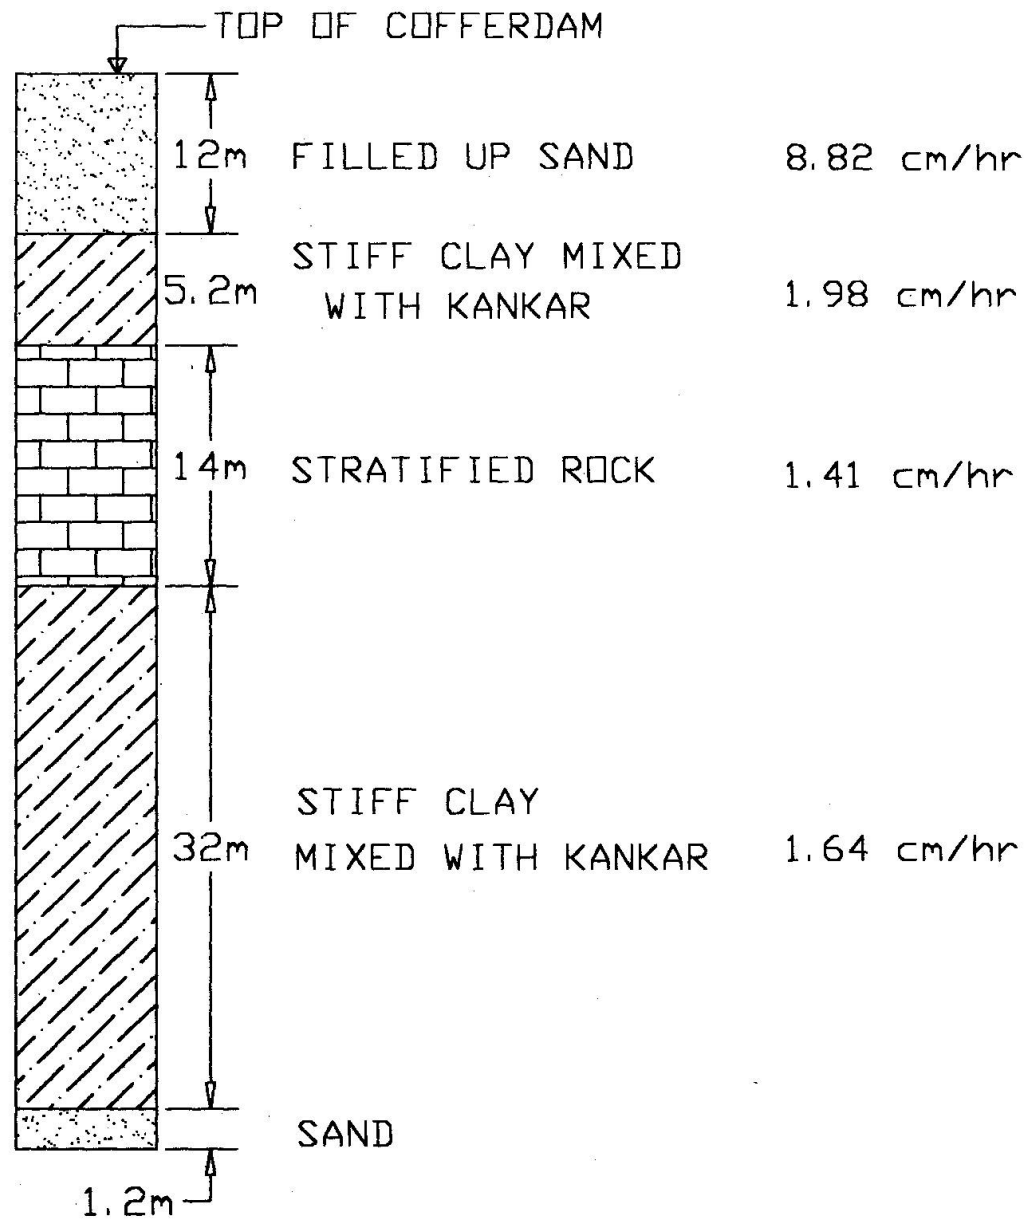
CASE STUDY 1 - DETAILS OF STRATA & RATE OF SINKINGSKETCH 1

The soil strata in general was sandy in the upper layers upto 25-30 m below bed followed by very hard and stiff clay layer, sometimes mixed with kankar. However, in the above location, there was hard clay all through with an intervening layer of hard stone in about 2 m depth. The work of this foundation was started in the month of March by making a 13 m high sheet pile island filled with sand. The curb was cast at the top of this island and sunk through this filled up sand. After the well reached the bed of the river it met with hard and stiff clay strata mixed with kankar. The river bed was sloppy towards one side which resulted in tilting of the well. The well had to be loaded eccentrically against the direction of tilt with about 180 T load. The well was also tied by means of wire ropes with the next well which had already been completed earlier and bottom plugged. The sinking was done by chiselling and grabbing. The weight of the chisel used for this was 2.5 T.

The rate of sinking achieved in this layer was about 1.98 Cm/hr.

The clayey layer was followed by rocky strata at about 18 m below the bed. The well was loaded by concrete blocks of about 180 T and sinking was done by chiselling and grabbing operation.

The rate of sinking achieved in this layer was about 1.41 Cm/hr.

The hard and stiff clay layer which followed after this was dealt with by chiselling and grabbing as above but under loaded conditions with 250 T concrete block over the well. The dewatering of the well was also done to make sump of the required depth to facilitate sinking. The rate of sinking in this third layer was 1.64 cm/hr. The well was finally sunk to its founding level about 65 m below LWL in the sandy strata. The total crane hours for sinking were 3500 hrs.

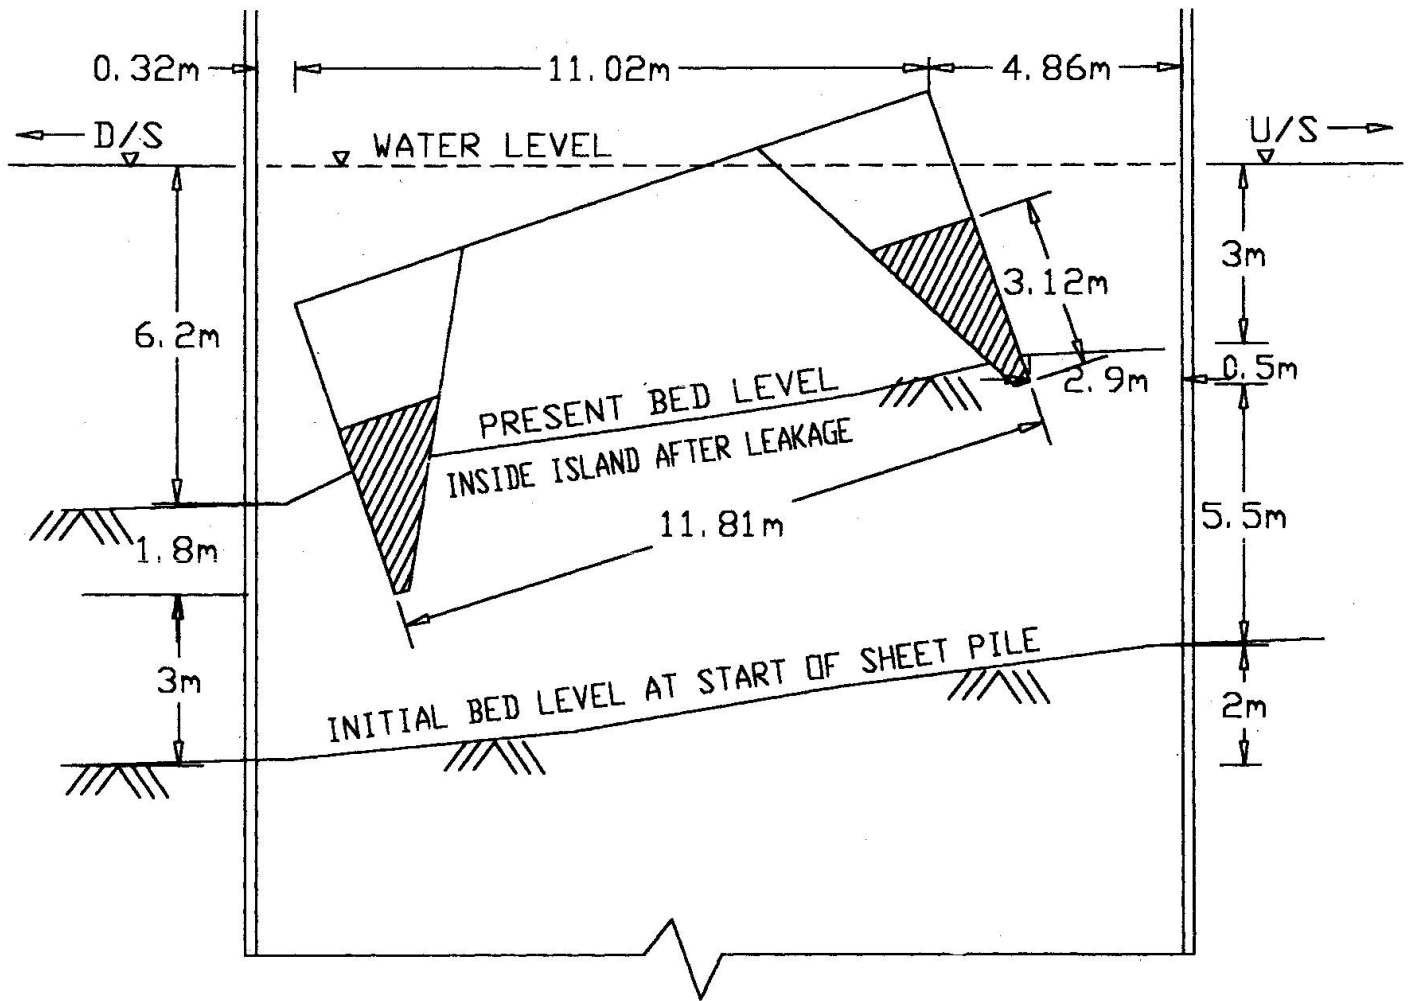
CASE STUDY 2 - REVIVAL OF SUBMERGED CURB

After about One and half hour of the concreting, leakage of sand from the island occurred in the upstream side. As a result, the entire curb, after getting tilted towards upstream side, sunk nearly 4.50 m below the water level.

The tilt was corrected by performing the grabbing in between the curb and sheet pile island in the down stream side. After correcting the tilt as above under water, and making the curb vertical, another sheet pile island was made inside the earlier island at a gap of 0.75m. This gap was filled with clay and bags filled with clay. After filling the gap, the dewatering of island was done by means of 4 submersible pumps of 20 KW capacity to a level lower than the concrete level of curb. The shuttering was then erected and reinforcement fixed and immediately concreting of further steining was done. This operation of dewatering and

concreting was continued for nearly 24 hours to complete the concreting of second lift, which also brought the curb top above the water level. The whole process took one complete month. Details shown in the sketch - 2

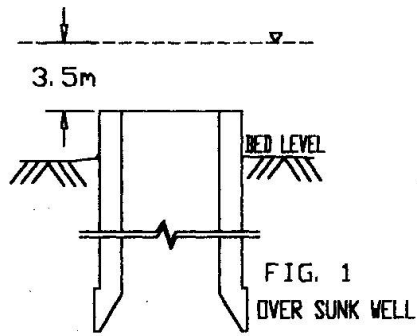
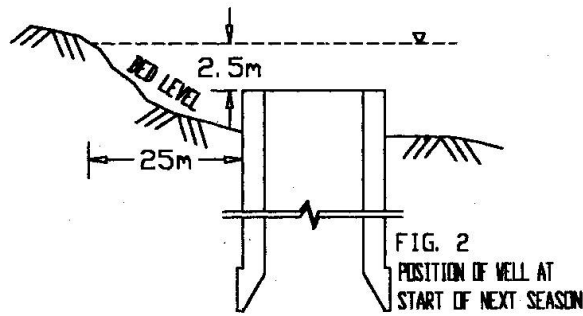
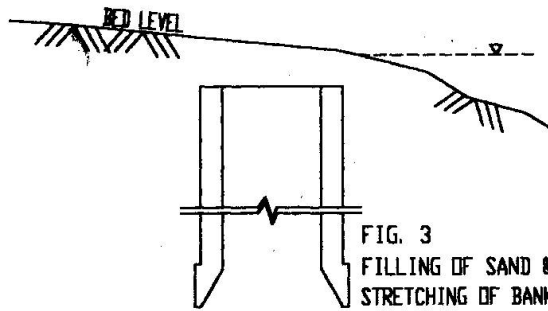
CASE STUDY 3 - REVIVAL OF OVERSUNK WELL

Some times, the well sink suddenly because of excessive grabing or sump or some weak soil layer and the steining of well, done upto that stage which is always kept above the water level by regulating the sinking and concreting operations, goes below the water level making it difficult to continue further work on steining.

In this case, a well foundation was being sunk in deep waters of River Ganges. The total height of steining except last 2.00 m was completed and the well was left to be sunk finally by about 7.5 m to reach its founding level. As the strata was of stiff clay in which the well was stuck up, chiselling and grabing operations were continued to make a sump of about 8 m below the cutting edge. This position of well remained for quite some time. Then one day the well sunk suddenly by 8.91 m, 1.43 m extra below the final founding level. Due to this extra sinking the top of steining also went below the water level by about 3.50 m. All this happened just before the monsoons when the water level started rising and work could not be continued. After the flood receded and water levels normalised, the work was resumed. It was found that the depth of water was 2.5 m. The well was in side the river bed and about 25m from bank. Sand embankment was made from the bank to extend and cover up the location of the well. A cutting edge of 2 m more dia than the dia of well was placed there and a cofferdam with 30 Cm steining thickness was made and got sunk to nearly 0.50 m below the top of the steining of the over sunk well. The concrete cofferdam was then dewatered and steining of the original well was exposed making it feasible to build up further steining to the required level. Details shown in sketch- 3.

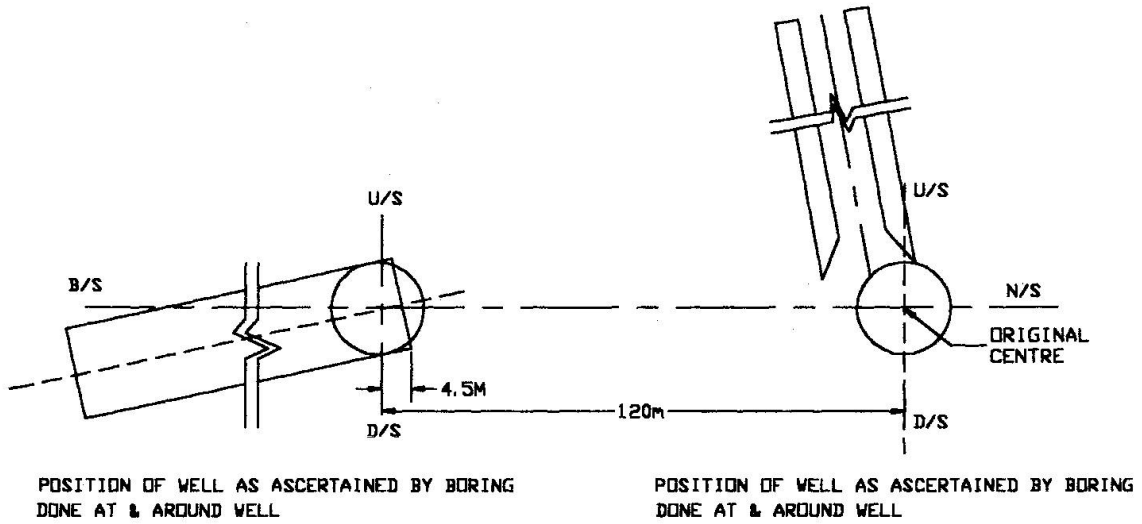
CASE STUDY 4 - SCOURING OF FOUNDATIONS DURING CONSTRUCTION

Two well foundations of a Bridge under construction over River Ganges were scoured below the cutting edge level during the floods and were carried with the flow and laid almost horizontally. The location of the well could not be traced as it was buried inside the scoured bed, later on silted. A number of methods were tried to locate the top of these well. When wells could neither be seen by naked eye nor could be located by various methods, (i.e., weight dropping method, Echo sounding method and through divers after the water level receded, exploratory borings had to be done to trace out the position of the well foundations. This is shown in the sketch.

From the perusal of the data it was seen that at the time of floods these two wells were already sunk to a safer level as far as the normal design scour was concerned and the other wells sunk to this level the same time and in previous years stood well during the floods. Moreover, the design HFL was also not achieved (was about 1.5 m less) which left a fair margin of safety in the depth of foundation at that time. The detailed account of the foundations revealed that there was probably an unforeseen scouring of the river bed along the length of the Bridge which resulted in excessive scour at uniform rate and also in some of the wells
