## CONSTRUCTION AND MAINTENANCE PROBLEMS OF KALIABHOMARA BRIDGE ACROSS RIVER BRAHMAPUTRA NEAR TEZPUR ON NH-37A

C.S.BALRAMAMURTHI  
Chief Engineer, Ministry  
of Surface Transport  
(Roads Wing), New Delhi  
India

SATISH KUMAR  
Superintending Engineer  
Ministry of Surface  
Transport(Roads Wing)  
New Delhi, India

The Kaliabhomara Road Bridge across Brahmaputra near Tezpur, Assam (India) has 24 main spans 120.00m and two shore spans 67.50m each. The span arrangement consists of Pre stressed Concrete balanced cantilever arms of 52.50m long on either side of piers with a central Reinforced Cement Concrete suspended span of 15.00m.

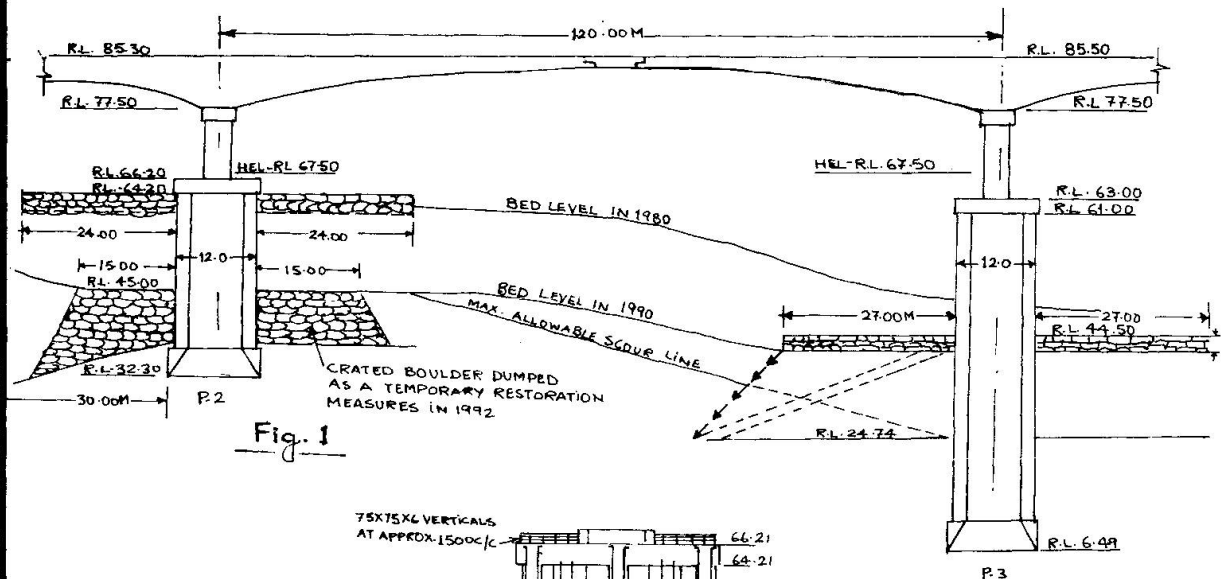
Fig. 1

The bridge work was taken up in December 1981 and completed in all respects by March 1987. When the bridge was under construction the river bed near pier P2 was dry. Later on during the floods of year 1991, the river started attacking the north bank and active channel developed near P2. The wire crated boulder garland was washed away and scour around this well extended up to RL 37.47.

During the year 1988 in the month of April and August a series of earthquakes in the region took place. A routine inspection of the bridge was carried out after the first earthquake on April 16-17/ 1988 when it was noticed that pier P3 showed a tendency of tilting towards south. Further routine inspections were continued and the following inferences were drawn: -

SKETCH SHOWING FOUNDATION LEVEL SCOUR LEVELS AND TENTATIVE PROTECTIVE MEASURES TO PIER WELLS P-2 AND P-3 OF KALIA BHOMARA BRIDGE ON NH-37-A

To arrest scour at RL 45.00m it was decided to provide a boulder apron around the pier. This was feasible since the well was near the bank. The well was protected by providing 60.00m dia, 3.00m thick crated boulder garland packed under dry conditions prevailing at the time of construction of the bridge at the location of well under pier P2 (Figure 3). The top level of this garland was kept as RL 64.12 and it was decided that the performance of this garland should be closely monitored so that under no circumstances the scour be allowed to reach below the RL 45.00, the calculated maximum scour level for which the well was found to be safe. Regular probing is being done now to see if the level has gone below RL 45.00 in which case crated boulders are dumped to make up the level difference.

Protection measures and replenishment of washed away boulders were carried out by dumping wire crated boulders and the top level of the garland was brought back to RL 45.00. A close monitoring of the top level of the garland up to RL 45.00 is being maintained by taking levels at regular intervals. This level has appeared to stabilize at RL 45.00.

- 1) The slab seals of the expansion joints are being replaced.
- 2) The pier P3 is kept under constant observation and as already mentioned in (d) in prepara no further tilt is noticed.
- 3) A garland of wire crated apron for a thickness of 2.50m has been provided with the top at RL 44.50m and for a diameter of 66m.

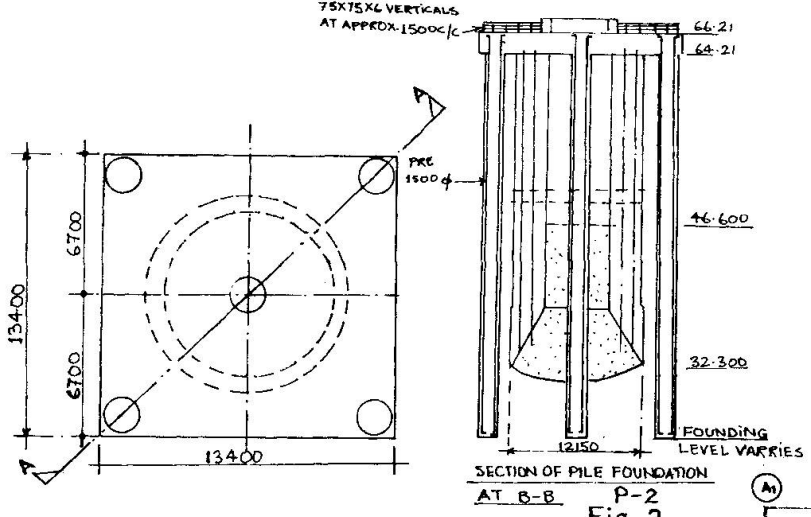
SECTION OF PILE FOUNDATION AT B-B P-2 Fig. 2

Sinking of well under Pier P2 was the first activity with which the work of Kaliabhomara Bridge commenced. It also so happened that it was the last foundation to be completed. As per preliminary sub-soil investigation report the strata for founding this well appeared to have dense sand. However after sinking for 25m deep upto RL 35.60m against the design founding level of RL 5.00m, the work slowed down as it encountered bouldery strata. For two seasons the work of removal of boulders continued and after removing 100 boulders the well reached a level of RL 32.08m. At this point the stability of the well was checked for scour considerations and it was established by the calculations that if the scour could be controlled at RL 45.00m the well will be safe. Secondly though the calculations proved that the well would be safe under normal conditions, under seismic effect there was tendency to develop tension.

To solve the second difficulty of development of tension under seismic conditions, it was decided to provide 4 No.R.C.C.bored piles of 1.50m dia on the outer periphery outside the well and 1 No. similar pile in the middle though the dredge hole (Figure 2). Apart from this a combined well-pile cap, square in size was provided so as to act as a

composite unit. This was based on the analogy of stays for a tower. The piles however had to be terminated at different levels due to the rock sloping steeply towards the riverside. The central pile has been taken to RL 24.00m and other piles to levels varying from RL 29.00 TO RL 32.00m. Thus the piles take care of the tensile (uplift) forces under seismic condition and ensure stability of the foundation as a whole. The above solution was preferred since the other alternative of anchoring well by inserting anchor rods through well steining or driving piles through the bottom plug was not considered satisfactory due to bouldery strata.

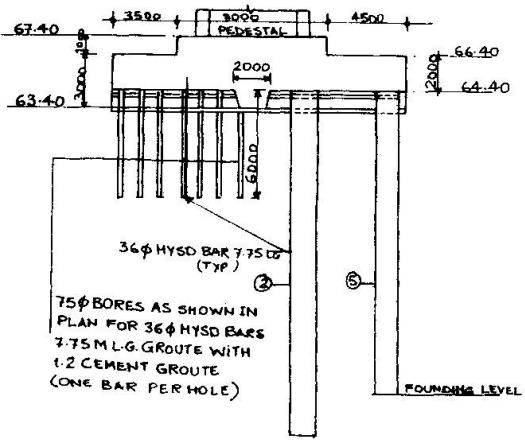
SECTIONAL ELEVATION AT A-A P-1 Fig. 3

During initial sub-soil investigations conducted in 1980 it was observed that the founding strata for pier well P1 would be on a dipping surface of rock. To overcome this the bridge was shifted by about 60m towards northwards. However when detailed boring was conducted at the shifted location of P1, it indicated the presence of a combination of hard

strata in northern half at a higher location and soft strata in southern half. On practical considerations, it was clear that it was not possible to provide a well foundation for shallow depth due to risk of tilting. Thus there was a design problem.

A separate design for pier P1 was carried out by providing a raft foundation for supporting the pier. The raft was designed in the following way: -

- 1) On the south side where the strata was soft, the raft was supported on 6 No. of bored piles of 1.50m dia.
- 2) On the north side where hard strata was found, the raft was anchored into the rock by means of 98 Nos.36 mm dia HYSD rock anchors.

Further in the design it was assumed that the piles would not share any longitudinal force. However the rock anchors would share part of the longitudinal force. They were designed for 9 t of uplift force. Balance force was proposed to be taken care of by providing shear keys underneath the raft in the form of beams embedded in the strata below. For this purpose large size R.C.C. shear keys were provided in both directions under the pile cap (raft) by cutting trenches below soil in a grid pattern and casting beams which formed an integral part of the raft.
