# Dynamic test of a pedestrian bridge as part of safety assessment

## Dynamic Test of a Pedestrian Bridge as Part of Safety Assessment

The results of the dynamic tests carried out on the approach pedestrian bridge to Civita di Bagnoregio, Italy, are shown. The structural elements were in bad conditions due to the carbonation of concrete. The results of the experimental campaign allowed to state that the structural behaviour of the bridge was quite similar to that we could expect. Under ambient vibrations the structure behaved as a whole, formed by the piers linked at their tops by means of the beams.

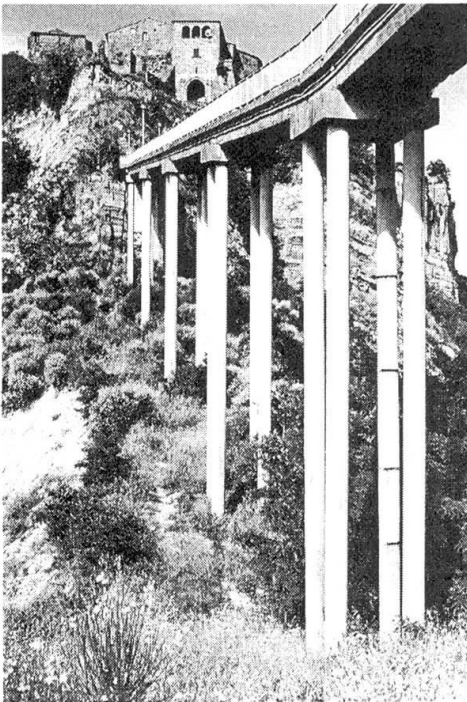
Fig. 1 Piers 1 to 5

The approach pedestrian bridge to Civita di Bagnoregio is composed by 14 spans, which are simply supported on the piers. These are spaced by about 19.00 m. Starting from Civita we first find a 20% steep slope, which interests five spans. The heights of the piers from pier 1 to pier 5 vary from 11 to 15 m, pier 4 being the highest. The viaduct between pier 5 and pier 9 is almost horizontal while in the last part, from pier 9 to pier 13, it shows a 6% slope. Piers from 6 to 13 are much shorter than the others. The girder is composed by three pre-stressed concrete beams and a concrete slab. The total height of the cross-section is 80 cm. The horizontal distance between the beam axes is 90 cm, the total width of the bridge is 2.50 m, included the two longitudinal parapets. Each span has a length of about 16.70 m, but the first one is 16 m. The beams are supported by the upper plate of the piers by means of leaden pads. All the piers are composed by 4 circular pillars, whose diameter is 50 cm, and by an upper plate of 65 cm height. The pillars start from a rectangular foundation plate, supported by concrete piles with a maximum length of 25 m. The structural elements were in bad conditions due to the carbonation of concrete. All the external beams were damaged, the phenomenon being favoured by the combined action of rain and wind. Several cracks could be seen in the pillars, where the concrete cover was split and the reinforcement bars was uncovered. The upper plates of the piers were damaged too.

The structure showed a very high deformability, more evident in the part where are the highest piers. This characteristic, due to the slenderness of the vertical elements was emphasised by the structural damages, which resulted in a reduction of the effective cross-sections of the pillars. Therefore the viaduct was very vulnerable to wind actions, which are particularly insidious in the area. Besides, when the bridge is very crowded the natural wind flow is obstructed, the vertical structures very stressed and the vibrations could be amplified very much.

We suggested that all the piers should be repaired, in order to be suitable to support the vertical and horizontal loads that can act on the structure. No works were needed on the foundation structures. These may be damaged in the future because of the landslides and the continuous erosion of the soil surface. Therefore they should be monitored or frequently tested.
